## Energy Services Department

Ref No. Docket PG-080110

**Subject: 2008 Standard Natural Gas Inspection – City of Ellensburg, Washington**

Thank you for the opportunity to comment on your letter of November 21, 2008 concerning the audit and inspection of the City of Ellensburg's natural gas system. Attached to this letter you will find a detailed response to the alleged violations found during the audit as well as the corrective actions taken by the City to address the issues raised.

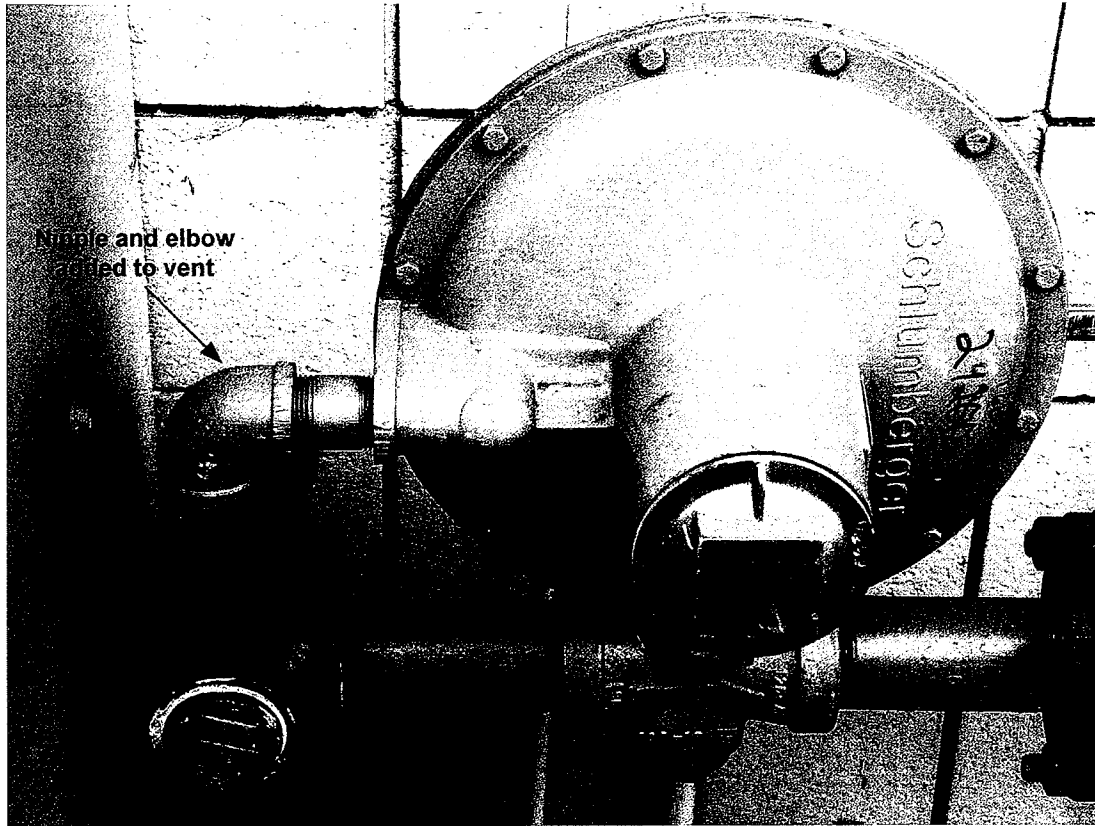
**Bar 14 - Showing modified vent (above)**

3 i. & ii. – The regulator installations did not go against manufacturer’s recommendations as there are no recommendations from the manufacturer’s of these regulators regarding the orientation of the vents. Copies of the manufacturer’s information (included in Attachments) show that vents can be ordered in any orientation. No regulation or, incorporated by reference, codes (ASME B31.8, etc.) dictate that regulator vents should face vertically down. [Note: although not required, to avoid future confusion the vents in question were re-oriented vertically down.]

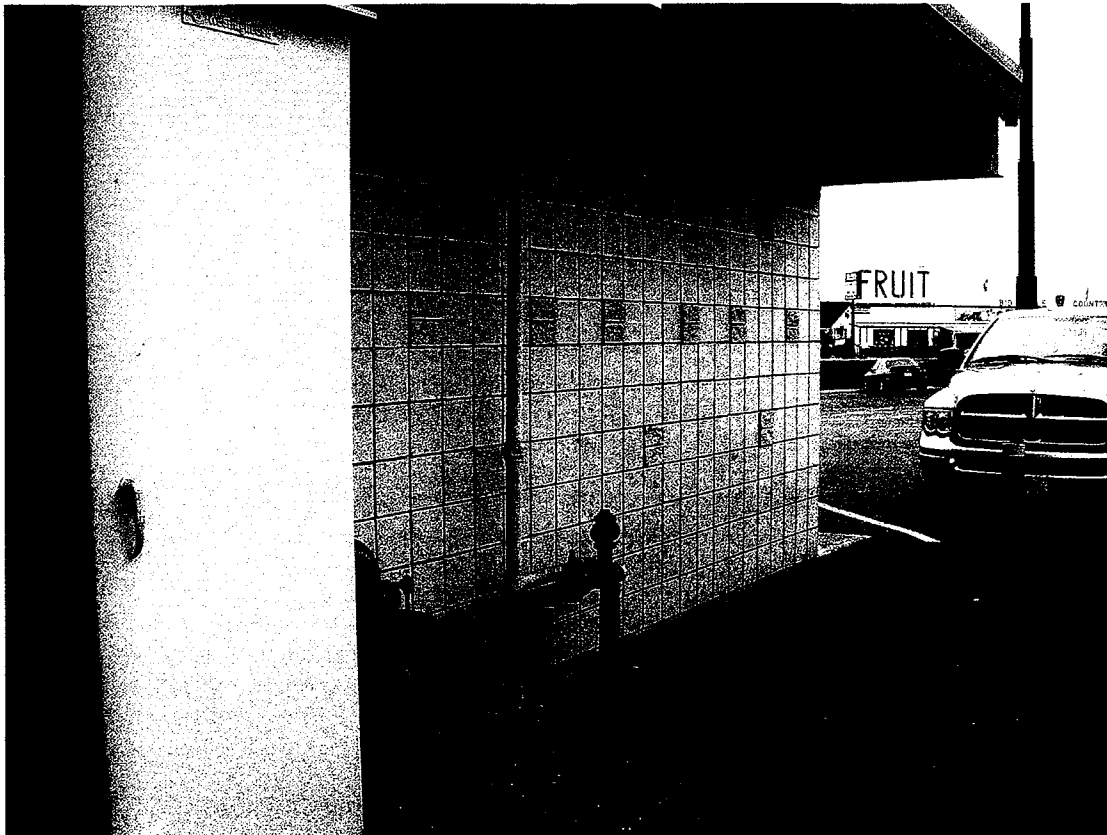
**Bar 14 - Showing meter location and (vent) protection from weather (above)**

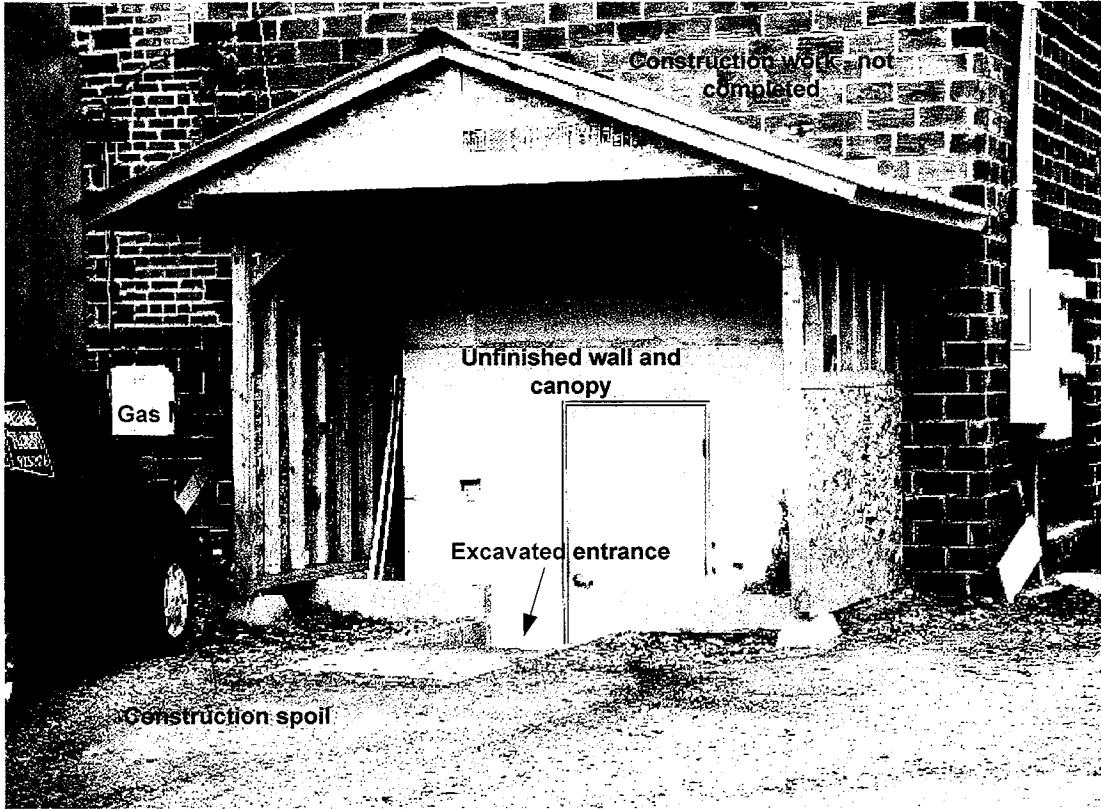
Rear of 600 N. Main Street showing building addition (Above)

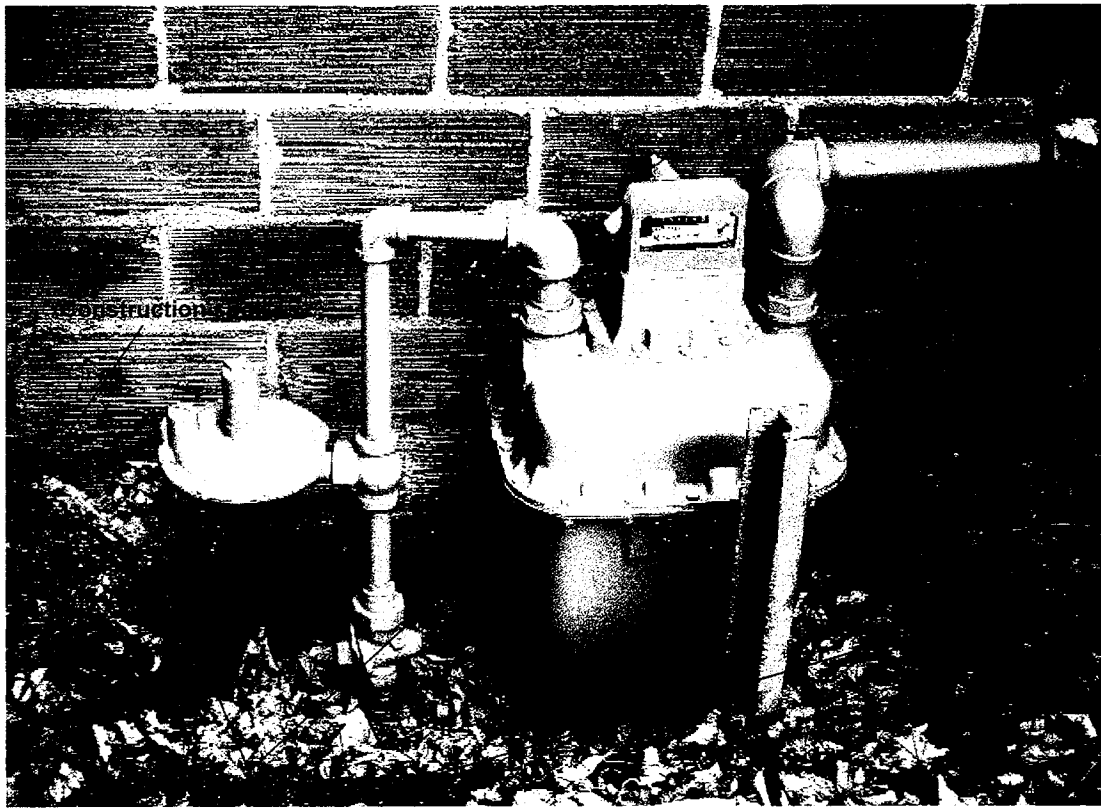
Rear of 600 N. Main Street showing existing gas meter (Above)

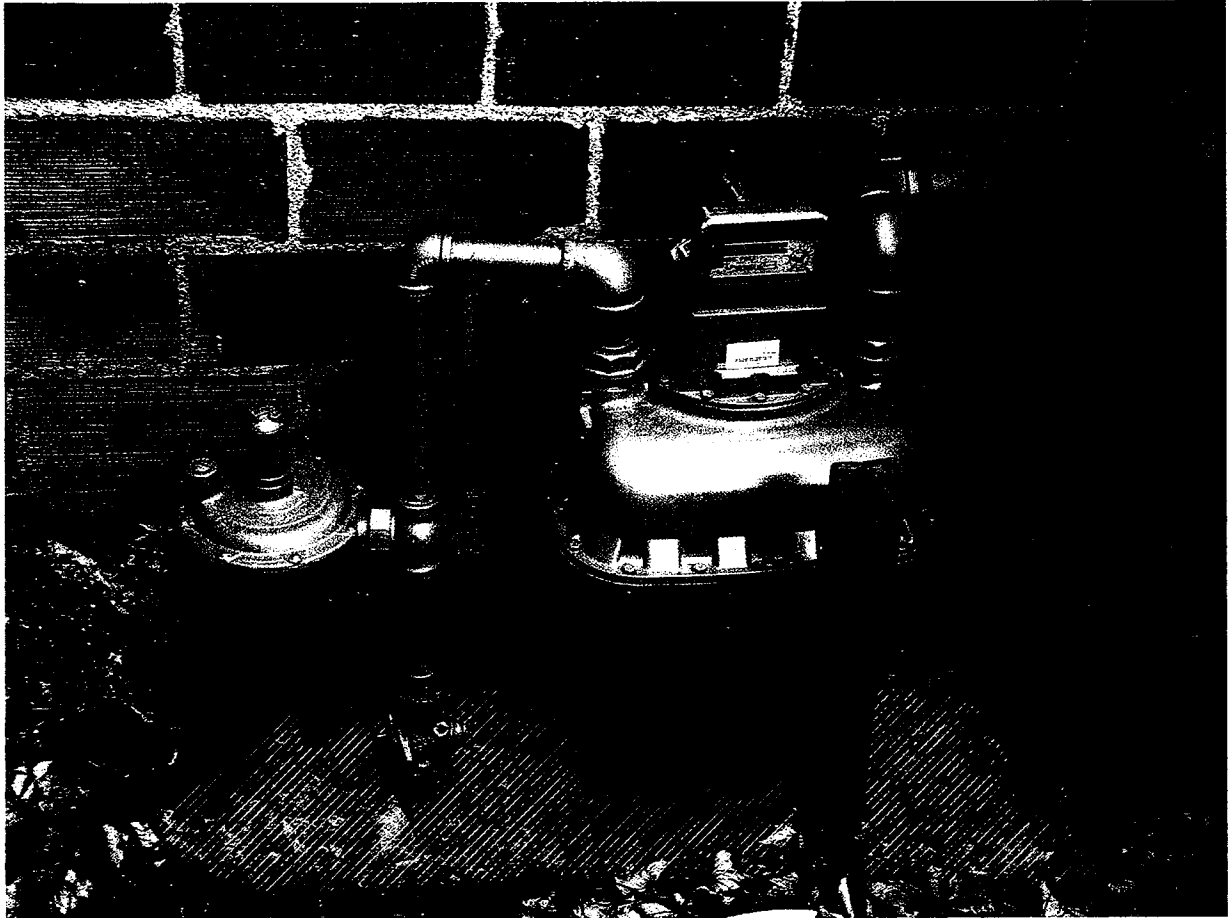
**Rear of 600 N. Main Street showing approx. ground level before building work**
