POST INSPECTION MEMORANDUM

Kelso-Beaver Pipeline Company
c/o Cascade Natural Gas Company
222 Fairview Ave. N
Seattle, WA 98109

Unit Inspected: Washington side of pipeline **Unit ID:** 9775

Inspection Type: I01 Standard Inspection Report, I08-OQ Field Verification

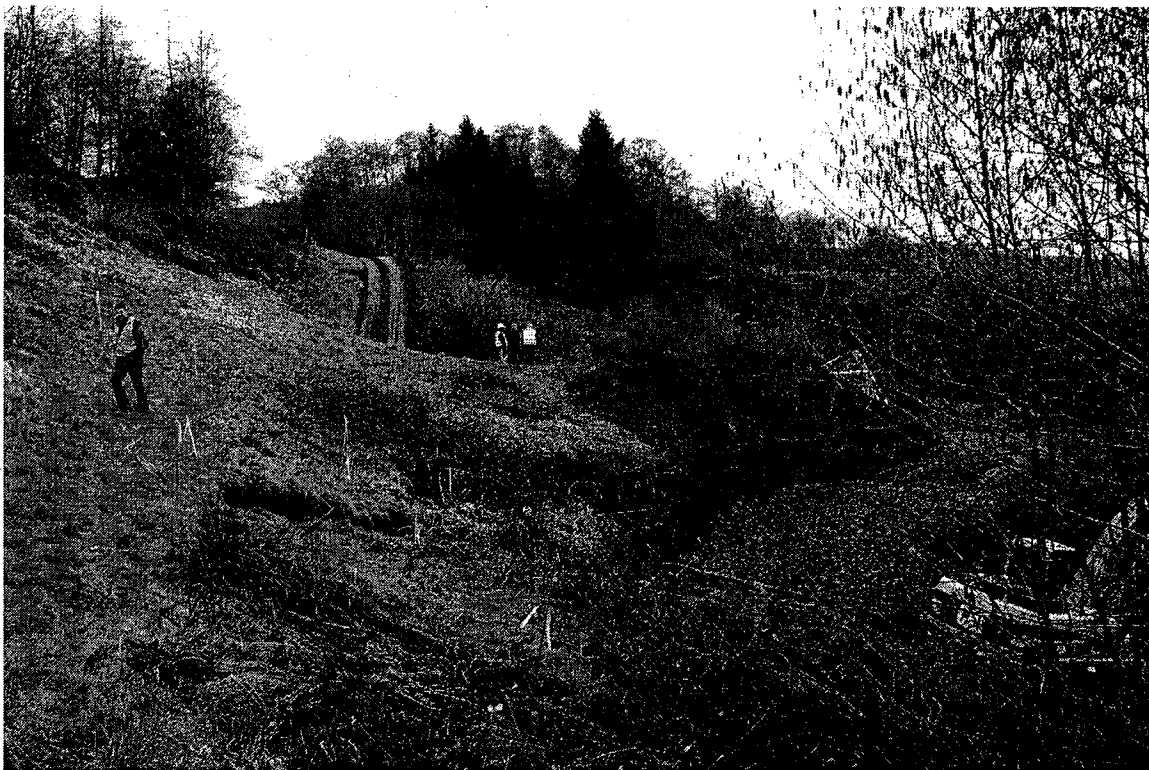
Probable Violations/Concerns: No Probable violations identified. One Area of Concern noted. The integrity of the pipeline at the "Hazel Dell Road Slide Area" is a great concern to us. The landslide is active in the "Flow Slide" area and there were signs of ground movement adjacent to the pipeline. The majority owner of the pipeline (PGE) started monitoring ground movement over the pipeline by using their own survey crew in 2000. Since 2006, PGE has been monitoring this area every two weeks during the rainy season (Nov. 1 through April 1), with additional monitoring following a 2-inch rain event in a 24-hour period. During the dry season, monitoring takes place every six weeks.

PGE stated that throughout the surveillance period, the pipe and the adjacent ground has not moved in this area. During the field inspection, we noticed that there were scarps down-slope of the pipeline and up-slope of the pipeline with approximately 50 feet separating these two scarps (with the pipeline in the middle).

We believe that the pipeline is under stress and it is holding the soil from sliding downward. New French drains were installed to improve drainage down-slope of the pipeline right after our field inspection. We recommend that the pipeline should be shut down and depressurized, and the section around the Flow Slide area be exposed to relieve pipe stress.

The K-B Pipeline is located below where the man in orange vest was standing on the left side of the picture.

PGE should consult with their geotechnical consultant to install French drains up-slope of the pipeline to minimize water from flowing into the area around the pipeline. Strain gages and piezometers should be installed to monitor pipe movement and ground water lever. The exposed pipe section may be re-buried. Alternatively, this exposed pipe section may be above ground with pile supports in lieu of strain gages.

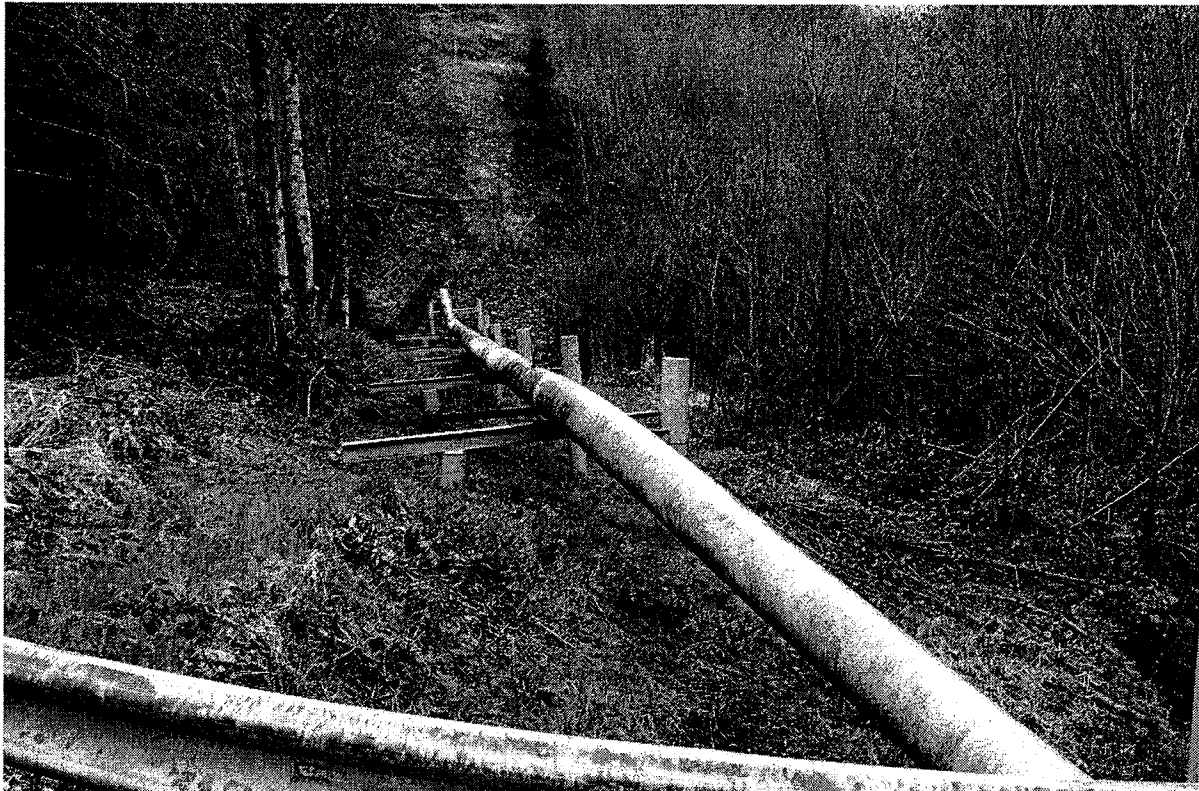
The aboveground section of the K-B Pipeline on pile supports looking toward the active landslide area at the top of the slope.
