TECHNICAL MEMORANDUM

SUBJECT: Summary of Field Testing and Test Results for 8" Bremerton Transmission Line #2

PROJECT NAME: CNGC Asset Management

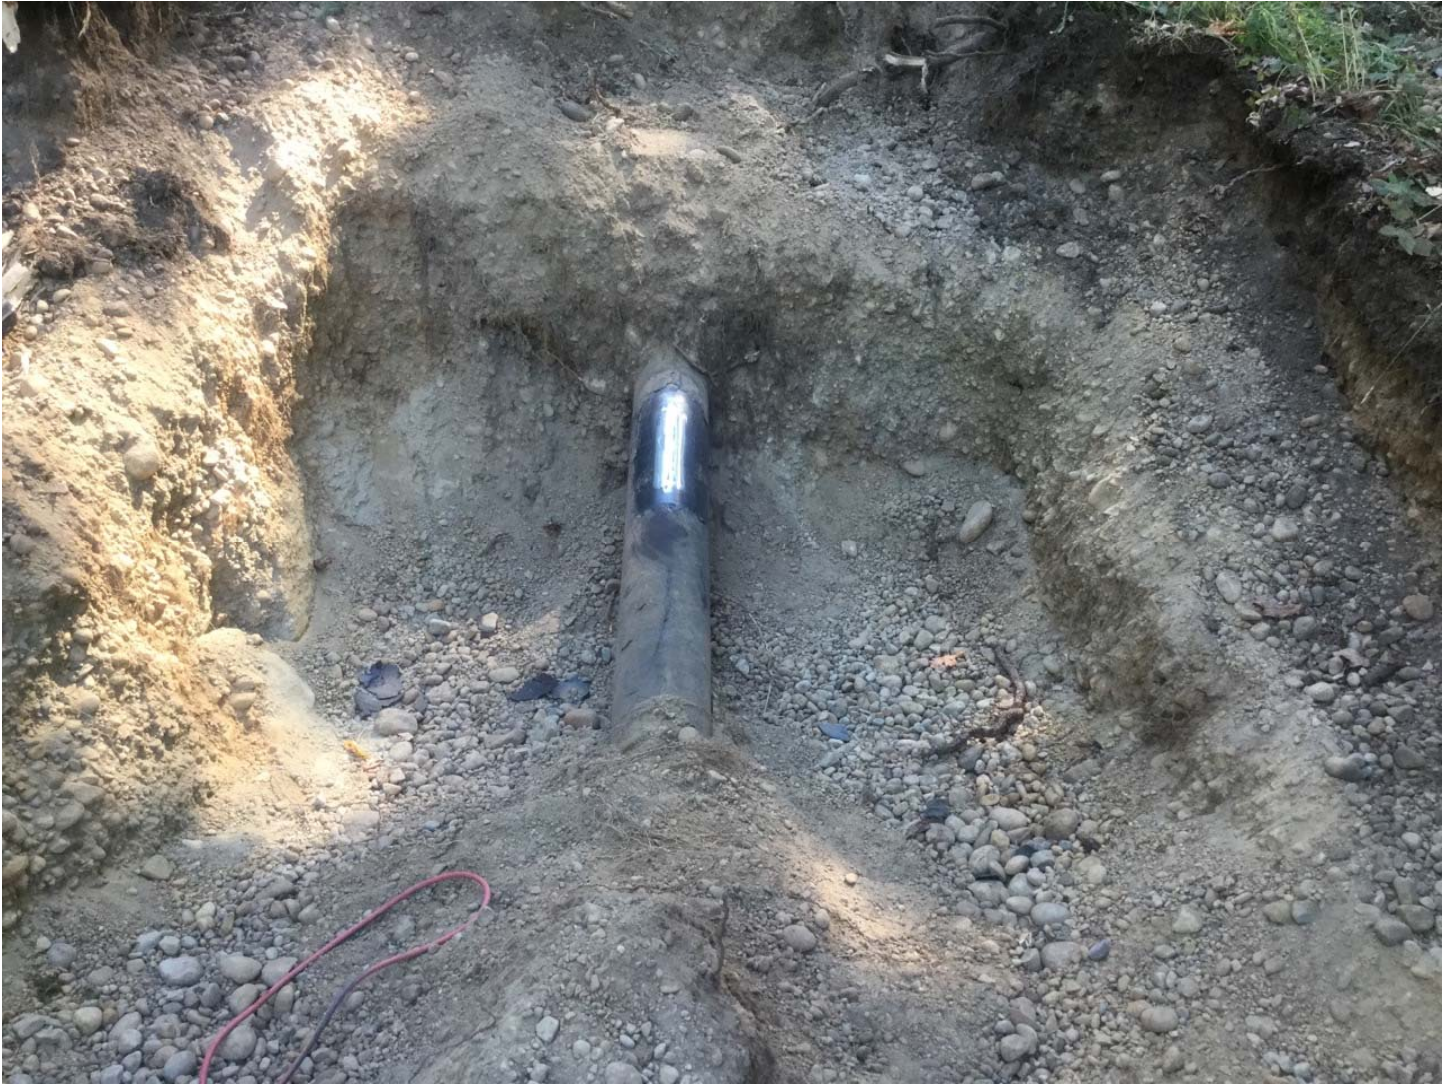
Pipeline Segment: 8" Bremerton Transmission Line #2 **Sample Order #:** 2 **Type:** Pipe **ID:** 38

Vegetation Condition: Scotch room, blackberries, salal, weeds

Soil Condition: Sand **Comments:** Gravel

Site Condition: Dry

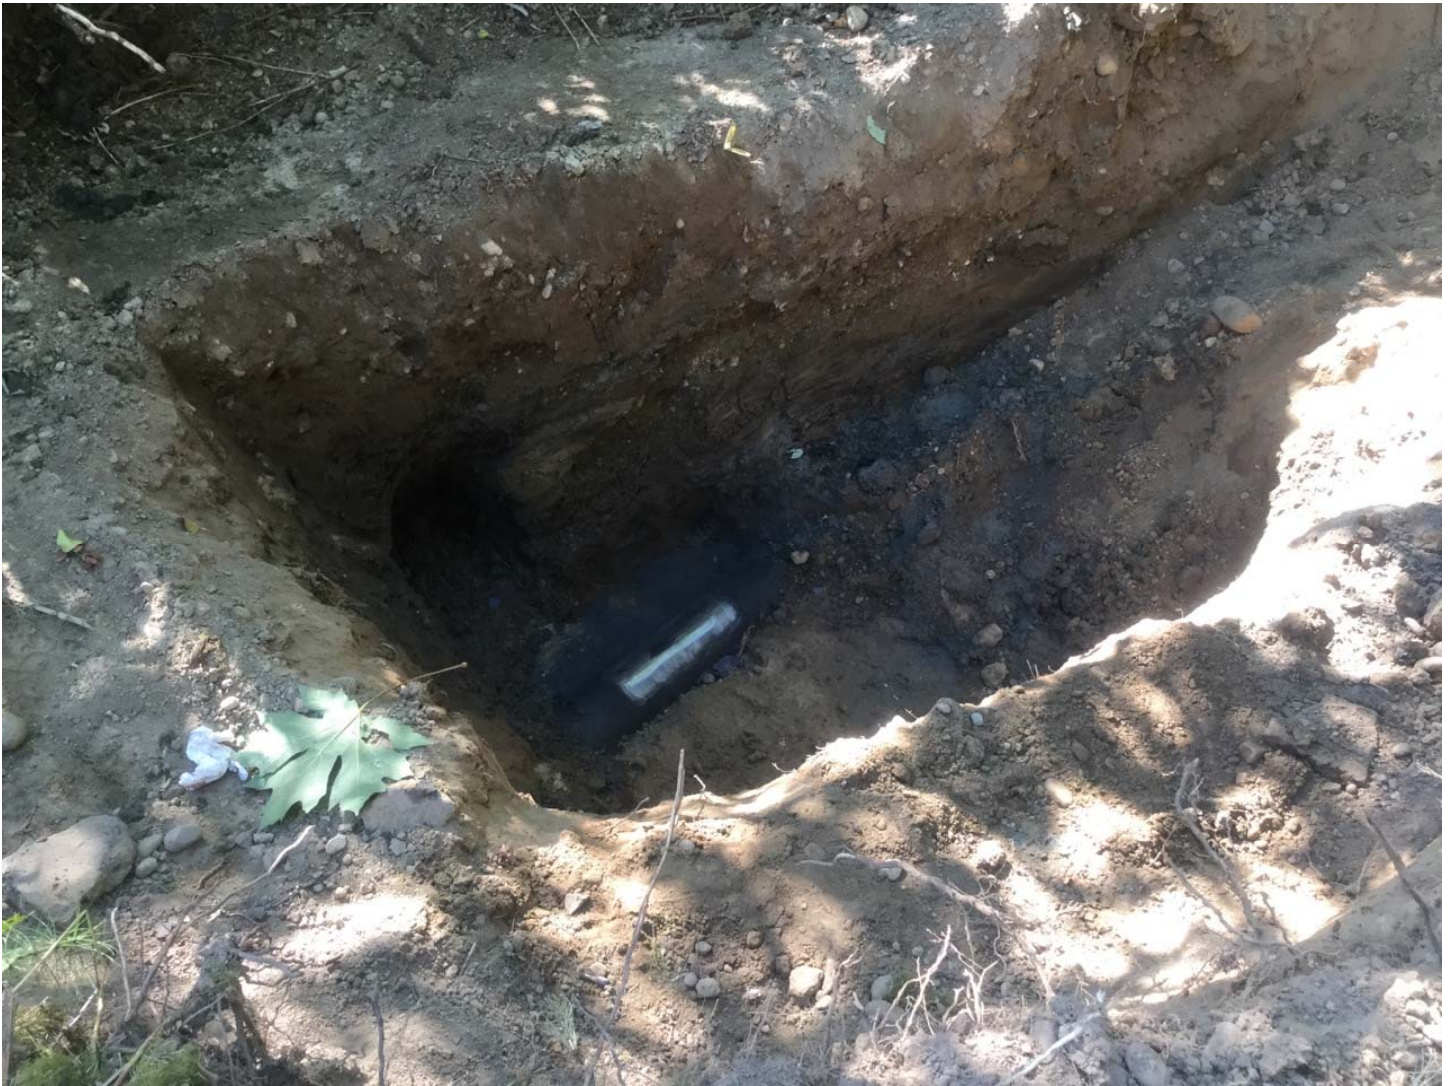
Pipeline Segment: 8" Bremerton Transmission Line #2 **Sample Order #:** 4 **Type:** Pipe **ID:** 1

Vegetation Condition: Blackberry bushes and weeds

Soil Condition: Sand **Comments:** Clay present at trench bottom

Site Condition: NA

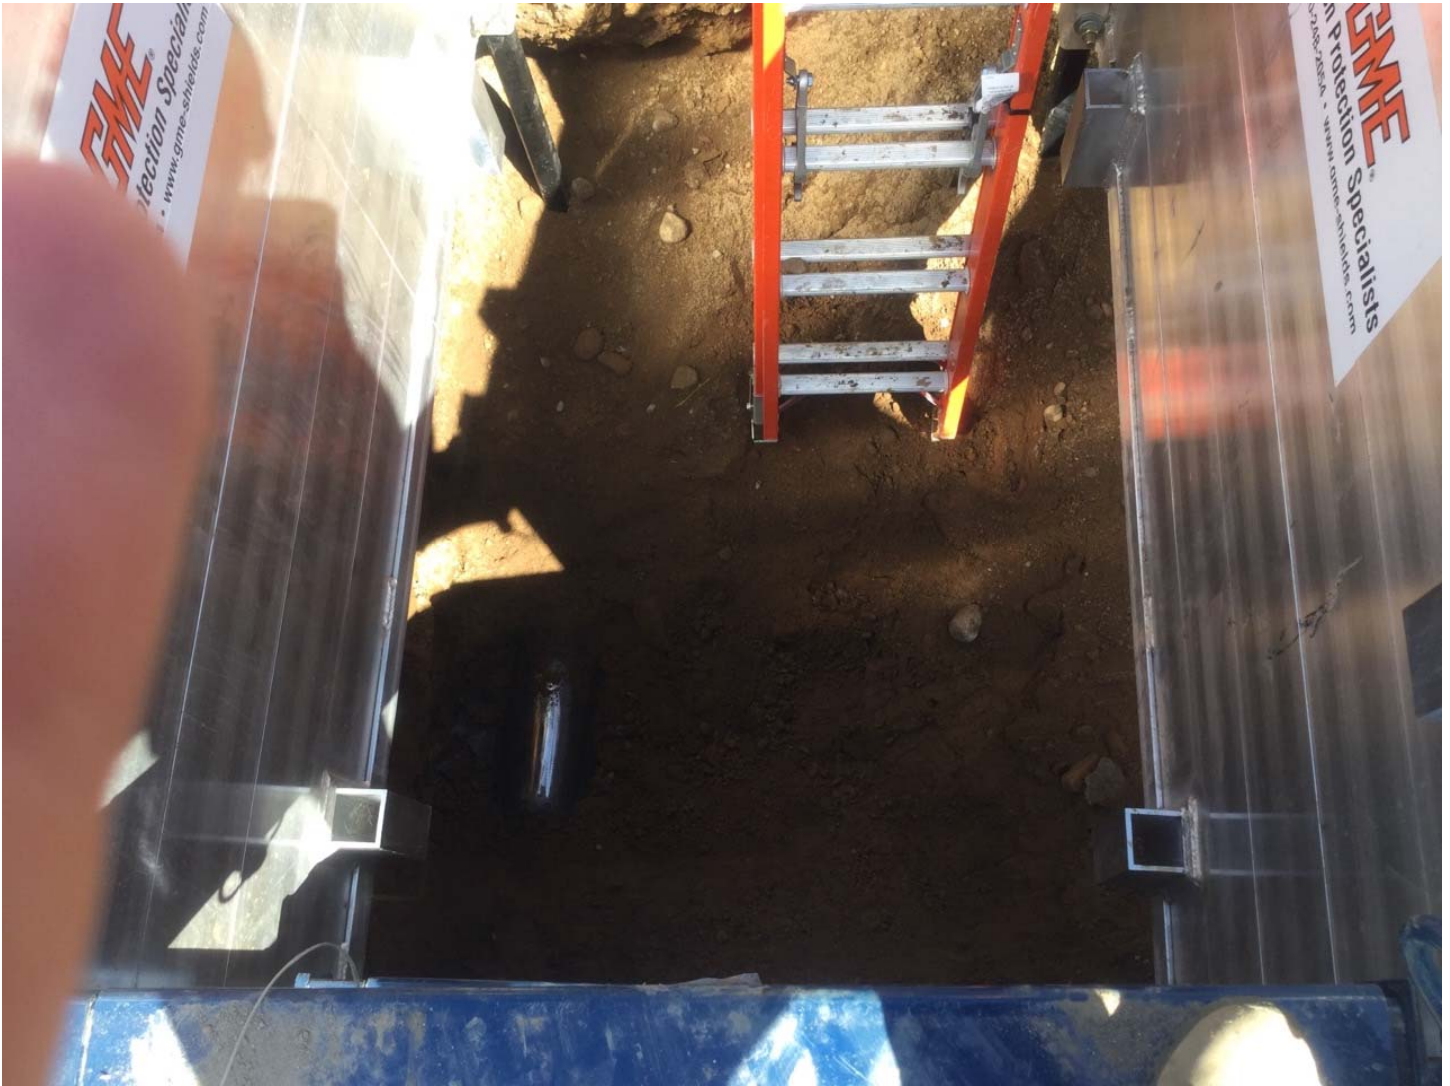
Pipeline Segment: 8" Bremerton Transmission Line #2 **Sample Order #:** 5 **Type:** Pipe **ID:** 57

Vegetation Condition: In pavement

Soil Condition: Sand **Comments:** Gravel

Site Condition: Sample in driveway to Port Orchard Sand and Gravel

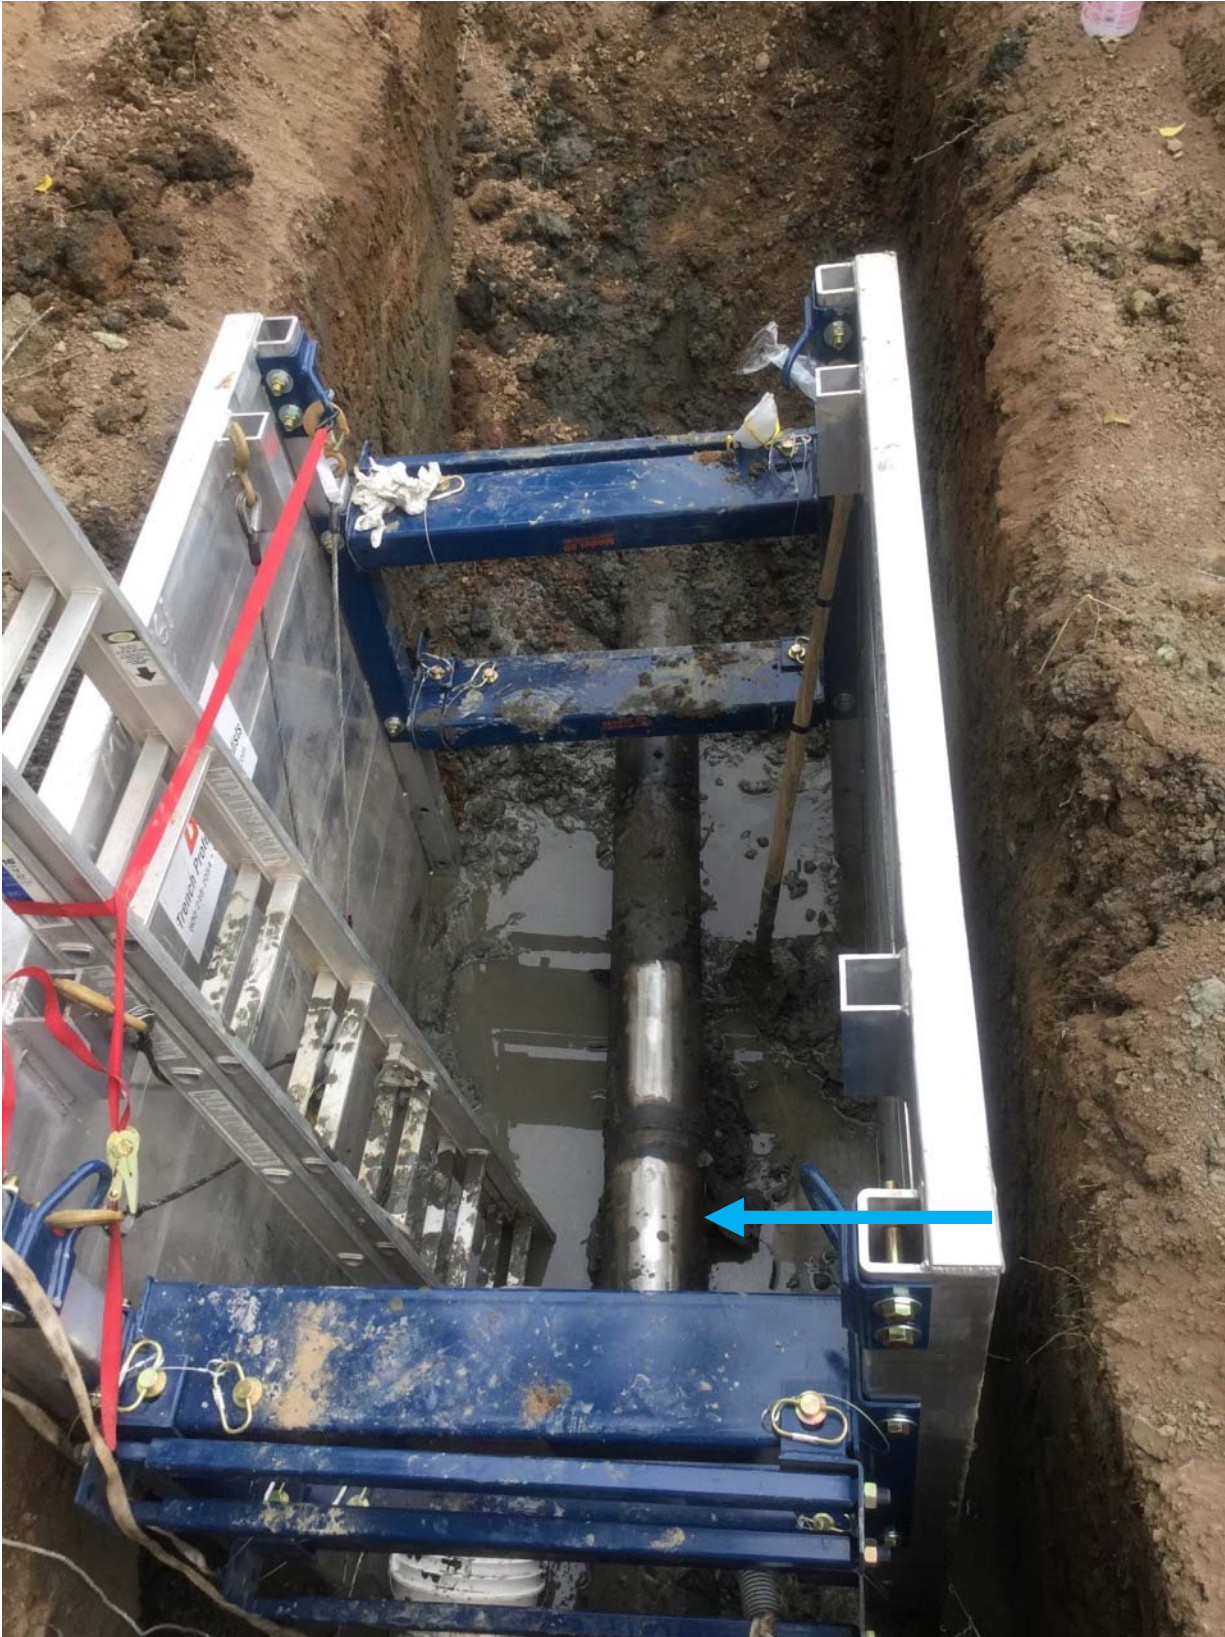
Pipeline Segment: 8" Bremerton Transmission Line #2 **Sample Order #:** 8 **Type:** Pipe **ID:** 15

Vegetation Condition: Weeds blackberry bushes

Soil Condition: Clay **Comments:** Clay at bottom.

Site Condition: Dry hole exposed
