National Transportation Safety Board

Marine Accident Brief

Sinking of Towing Vessel *Delta Captain*

| Accident no. | DCA-13-NM-016 |

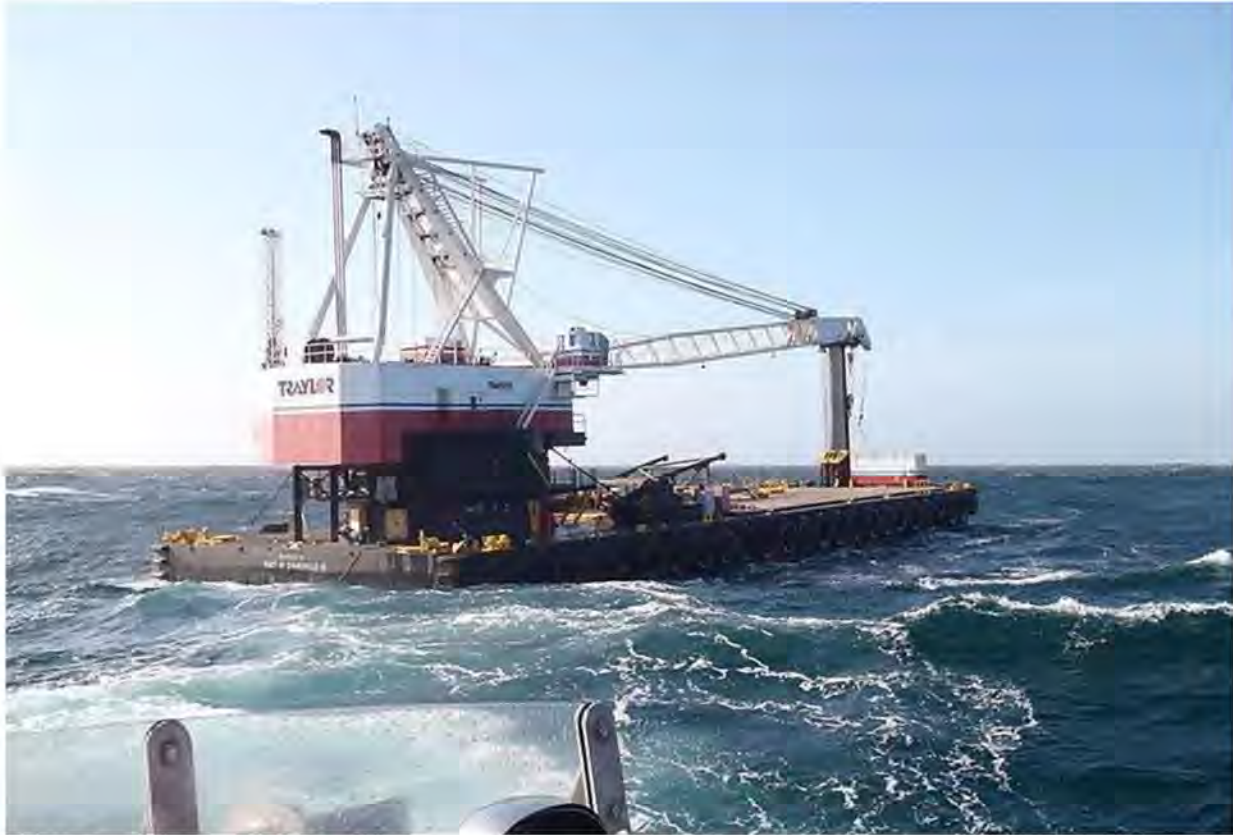
The deck barge *DB 5* after the accident. (Photo by California Department of Fish and Wildlife)

The water depth at the location of the accident was about 3,000 feet, and the *Delta Captain* crew reported that the vessel appeared to still be attached to the towline of barge *DB 5* after sinking. However, about 1100 the next day, two towing vessels arrived at the location of the adrift *DB 5* and reported that the *Delta Captain* was not still connected to the barge's towline. About 1500, one of the two responding towing vessels began towing the barge to Los Angeles, arriving there the following day, April 15.
