**PUGET SOUND ENERGY  
PIPE SEGMENT INTEGRITY STUDY  
IN THE VICINTIY OF THE VASA PARK RECTIFIER**

**June 21, 2005**

**Purpose**

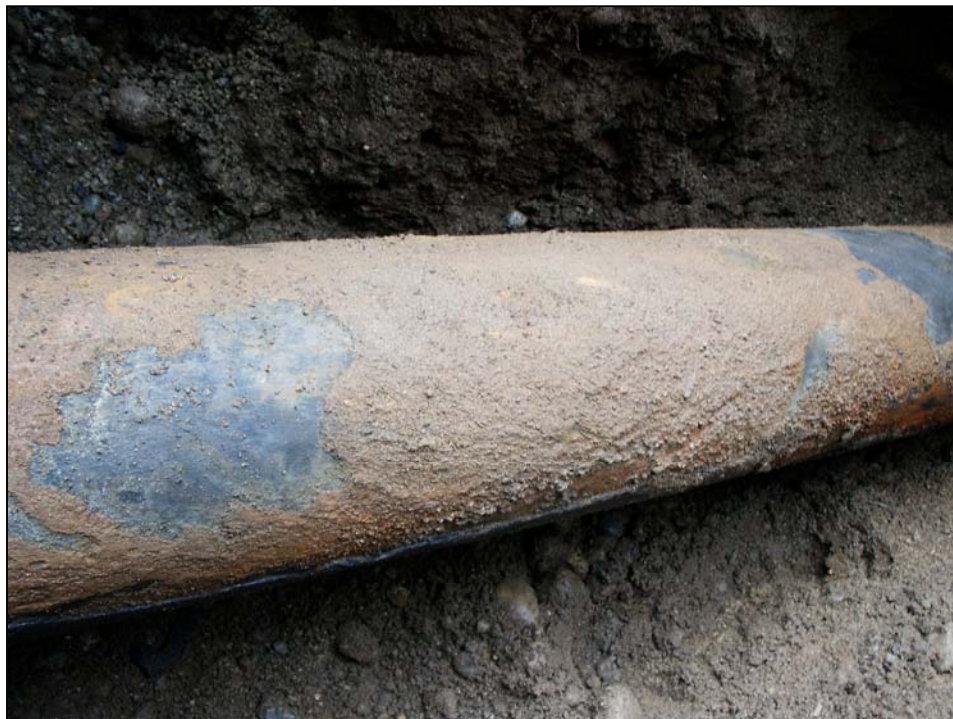
### Examination Site 2

This site exhibited minor pitting at a large coating holiday. The coal tar enamel coating damage was attributed to third party excavation. The coating is tightly bonded to the pipe. A crusty material adhered tightly to the exposed pipe steel surface at the holiday. The cross-section of the incrustation exhibited a thin white colored layer adjacent the pipe surface covered by a thicker layer with a rust colored matrix embedded with backfill material. The incrustation is an indication that the corrosion at this site had not occurred recently. Enough time had elapsed since the pitting occurred for ions to migrate to the pipe and form an incrustation on the exposed steel pipe surface as shown in the following photograph. Cathodic protection promotes ion migration in the electrolyte<sup>2</sup>. It is very likely this process commenced with the application of protection in the 1980's and the corrosion predates this event.

Two pits were discovered at the holiday. Their dimensions were 1/2" x 1/8" and 30 to 40 mils deep. The soil resistivity measured at the site is 150,000 ohm-centimeters. The laboratory resistivity measurement in a saturated condition is 50,000 ohm-centimeters. Both resistivity values indicate the soil is not very corrosive at this site and the degree of corrosion supports this conclusion. The soil is sandy with round rock up to 6" diameter.

This incrustation at Examination Site 2 was typical of that found at most of the coating holiday sites exposed during the investigation.

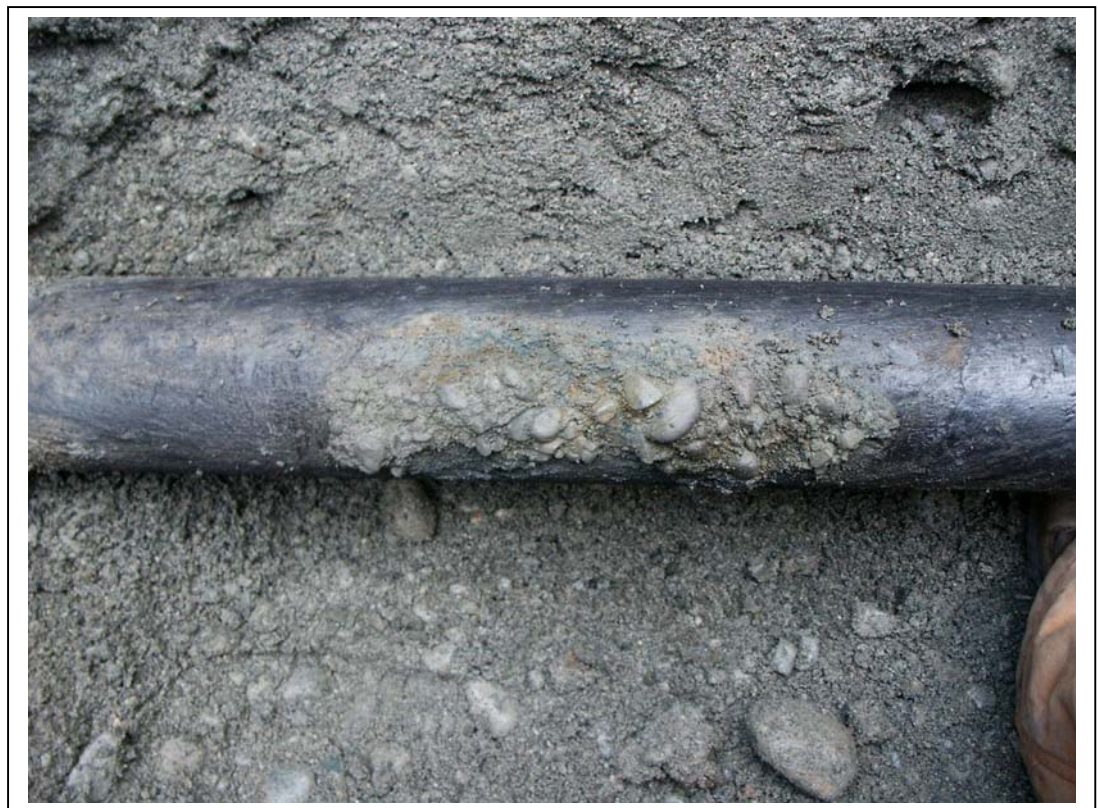
**Examination  
Site 14**

A moderate sized coating holiday was discovered at this site with dimensions of 2" wide by 11" long axially oriented on the pipe at about 3 o'clock. The cause of the coating damage could not be determined. The coal tar enamel coating is tightly bonded to the pipe surface. The bare steel at the coating holiday was covered with a tightly adherent crust which had round rock, up to 3 inches in diameter, embedded in it. Removal of the incrustation exposed minor pitting to 10 mils deep in a 3-inch diameter area. Within the corroded area is 30 mils deep x 1-1/8" diameter pit. The formation of a crust over the pitted area and the lack of corrosion product, suggests the corrosion did not occur recently and is not active. The EDS analysis indicates a sample taken from the incrustation is composed of silicon, aluminum, and iron with minor constituents of calcium, potassium, magnesium oxygen and carbon, elements typically found in soils.

The soil adjacent to the corroded area is sandy with round rock up to 3 inches diameter. This soil has a resistivity of 32,000 ohm-centimeters. Soil within 2 feet of the corroded area is blue colored clay with a resistivity measured in the field of 8,000 ohm-centimeters. The laboratory resistivity measurement is 5,100 ohm-centimeters. The resistivity values are typical of moderately corrosive soils. The clay is more corrosive than the sandy material and the change in resistivities of adjacent soils is characteristic of a local corrosion cell.

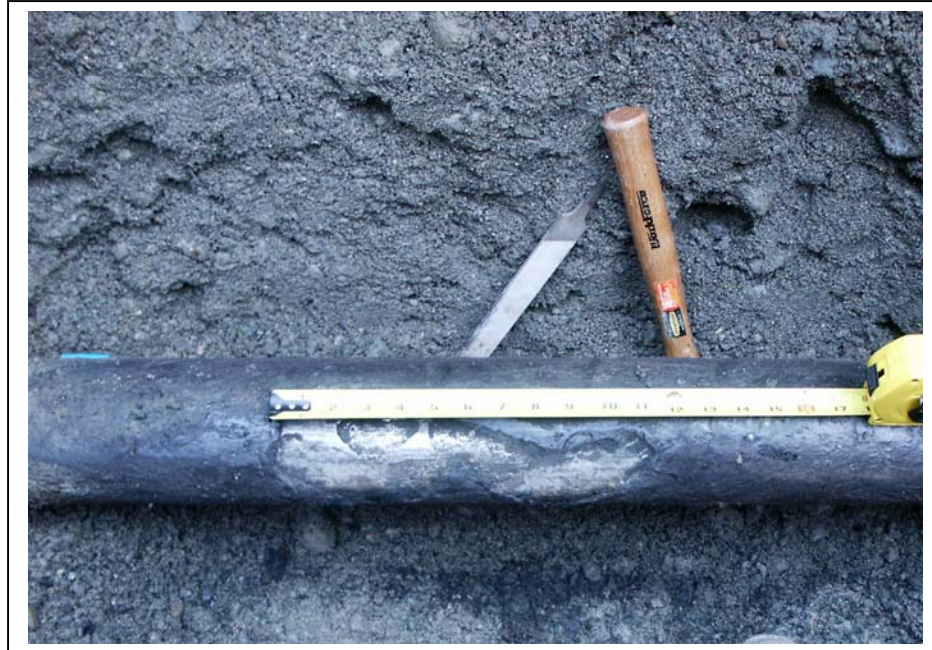
The incrustation at the coating holiday found at Examination Site 14 exhibits round rock cemented to the pipe surface. Removal of the incrustation revealed minor pitting in a 3-inch area as shown in the following photograph.

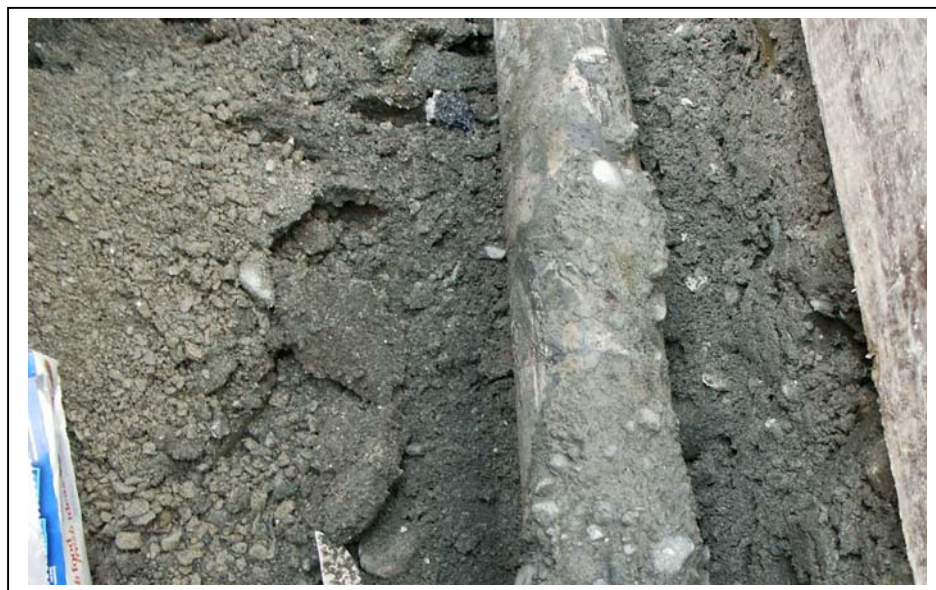
**Examination Sites 28 and 31**

Six coating holidays were discovered at this site located at 12 and 1 o'clock. The locations suggest a third party caused the damage. The holidays were heavily encrusted. Rocks up to 1 inch in diameter were embedded in the incrustation.

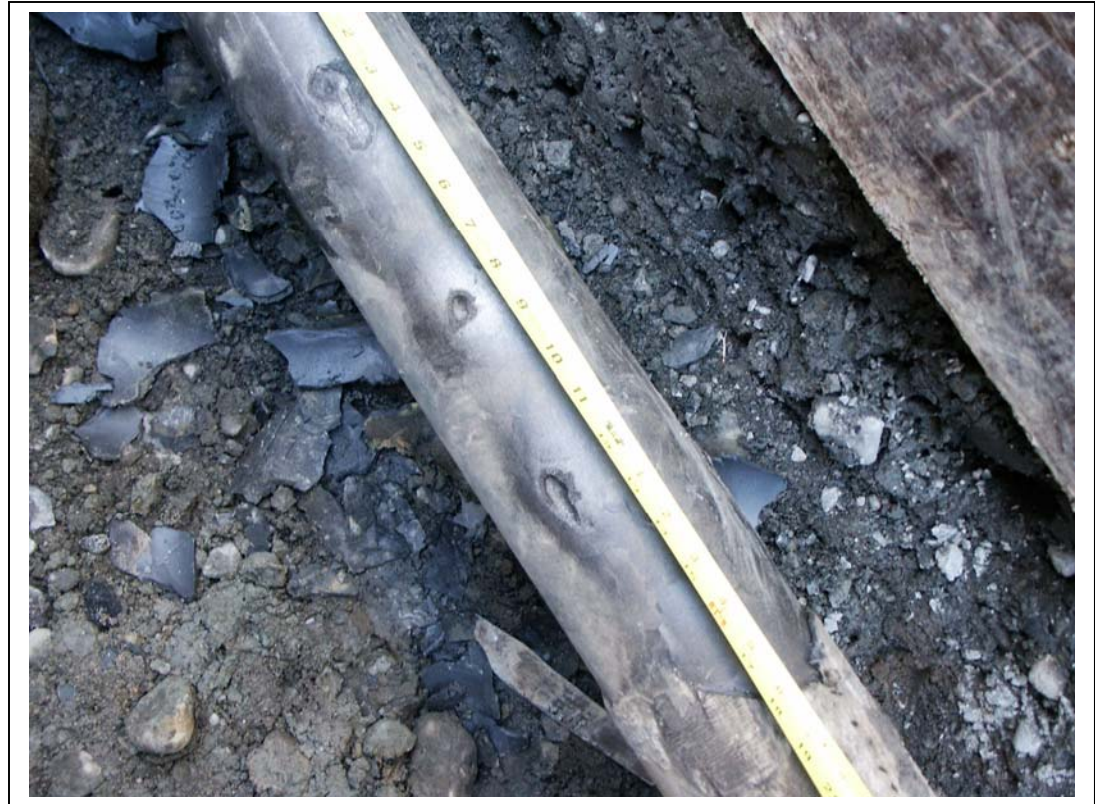
Four pits, which had penetrated the 0.188" thick pipe wall, were discovered under the incrustation. Pitting was observed within the larger pits.

A black, moist substance was removed from the pit closest the bottom of the photograph above. It was analyzed using EDS technology. Two spectra were recorded. One run had major peaks for iron, sulfur, silicon, sodium, and aluminum with minor peaks of potassium, calcium, oxygen and manganese. These elements are characteristic of corrosion. Another run exhibited major peaks for the elements silicon, aluminum and iron with minor peaks of sulfur, potassium, calcium, carbon and oxygen. The elements detected in the latter portion of the sample are typical of soil. This substance indicates corrosion may have been actively occurring in the pit.

The soil is sandy blue clay with rounded rock up to 6 inches in diameter. The resistivity measured in the field is 7,000 ohm-centimeters and that in the laboratory is 6,600 ohm-centimeters. These values are typical of moderately corrosive soil.
