Marine Safety Information Bulletin

MSIB Number: 01-22
Date: September 14, 2022
Contact: Port State Control Office
Phone: (503) 240-9339
E-Mail: PSC-PDX@uscg.mil

Reduced Visibility from the Navigational Bridge Due to Overloading of Wind Turbine Parts

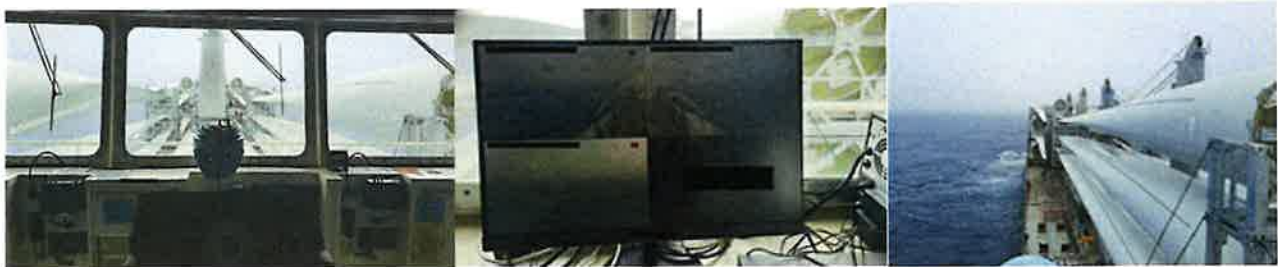
The purpose of this Marine Safety Information Bulletin (MSIB) is to update mariners and the maritime industry of the recent upward trend in the number of break-bulk and retrofitted bulk carriers carrying wind turbine parts stowed in ways to limit visibility from the navigation bridge. Specifically, the worst scenarios cases have stacked turbine blades four levels high, which increases the forward blind spot to 2.5 miles or more. This is in violation of both domestic regulation and international convention, specifically:

Over the last 3 months, multiple vessels have come into Sector Columbia River under violation of the above regulations, which have each provided significant challenges to ensure the safety of the Navigable waters of the United States, and that of all waterway users. While ships may be able to structurally support increased loading, doing so in such a way that obscures vision from the navigation bridge comes at an increased risk of collision.

To mitigate the increased risk of collision, the vessel operators have obtained Flag State Dispensations allowing the vessel to sail with additional requirements. For example, requiring the vessel to maintain a Closed Circuit Television (CCTV) feed that grants the master visibility of the obscured sectors. The use of CCTV systems to address substandard navigation bridge visibility is covered under the unified interpretation of Regulation 22 in MSC.1/Circ.1350/Rev.1; however, the circular addresses the use of CCTVs to correct visibility of the sides of the vessel from the bridge wing ONLY, and makes no mention or concession of their use to correct forward visibility.

The Coast Guard strongly recommends that vessel owners, operators, and maritime stakeholders:

- Strongly consider the impacts to safe navigation of loading cargo in such a way that impacts visibility from the bridge
- Proactively notify Port State Authorities and local Pilotage Agencies of the departure and arrival ports if bridge visibility is impacted, before the vessel sets sail

- Provide additional crewmembers in order to combat fatigue and augment enhanced / doubled lookout watches, especially when transiting through areas of high traffic density

- Ensure that any equipment provided to increase visibility works as intended, accounting for sea conditions, camera quality, and screen size
- Identify and contract with possible commercial or governmental vessels that may be able to serve as an escorts to clear the waterway ahead of the vessel

- Employ risk-analysis and mitigation strategies recognizing the concerns of such condition
- Adjust loading configurations to comply with the International and US requirements for visibility from the bridge
