Sinking of US Cargo Vessel *SS El Faro*  
Atlantic Ocean, Northeast of Acklins and Crooked Island,  
Bahamas  
October 1, 2015

NTSB/MAR-17/01  
PB2018-100342

# Marine Accident Report

**Abstract:** On Thursday, October 1, 2015, the SS *El Faro*, a 40-year-old cargo ship owned by TOTE Maritime Puerto Rico and operated by TOTE Services, Inc., was on a regular route from Jacksonville, Florida, to San Juan, Puerto Rico, when it foundered and sank in the Atlantic Ocean about 40 nautical miles northeast of Acklins and Crooked Island, Bahamas. The ship had sailed directly into the path of Hurricane Joaquin, carrying a crew of 33, including 5 Polish contract repair workers. All those aboard perished in the sinking. As part of its accident investigation, the National Transportation Safety Board (NTSB) led a joint effort with the US Navy, Woods Hole Oceanographic Institution, and the National Science Foundation to locate the ship's wreckage and retrieve its voyage data recorder (VDR). The VDR was pulled from 15,250 feet below the ocean surface in August 2016 during the third undersea mission and yielded more than 26 hours of parametric data and audio files. The NTSB's accident investigatio

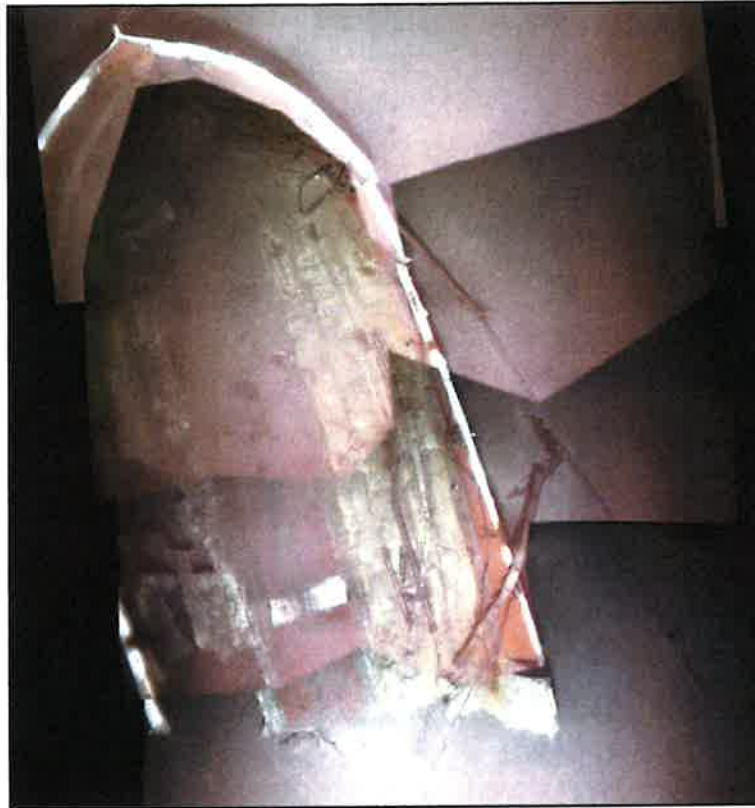
**Figure 24.** Photomosaic of *El Faro's* port lifeboat from images taken during second search mission. Bench seats and other internals are missing. Reflective tape on top of gunwales is illuminated.

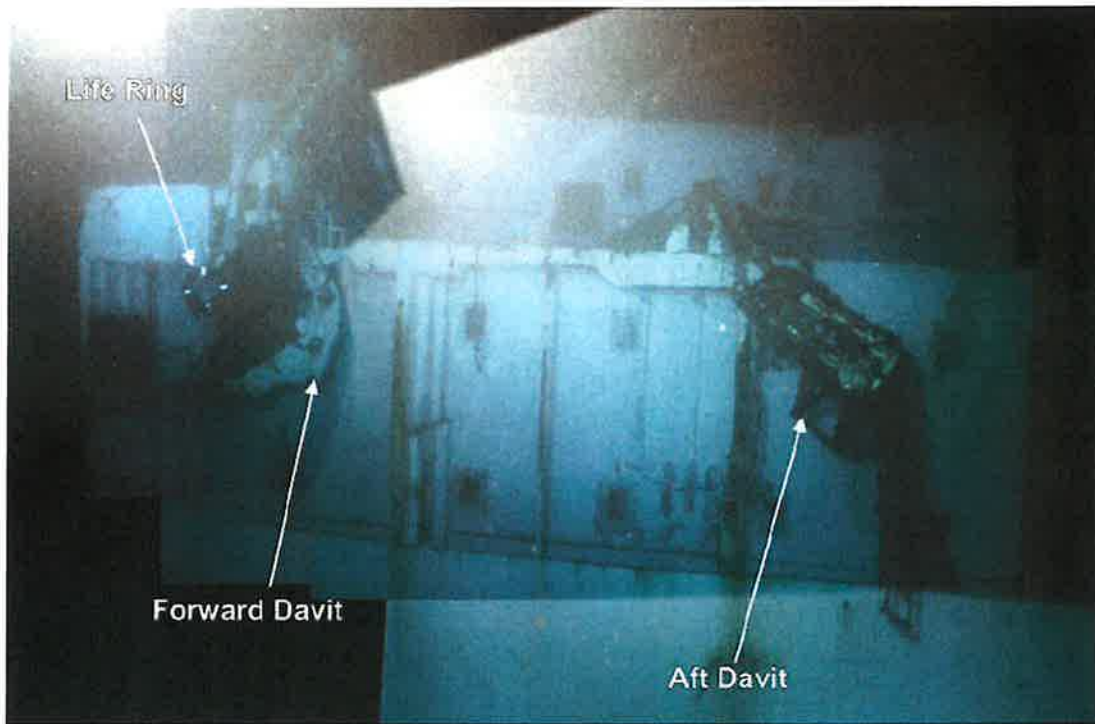
**Figure 26.** Gravity davits for port lifeboat, showing forward davit in place but damaged and aft davit broken and dangling. (Photomosaic image from mission 2)

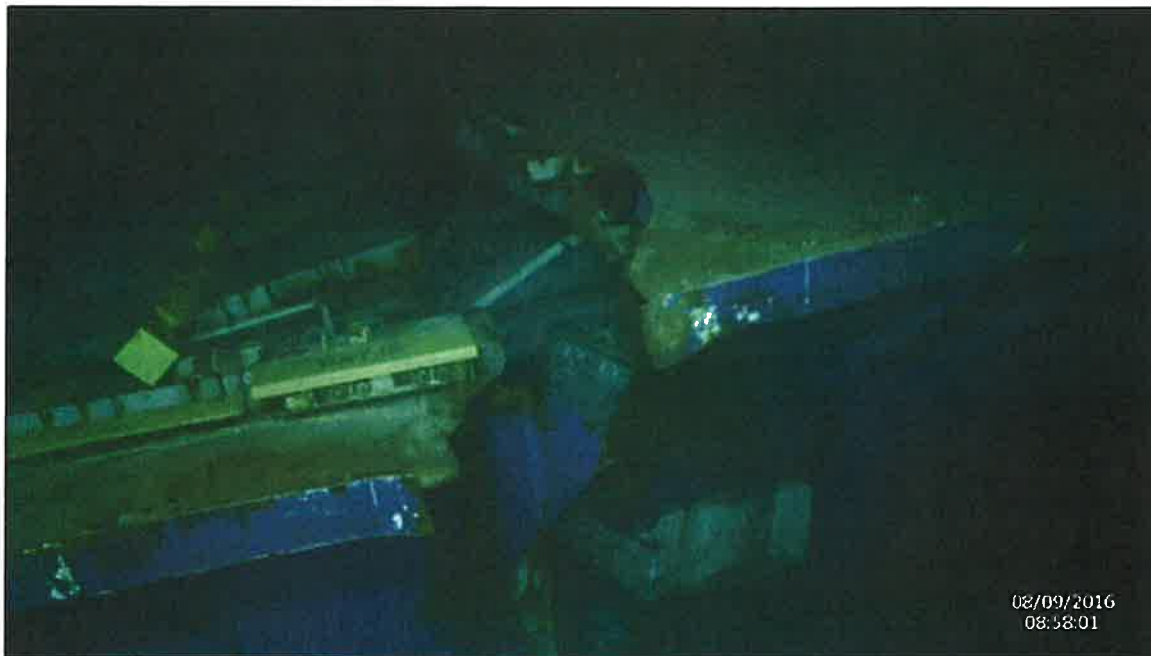
**Figure 30.** Hull fracture in starboard sideshell and across main deck at container bay 16, forward of frame 200. (Image from mission 3)

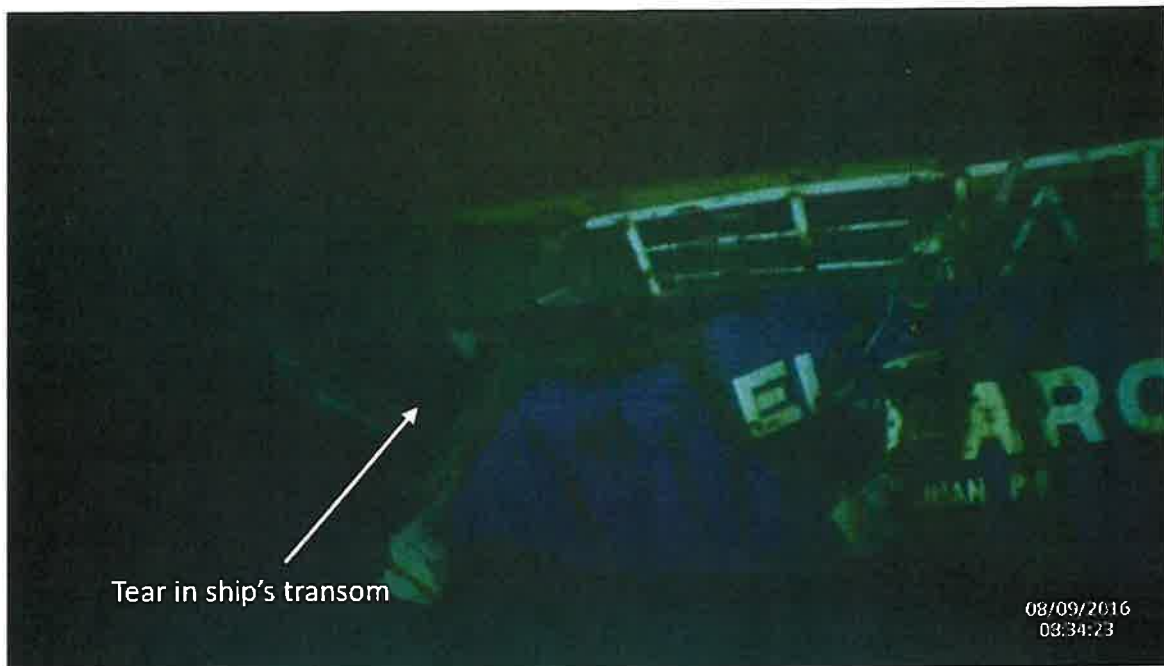
**Figure 31.** Tear in ship's transom. (Image from mission 3)

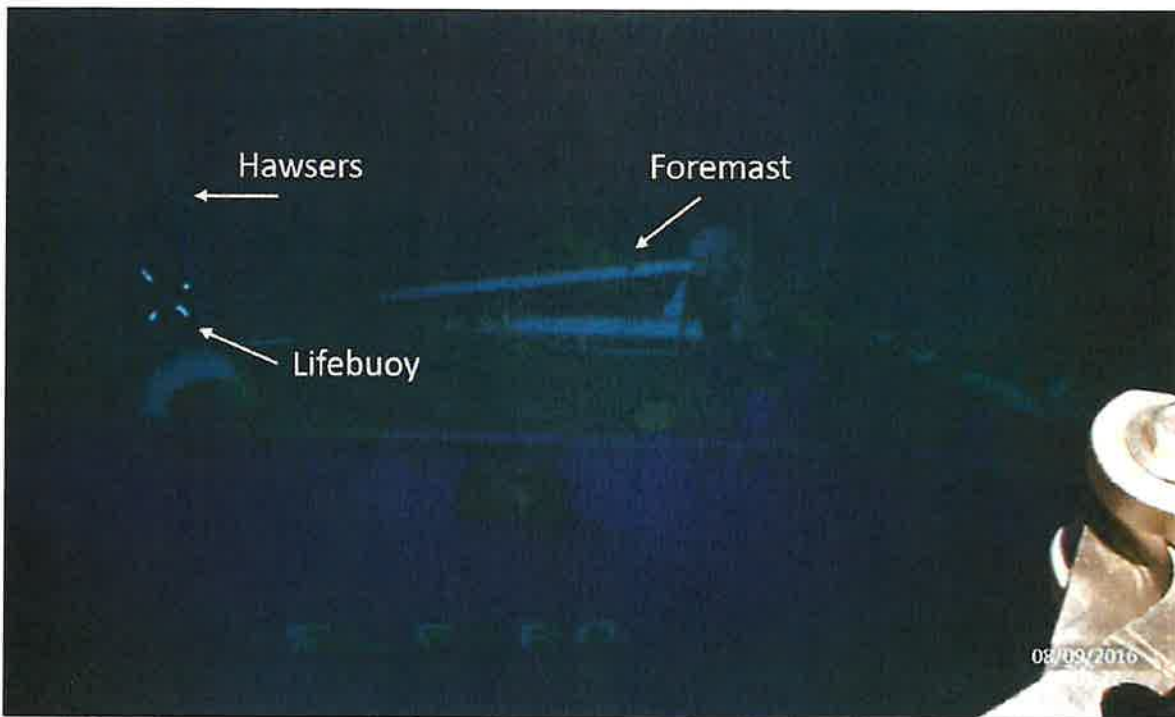
**Figure 32.** Foremast toppled on port side of bow; reflection is from lifebuoy on railing next to hawsers. (Image from mission 3)

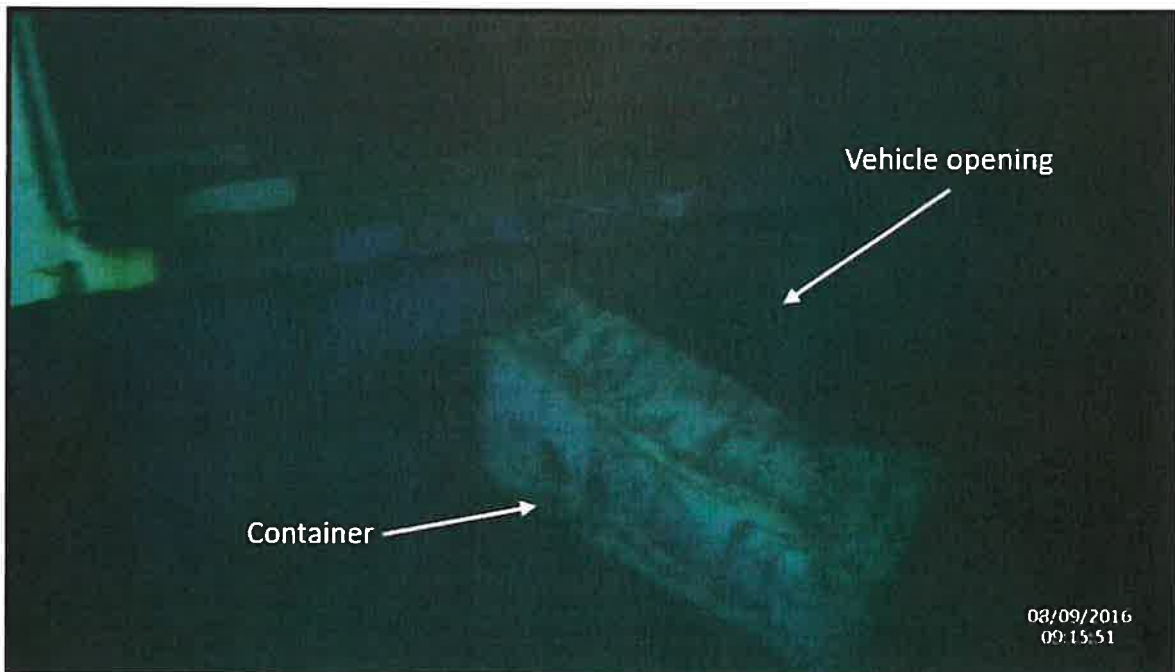
**Figure 33.** Container protruding through vehicle opening in bay 15, starboard side. (Image from mission 3)

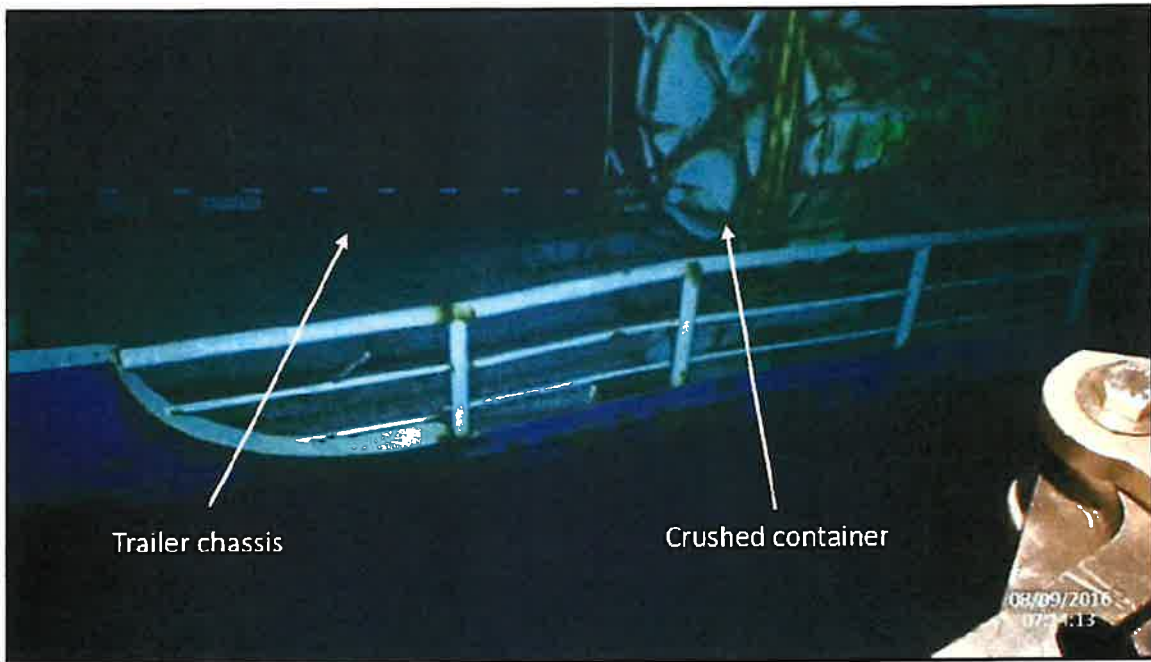
Figure 34. Crushed tank container in bay 2, starboard side. (Image from mission 3)

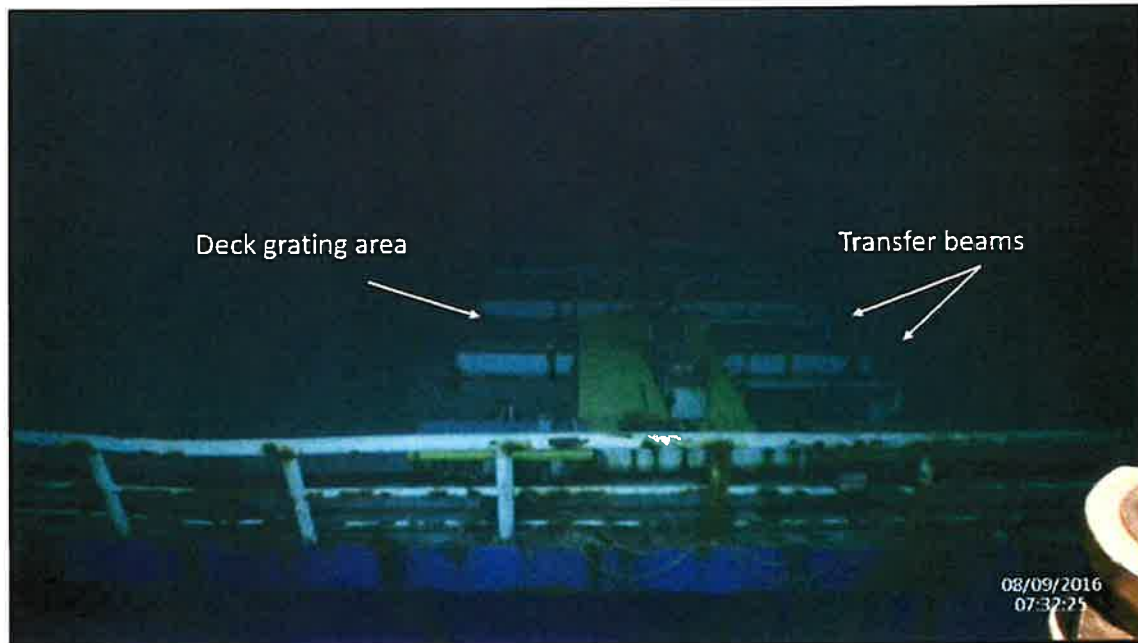
Figure 35. Fiberglass deck grating missing from container support beams, port side, with intact transfer beams. (Image from mission 3)

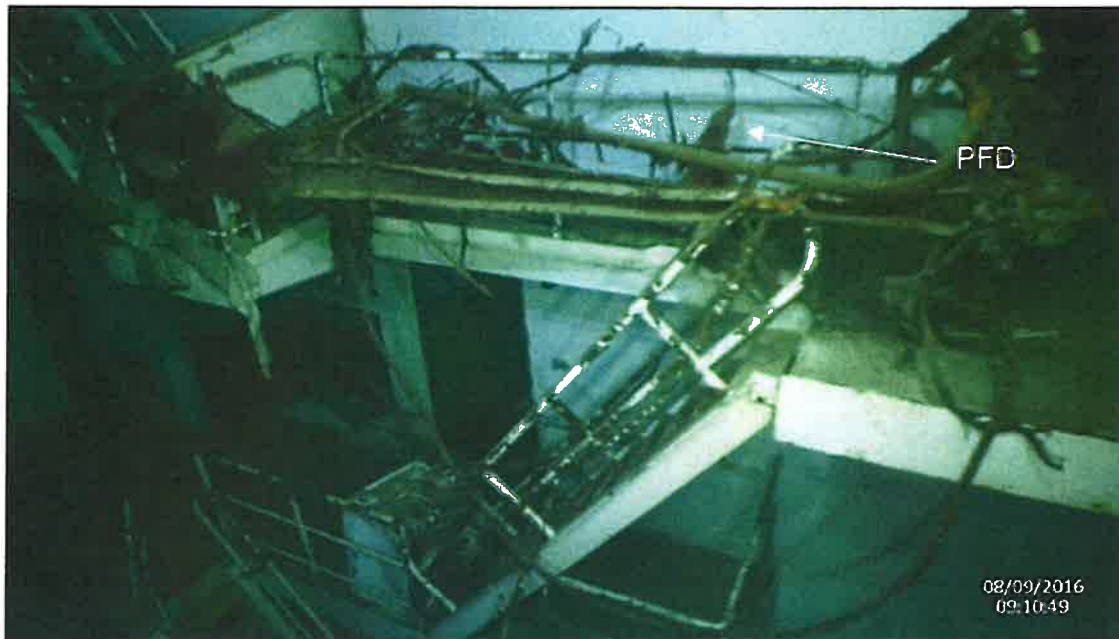
Figure 36. PFD entangled on boat deck walkway. (Image from mission 3)

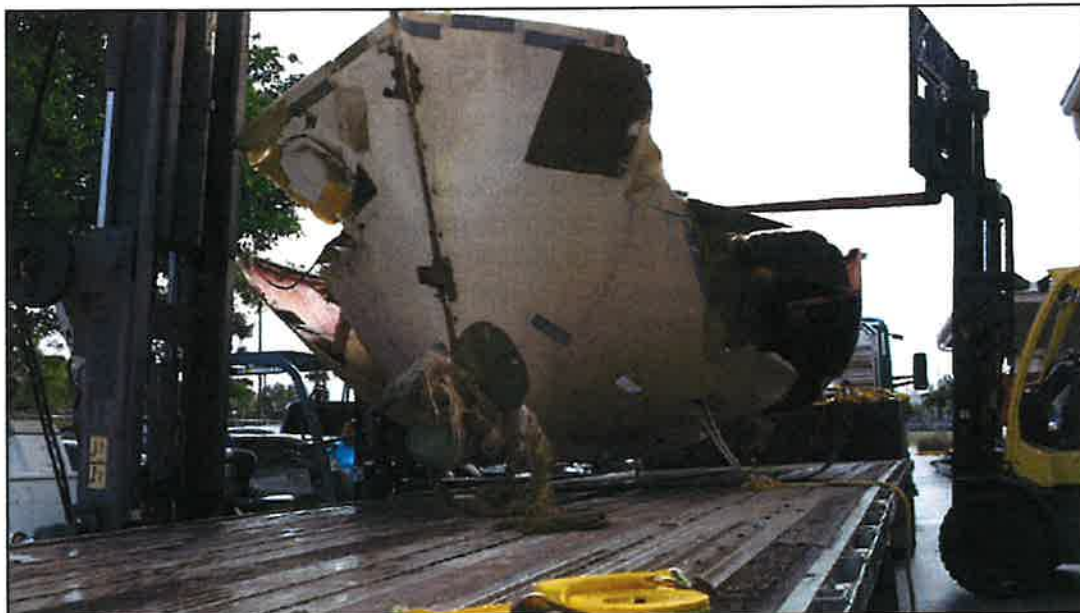
**Figure 53.** *El Faro's* starboard lifeboat on arrival at Coast Guard Air Station Miami. Note fouled propeller, bent propeller blade, and damage to port and starboard sides of hull.

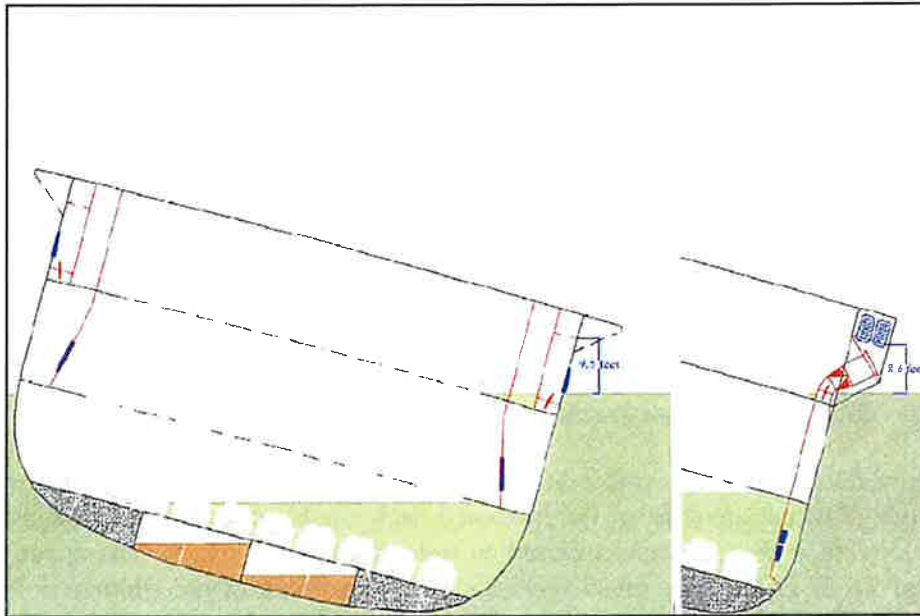
**Figure 59.** Ventilation supply trunk (right) and aft exhaust trunk (left) in hold 3, with flooding of hold to 20 percent (0.7 permeability) and heel angle of 15°. (Adapted from figure 6-18 in MSC 2017)

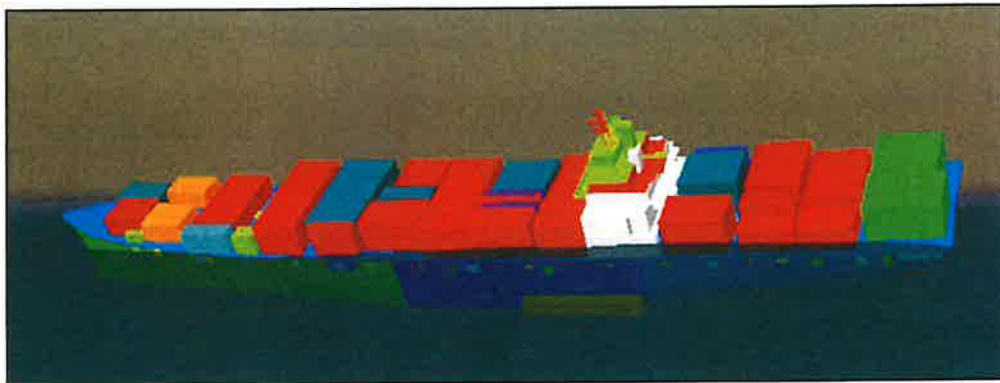
**Figure 61.** *El Faro* rolling about a 15° to 18° static heel with waves or green water reaching ventilation openings after propulsion loss. (Screen shot at extreme position from CSRA video simulation)

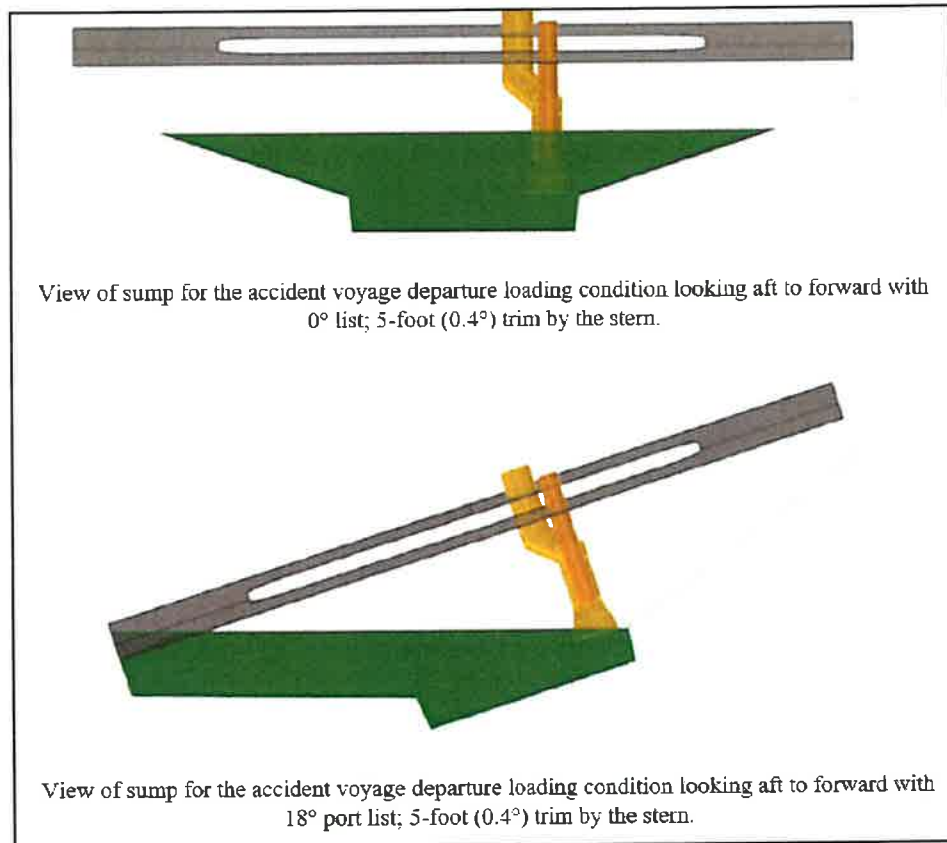
**Figure 64.** Effect of  $18^\circ$  port list on lube oil system with oil level at 26 inches. (Graphic by Coast Guard Marine Safety Center, modified by NTSB)

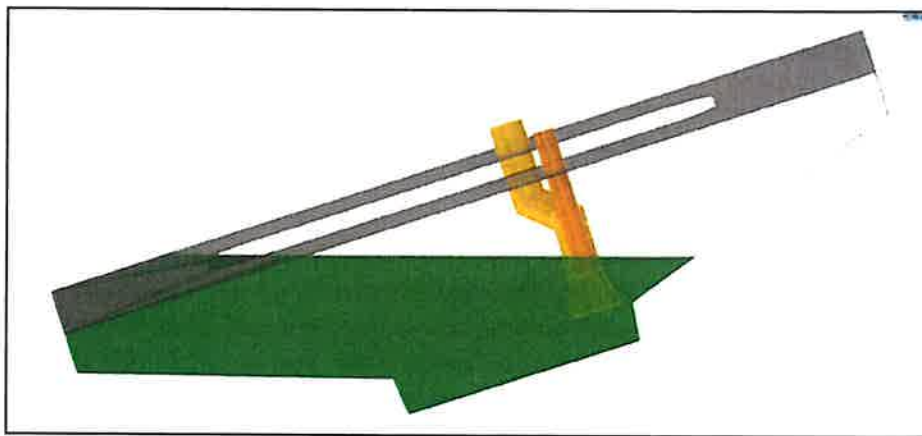
**Figure 65.** Effect of 18° port list on lube oil system for main engine with 32 inches of lube oil in sump, looking from aft to forward. (Graphic by Coast Guard Marine Safety Center, modified by NTSB)
