# National Transportation Safety Board

## Marine Accident Brief

### Contact of Bulk Carrier *Shandong Fu En* with Ergon-St. James Terminal Wharf

<b>Accident type</b>	Contact	No. DCA18FM020
<b>Vessel name</b>	<i>Shandong Fu En</i>	
<b>Location</b>	Lower Mississippi River near mile 161, Convent, Louisiana 30°01.82' N, 090°50.40' W	
<b>Date</b>	April 6, 2018	
<b>Time</b>	0637 central daylight time (coordinated universal time – 5 hours)	
<b>Injuries</b>	None	
<b>Property damage</b>	\$6.25 million est.	
<b>Environmental damage</b>	None	
<b>Weather</b>	Visibility 10 miles, mostly cloudy, winds south-southeast 11 knots; air temperature 70°F; morning twilight 0621, sunrise 0645, evening sunset 1723, evening twilight ends 1947	
<b>Waterway information</b>	Lower Mississippi River has a project depth of 45 feet at the accident location; high-water conditions were in effect, with the current about 5.4 mph (4.7 knots). The distance between the north end of the Ergon-St. James Terminal and the south end of the Convent Marine Terminal wharves is 1,479 feet (451 meters).

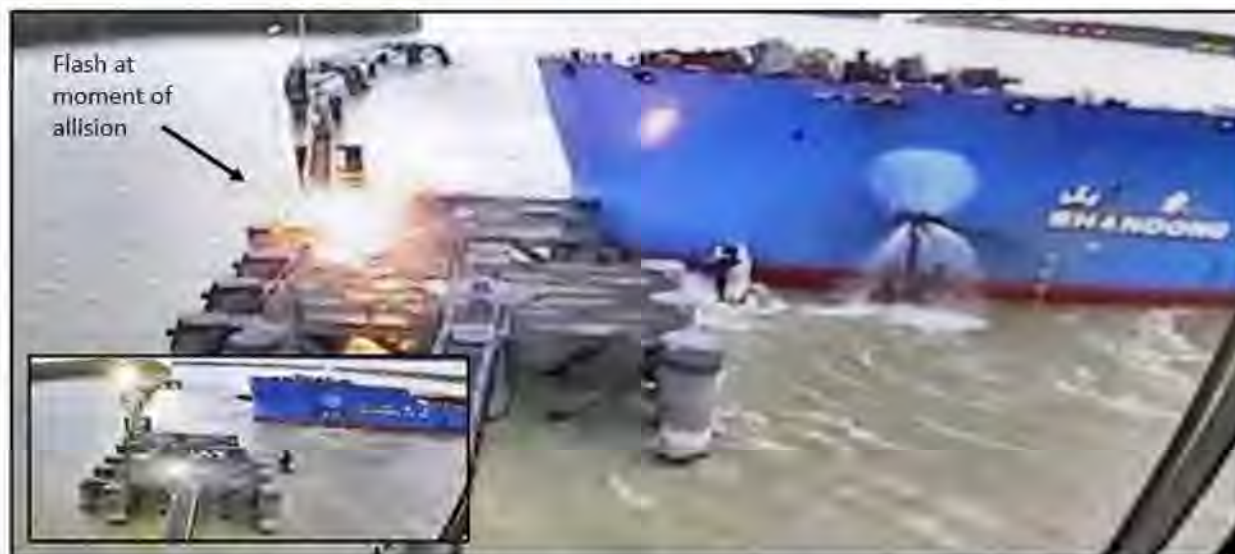
Initial impact of the *Shandong Fu En* bow swinging into the Ergon-St. James Terminal wharf at 0637:08. Inset: Screenshot of the *Shandong Fu En* 20 seconds earlier. A crack and three other holes were found in the bulk carrier's shell plate below the waterline. (Video by Ergon-St. James Terminal)

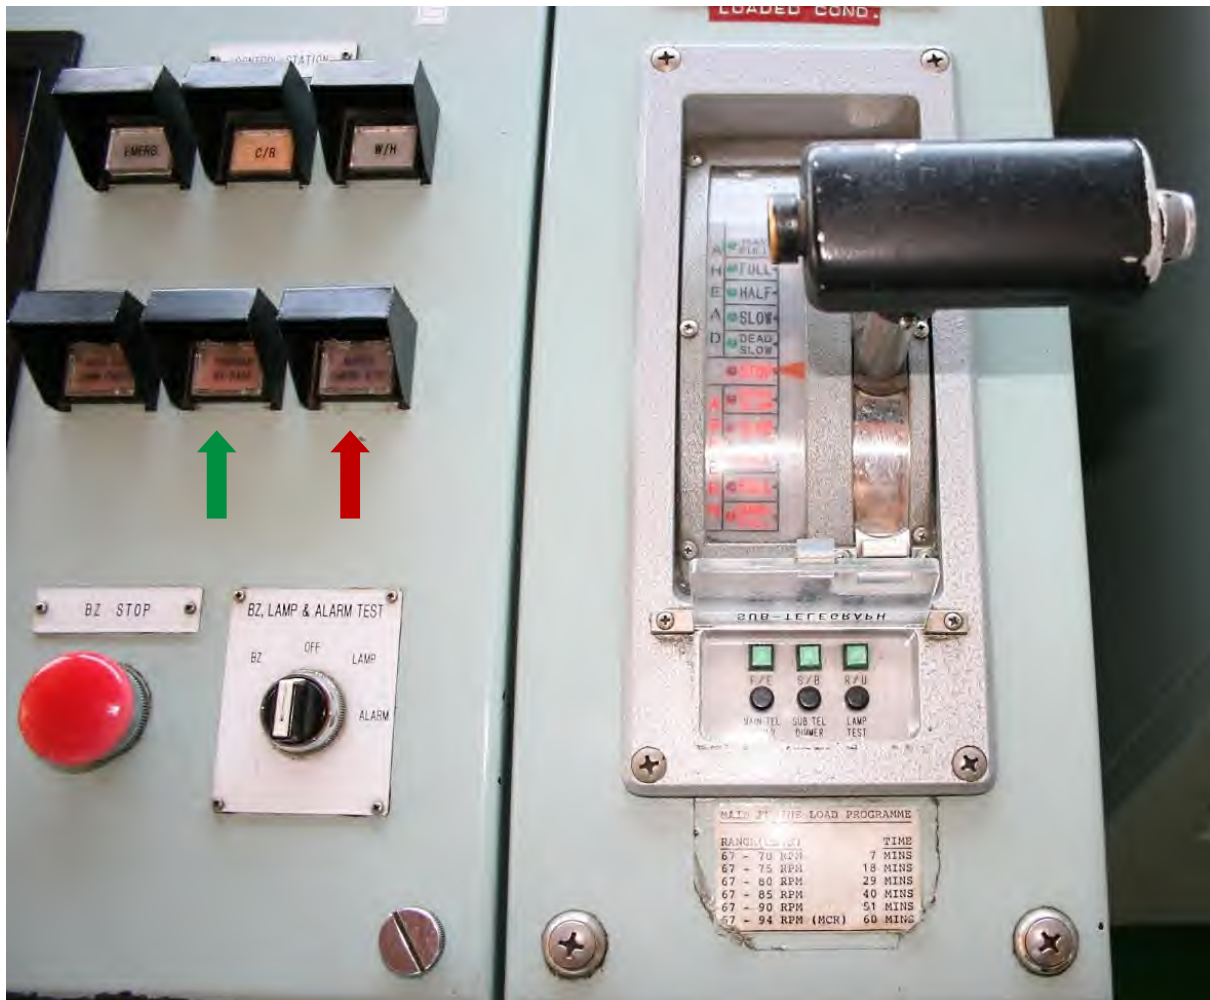
**Figure 8.** Section of the engine control console on the *Eagle Otome*. Activating the navigational full ahead required pushing the button marked with a green arrow. However, the master inadvertently pushed the "manual emergency stop" button, marked with a red arrow. (The arrows were added to this image; they are not featured on the actual engine control console.)

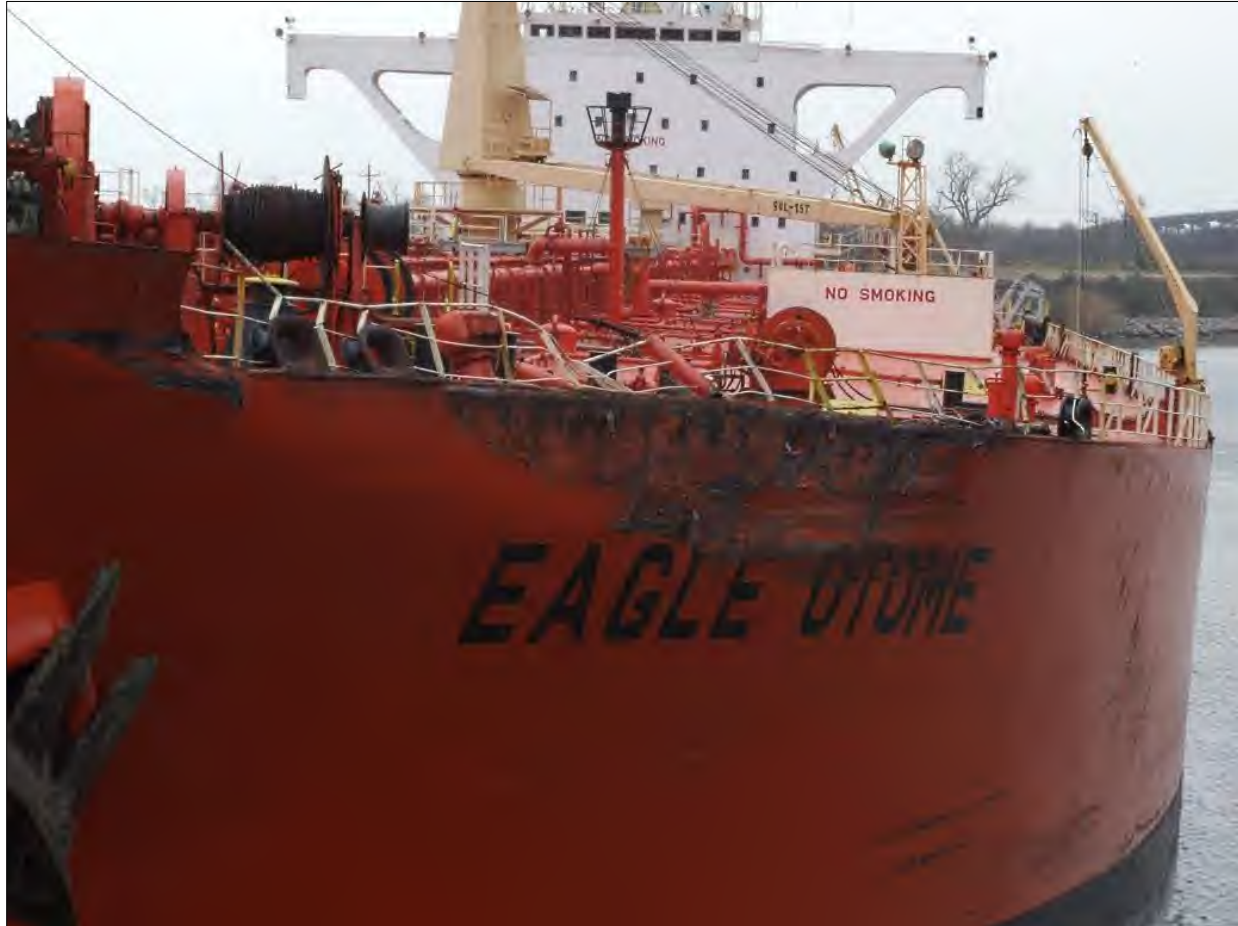
side. The damage to the portside shell plating and internal structure extended horizontally about 55 feet and down about 12 feet from the main deck. The damaged compartments in this area were the No. 1 port ballast tank, the forward cofferdam,<sup>30</sup> and the bosun store room, and involved buckling, detachment, and fracturing of the internal structure, which was inset about 3 feet as a result of the impact. The main deck plating, deck railings, and port bulwark were also damaged in this area (figure 10).

**Figure 10.** Portside damage to the *Eagle Otome*.

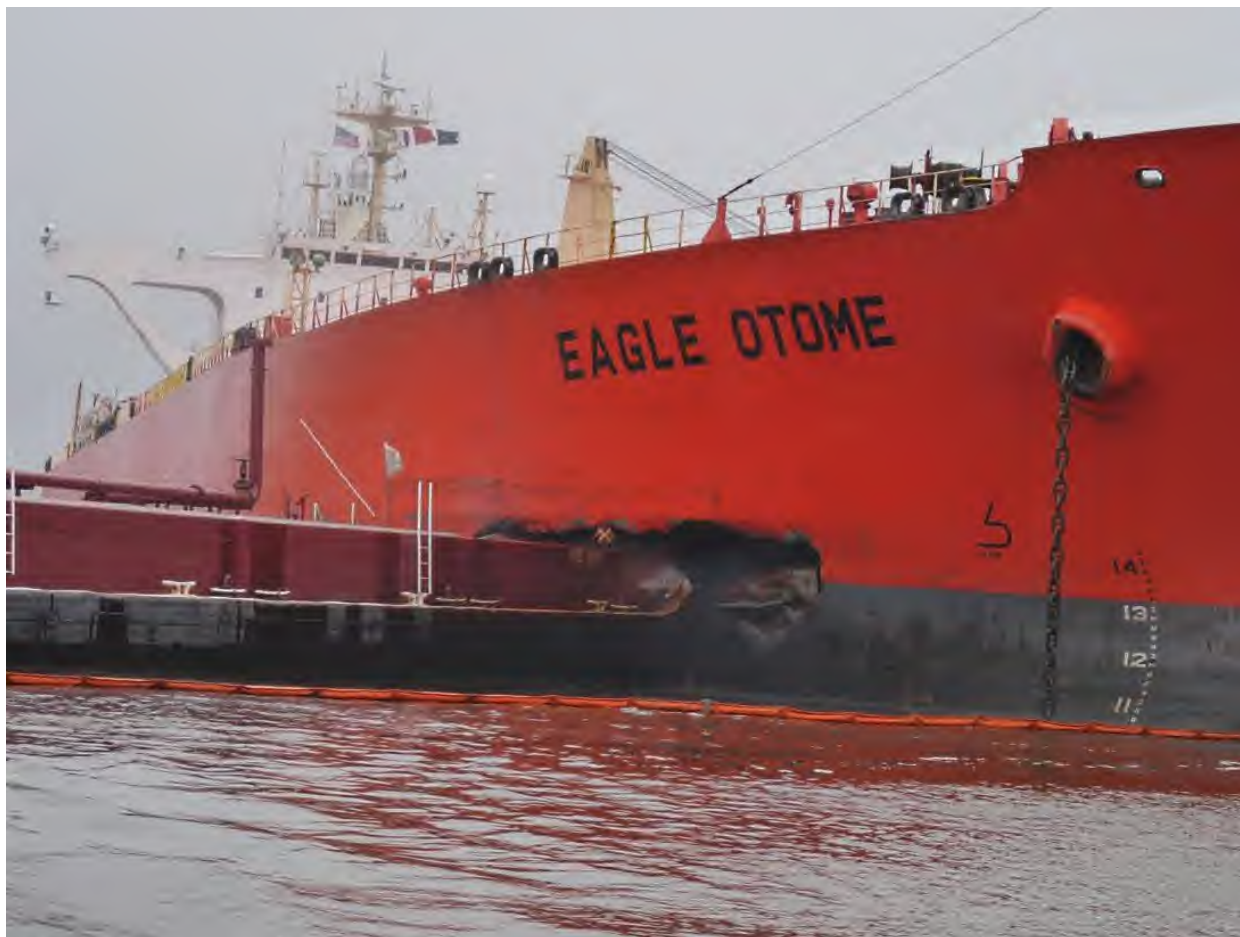
**Figure 11.** Starboard side of the *Eagle Otome*, with the *Kirby 30406* lodged in it.

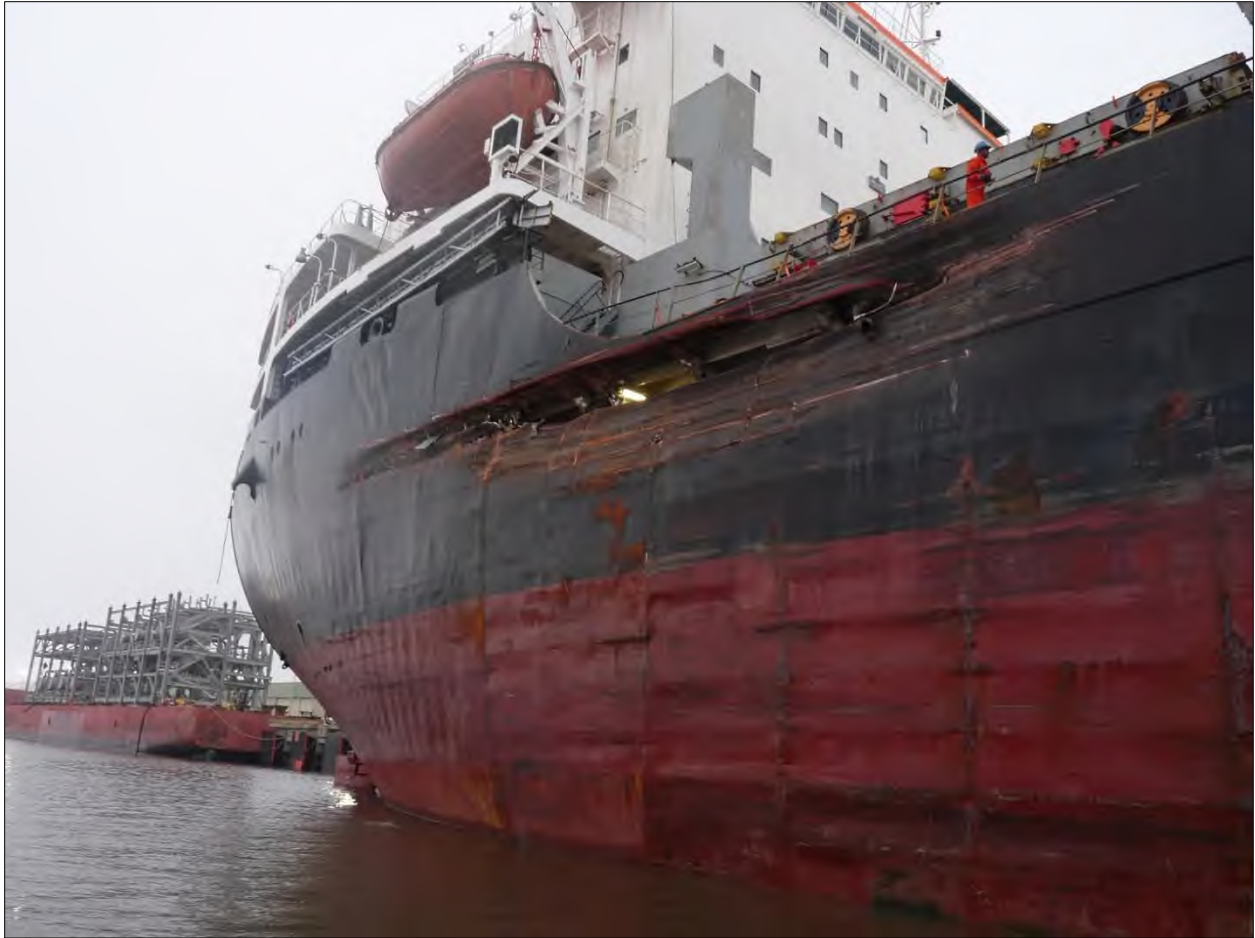
**Figure 12.** Damage to the *Gull Arrow*.

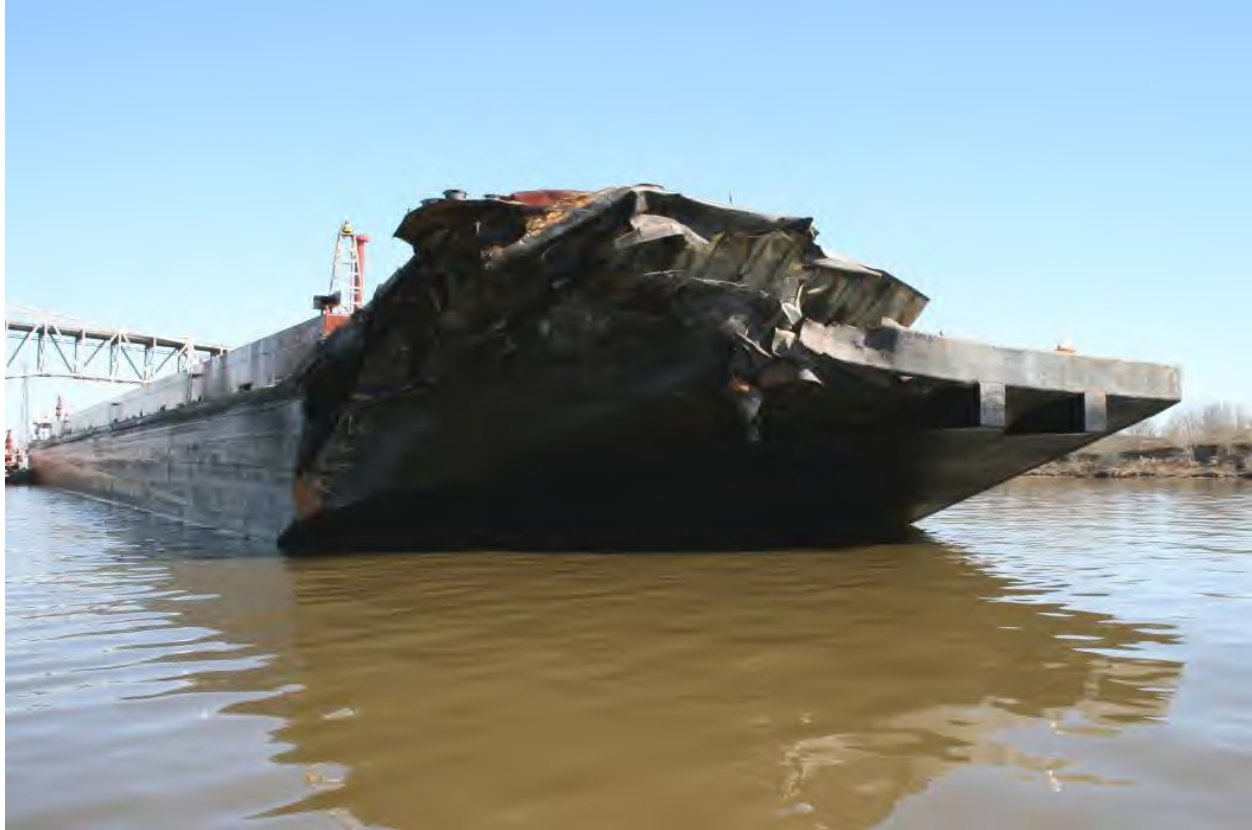
The damage to the *Kirby 30406* was estimated at \$35,000.

**Figure 13.** Damage to *Kirby 30406*.

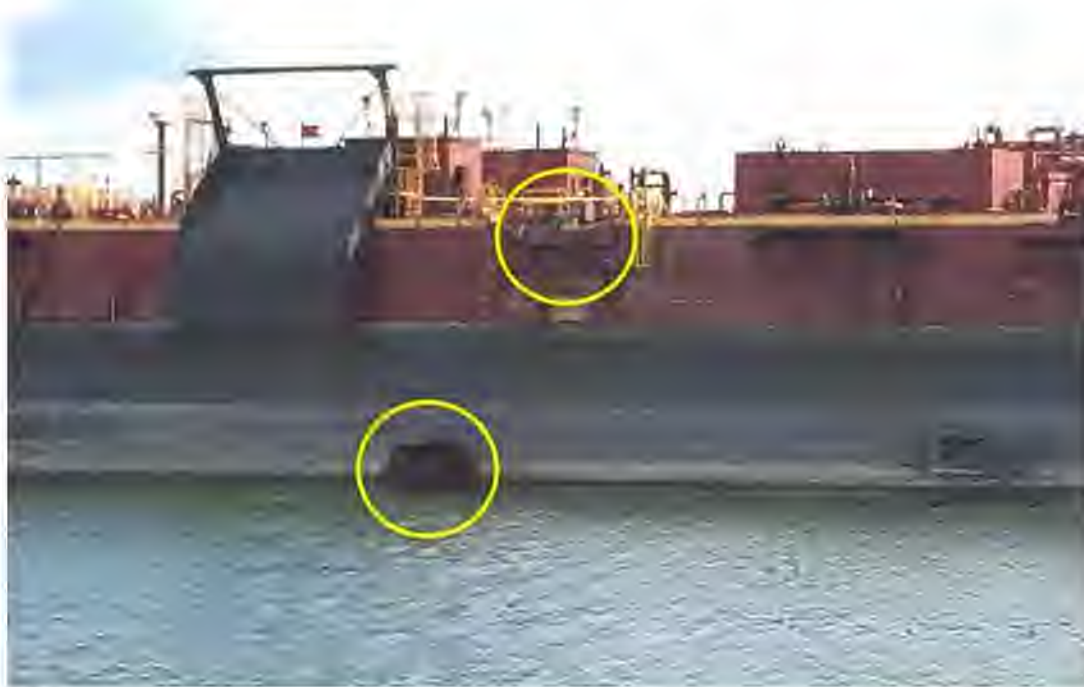
Damage to *OSG 243*, port side. Yellow circles identify, at top, cantilever deck damaged by *Yochow*'s bow rake and, at bottom, side shell at waterline in no. 5P ballast tank penetrated by bulk carrier's bulbous bow.

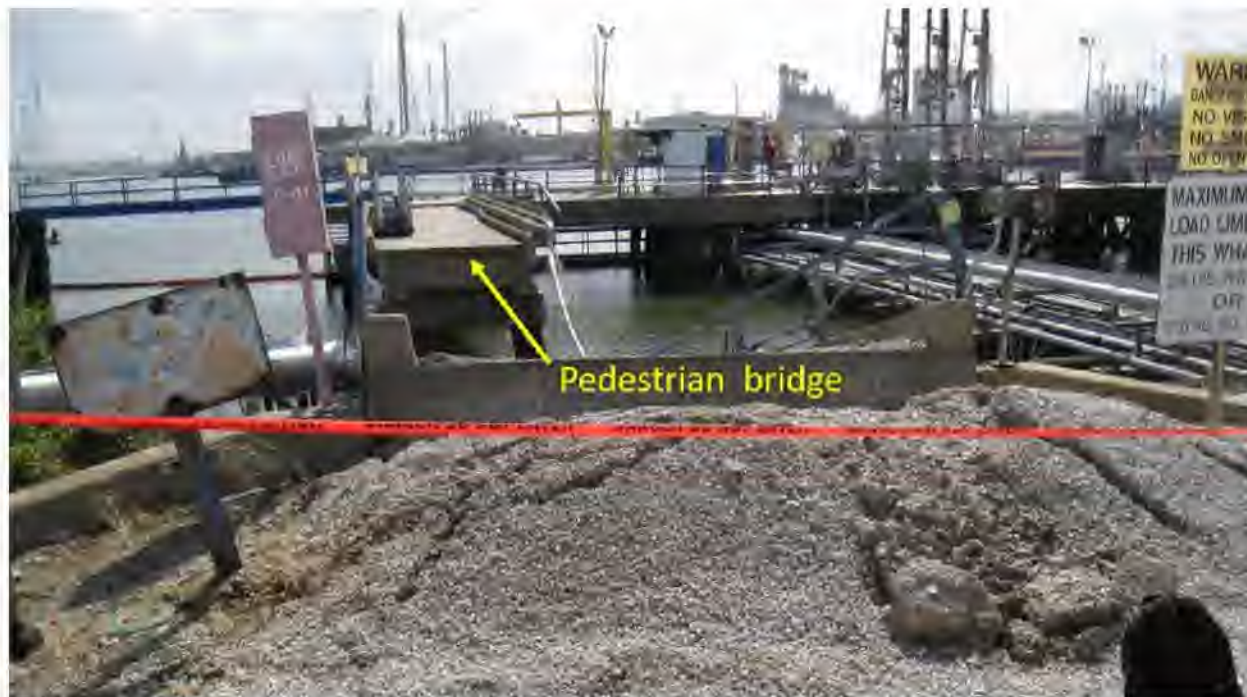
TPC facility on Houston Ship Channel. The impact pushed the pedestrian bridge off its support, crushing conduit below. (Photo by Coast Guard)

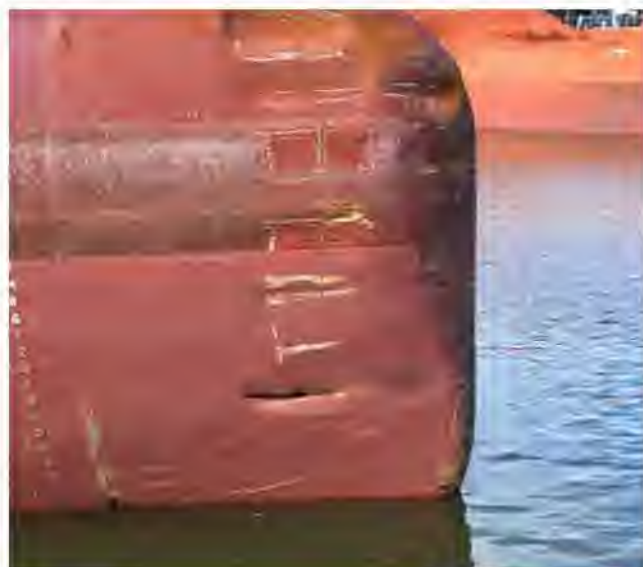
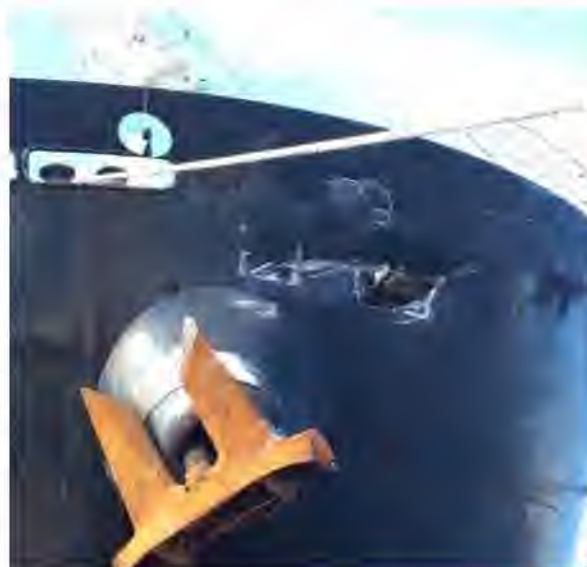
The *Yochow*'s bulbous bow was holed, and the forepeak was flooded to the waterline. The bow at the main deck was damaged where it contacted the barge's upper deck.

*Yochow's* bow showing, at left, holed bulbous bow and depth of penetration and, at right, damaged upper starboard bow.

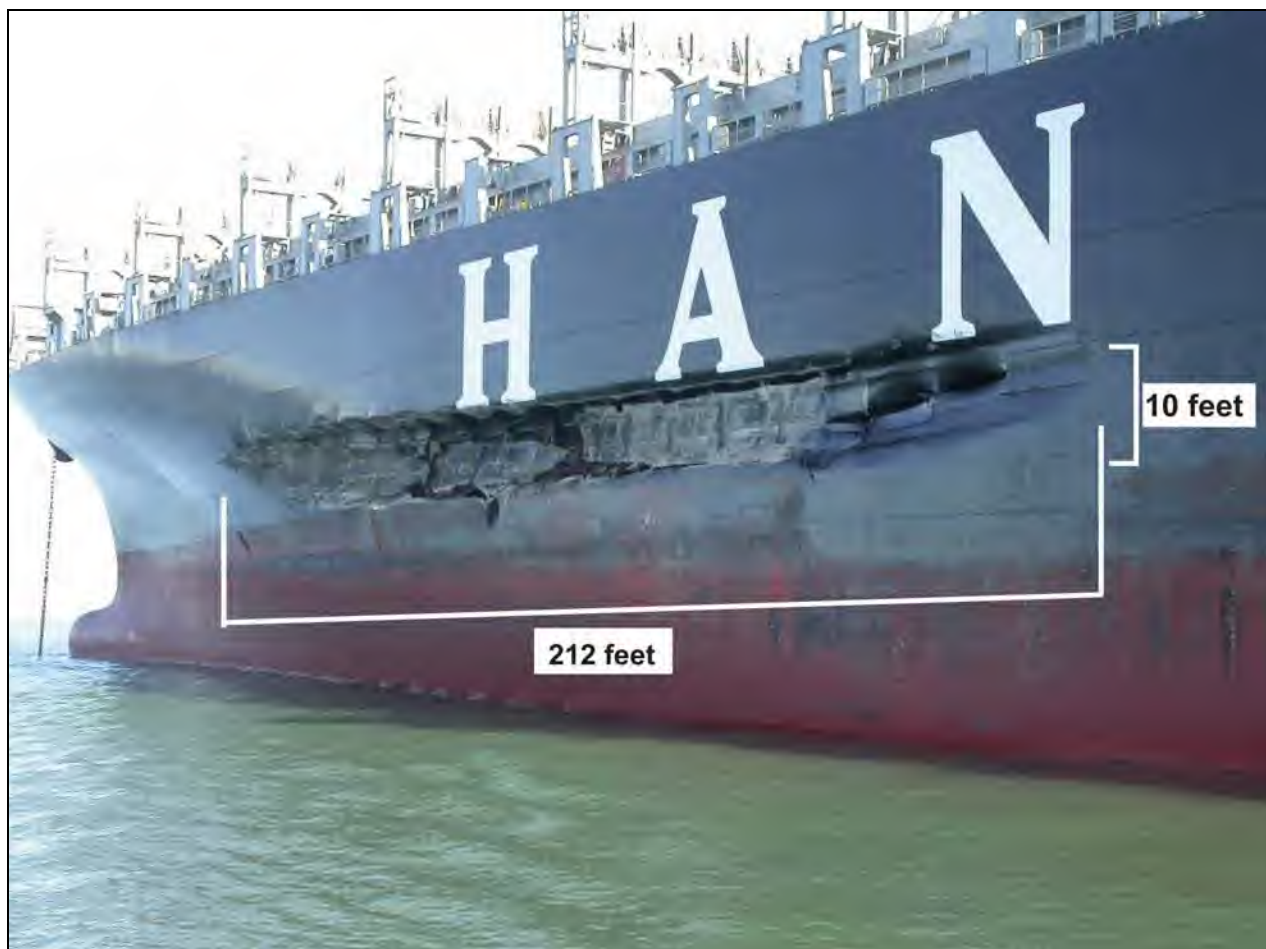
**Figure 4.** Damage to the forward port side of the *Cosco Busan* after the allision with the bridge tower.

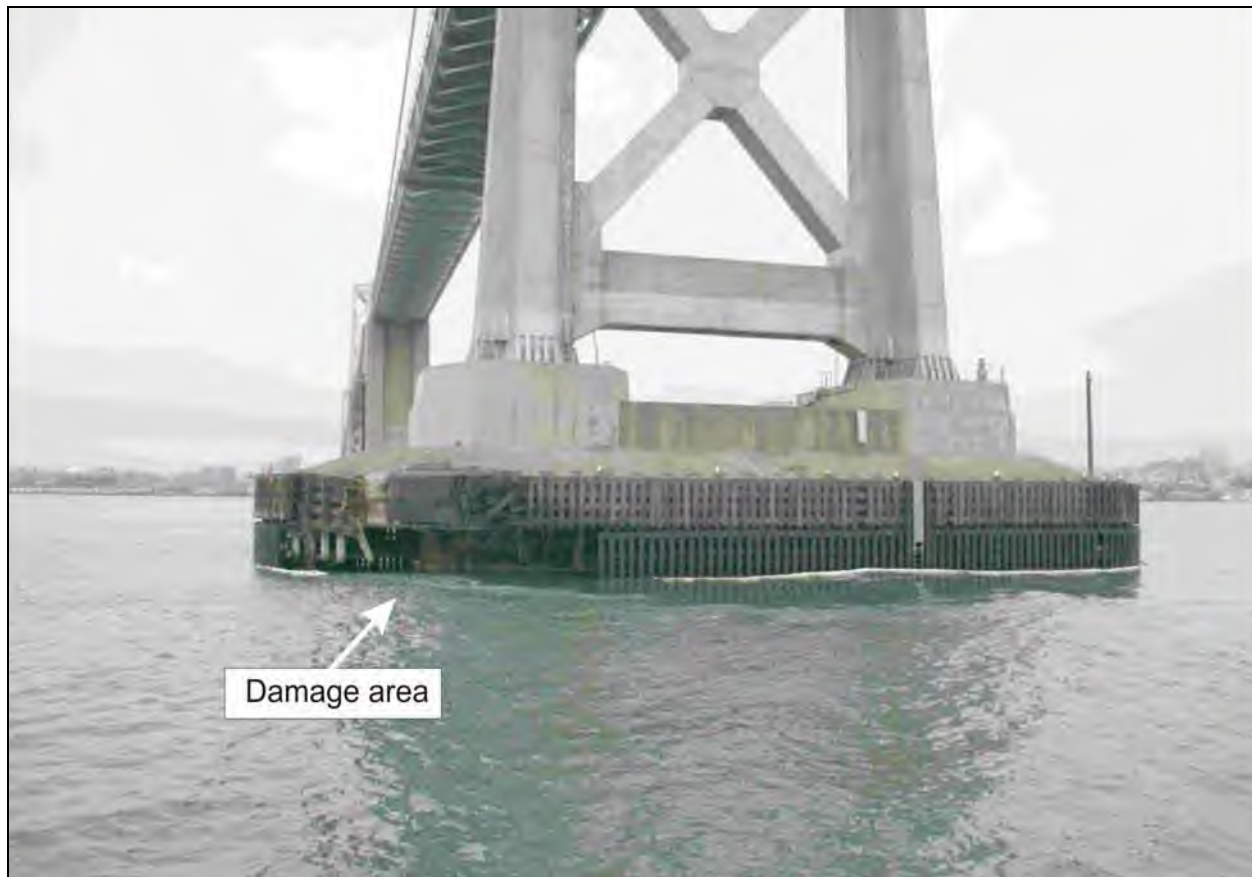
**Figure 5.** Damaged fendering system at the base of the Bay Bridge Delta tower.

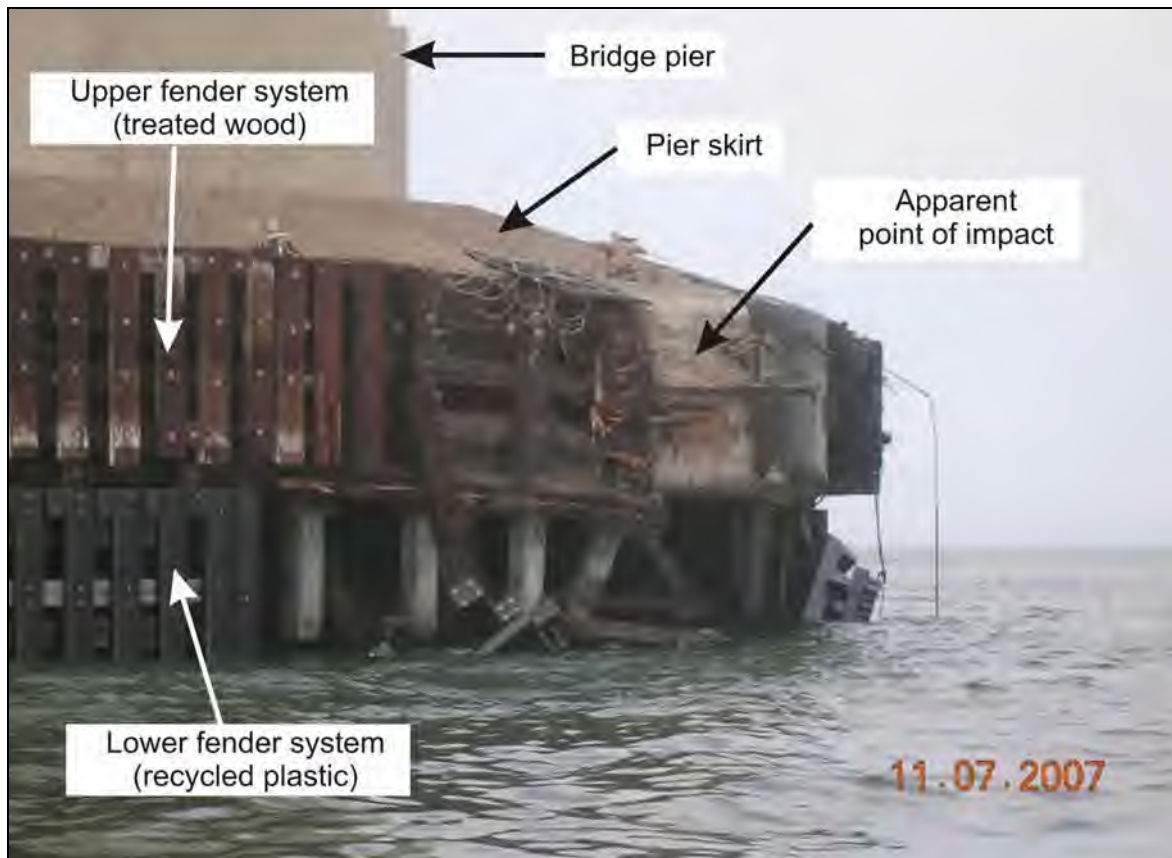
**Figure 6.** Close-up view of the fendering system at the base of the Delta tower showing the likely point of impact and a portion of the 100-foot-long damage area.
