**G4434-21G**

**SUMMARY REPORT - FAILED SERVICE LINE  
BELLEVUE, WASHINGTON**

PREPARED BY  
**CC TECHNOLOGIES SERVICES, INC.**  
KEVIN C. GARRITY, P.E.  
KURT LAWSON

**FEBRUARY 28, 2005**

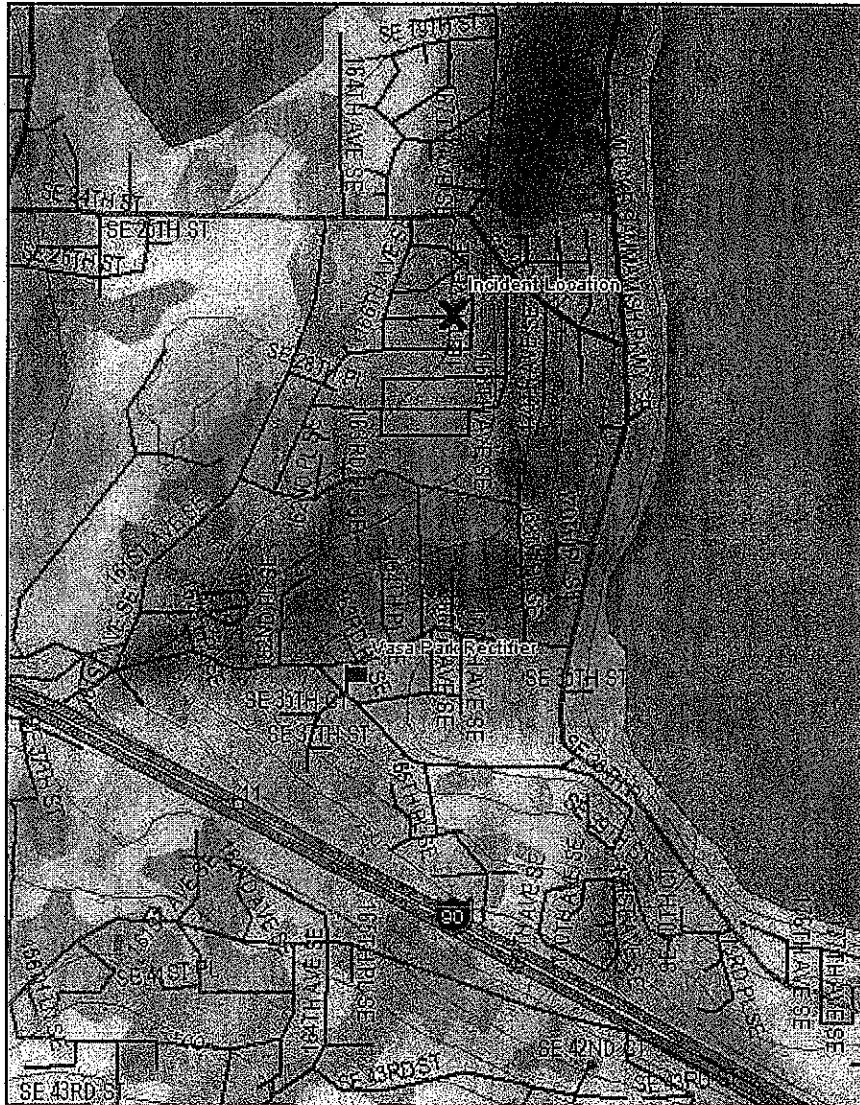
Cathodic protection was applied to the gas mains in the vicinity of the incident during the early 1980's. The coated and wrapped steel service was installed with no dielectric union at the tie-in to the main. The service therefore, was cathodically protected via the CP sources protecting the main. The predominant CP current source in the vicinity of the Spirit Ridge subdivision is located at SE 43rd Street and 164th Place SE and has been referred to as the Vasa Park rectifier. Figure 3 shows the relative location of the incident and the influencing rectifier. The rectifier is situated approximately 3,240 feet from the incident site. Documents reviewed indicate that this

rectifier and ground bed were installed in March 1982. It is reported that supplemental magnesium sacrificial anodes have been installed at various locations during the normal course of pipe excavations and service installations.

Figure 3. Map depicting Incident location and influencing rectifier.

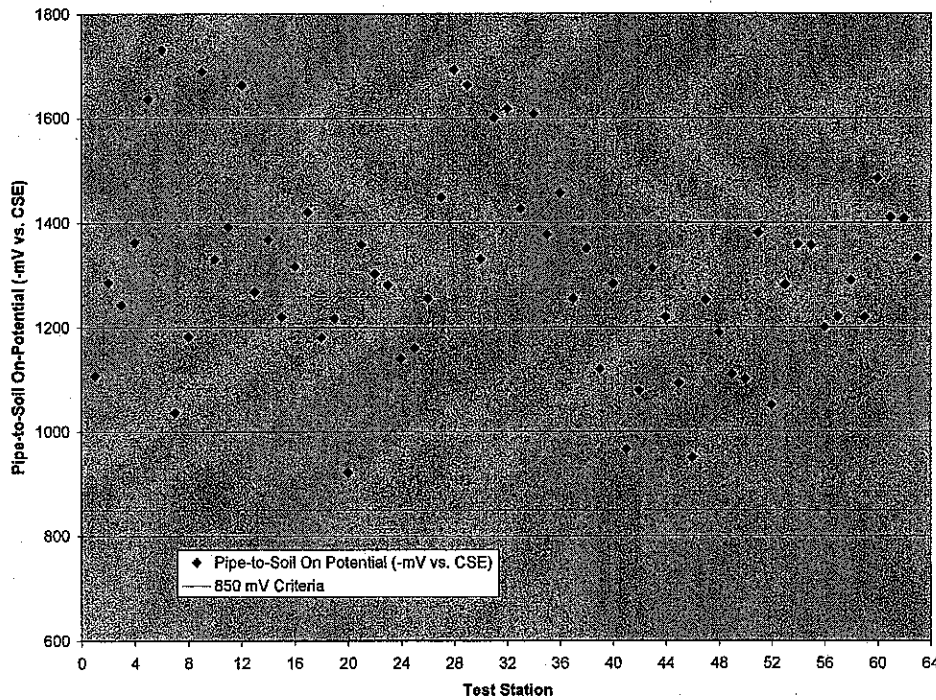
In the summer and fall of 2003 an annual cathodic protection survey was conducted in the Spirit Ridge area. Over sixty test points were investigated in the Spirit Ridge vicinity during the survey. The results of that survey are summarized in Table 1 below and shown graphically in Figure 4. Test stations highlighted in yellow lie directly in the Spirit Ridge area plats. The data indicate that throughout this area of the system at the time of these tests the CP system was operating at a level sufficient to meet the industry recognized criteria for effective CP in the Spirit Ridge area (See Appendix B for CP criteria listed in 49 CFR Part 192).

Figure 4. Pipe-to-soil potentials from the 2003 annual survey of the Spirit Ridge area.

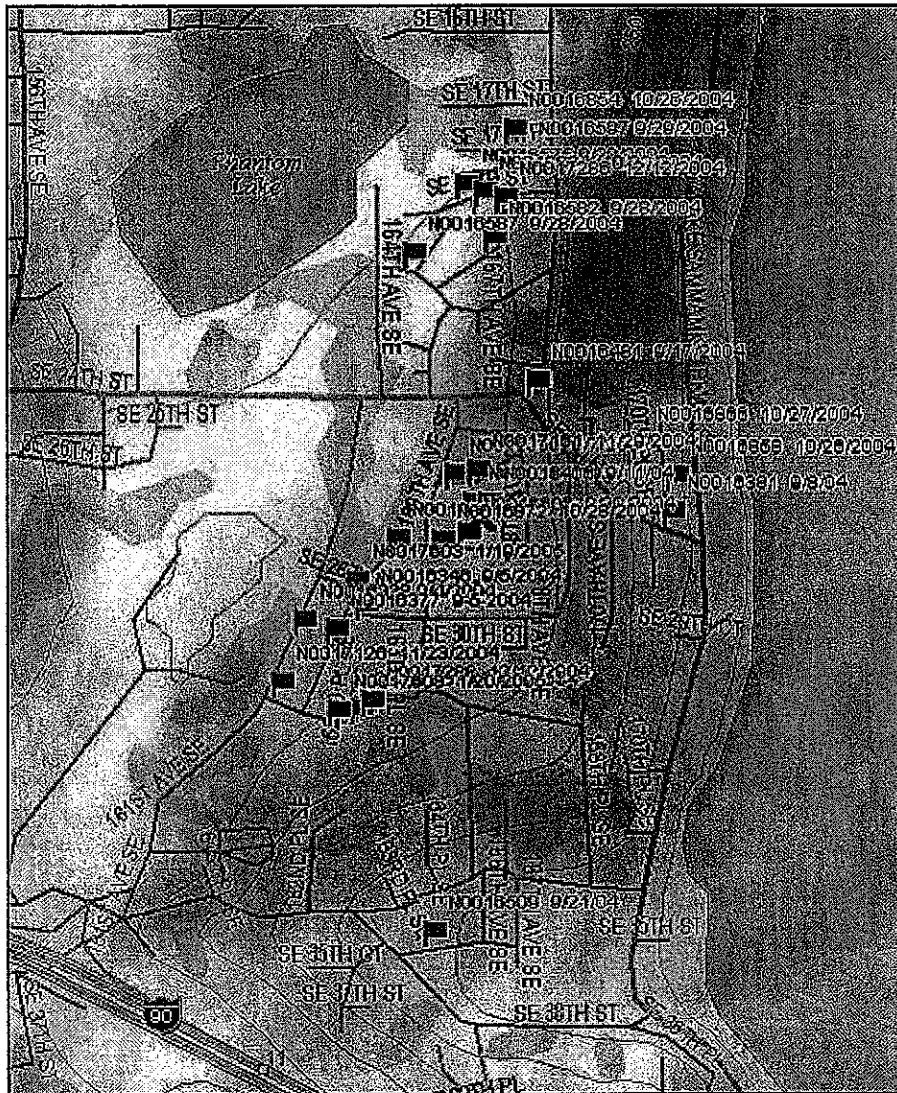
As the leak surveys continued during the months of September and October 2004, an increase in leaks was observed on the portion of the system connected to the Vasa Park rectifier. As of January 25, 2005, a total of 23 additional external corrosion leaks have been detected during this investigative program in the Spirit Ridge neighborhood. Figure 5 below shows the approximate location of these leaks within the Spirit Ridge area. To alleviate the public's concerns over the safety of the system, PSE officials decided in November to replace all of the steel mains and services.

**Figure 5. Approximate locations of identified leaks in the Spirit Ridge Vicinity.**
