**Re: Docket No.: UT-181051
Confidential Response Testimony of CenturyLink
Communications, LLC**

DOCKET NO.: UT-181051

RESPONSE TESTIMONY

STEVEN E. TURNER

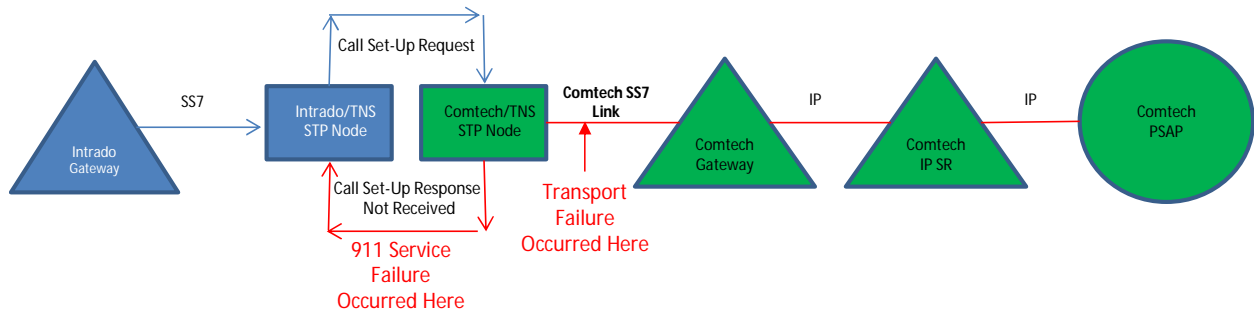
4 **Figure 8**
5 **Network Demarcation**

7 As discussed above, during the outage, CenturyLink successfully sent a call set-up IAM
8 request message. At that point, the ball is in Comtech’s court to respond and set up the
9 call. By Comtech’s own admission, the demarcation for both the transport and the 911
10 service failure occurred on Comtech’s “side of the network.”³⁸
