EXH. HLR-4

Avista Utilities Asset Management

Protocol for Managing Select Aldyl A Pipe in Avista Utilities' Natural Gas System

May 2013

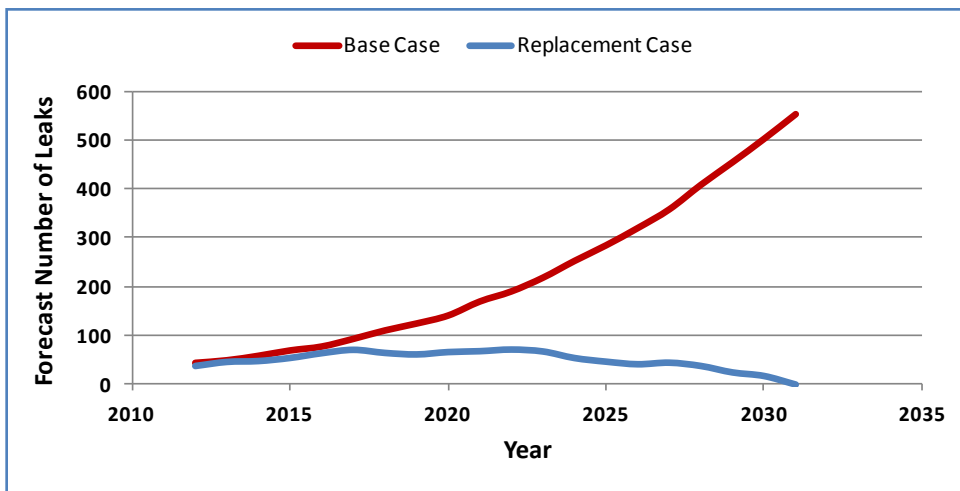
failures each year is expected to increase slightly until 2017, at which time the cumulative effect of priority piping replaced since 2012 begins to check the failure count and then drive it toward zero over the remaining course of the program (Figure 8).

Figure 8. Expected numbers of material failures in Avista’s priority Aldyl A piping in two cases: Replacement Case - piping replaced over a twenty year horizon in the manner proposed by Avista in this report, and Base Case – assumed that priority piping was not remediated under any program.
