## **Report Reviewing CC Technologies**

### **Laboratory-based Evaluation of Failed Service Line Final Report, F4434-01G (Dated February 18, 2005)**

M.J. Schiff & Associates, Inc.  
Consulting Corrosion Engineers  
431 West Baseline Road  
Claremont, CA 91711  
(July 18, 2005)

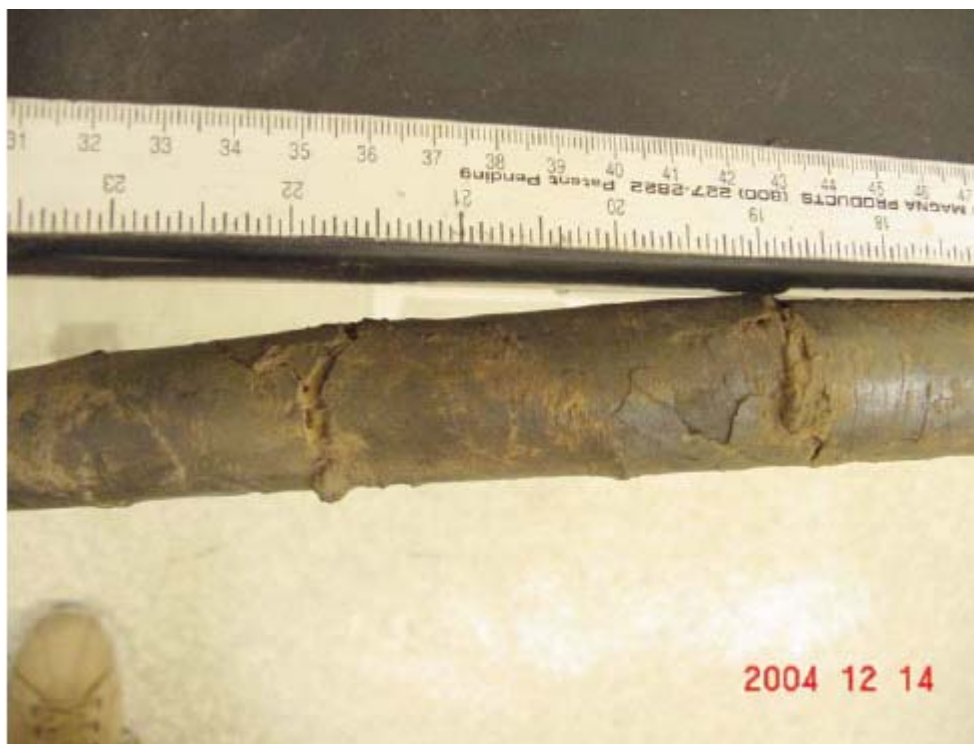
**Item 2: Photograph from page 47 (Figure 34) of the CCTL Report, showing cracks in coating on extrados of pipe segment 10 not reported in Table 2 of the CCTL Report.**

In analyzing the table, we find at least six coating holidays, including coating holidays which must have been present for the corrosion damage on segments 1 and 10 (leak location) to have occurred. In addition, we note that the cracks in the coating on the extrados of segment 10 are not documented in Table 2 of the CCTL Report, although clearly present in Figures 34 (page 46) and 35 (page 47) of Appendix D of the Report. Figure 34 is reproduced here in Item 2.

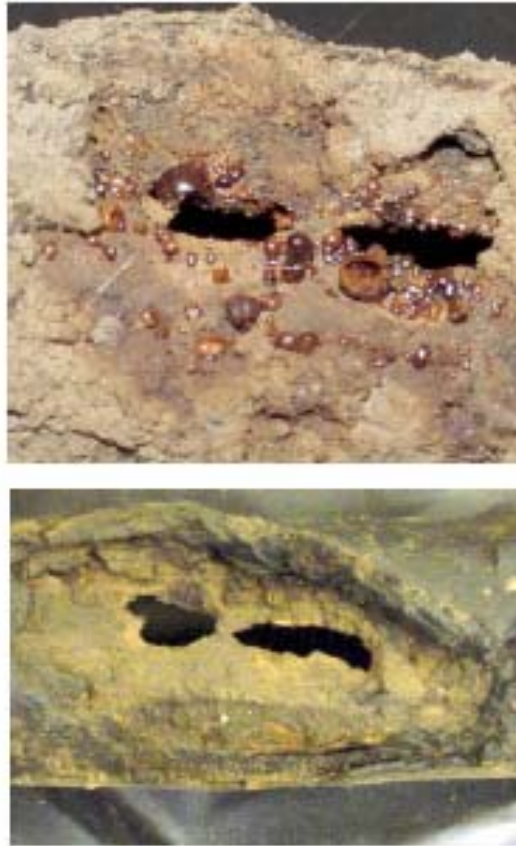
**Item 7: Figure 14 from CCTL Report, page 16, showing corrosion feature on segment 10 at leak location before and after removal of surface debris and deposits**

Figure 14. The leak site in Segment 10. Top photo – as received condition with protective plastic enclosure removed; bottom photo – debris and surface deposits removed.

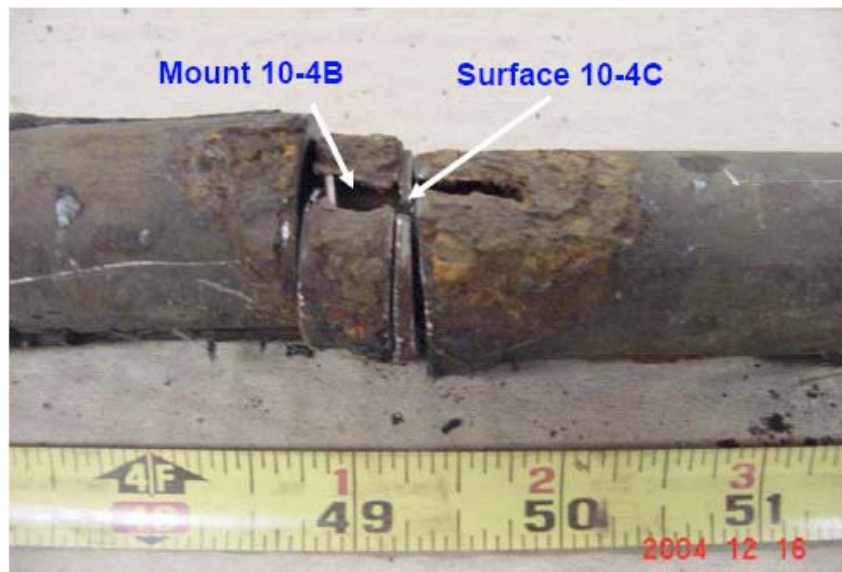
**Item 8: Figure 19 from CCT Report, page 20, showing subsequent sectioning and metallographic mounting of leak location for additional analysis and testing.**

(closest to the customer's meter). The leak location was in Sample 10-4, which was further sectioned to 10-4B and 10-4C (Item 8)

**Figure 19. Segment 10 showing Mount 10-4B (2<sup>nd</sup> piece from left) and Surface 10-4C (3<sup>rd</sup> piece from left).**

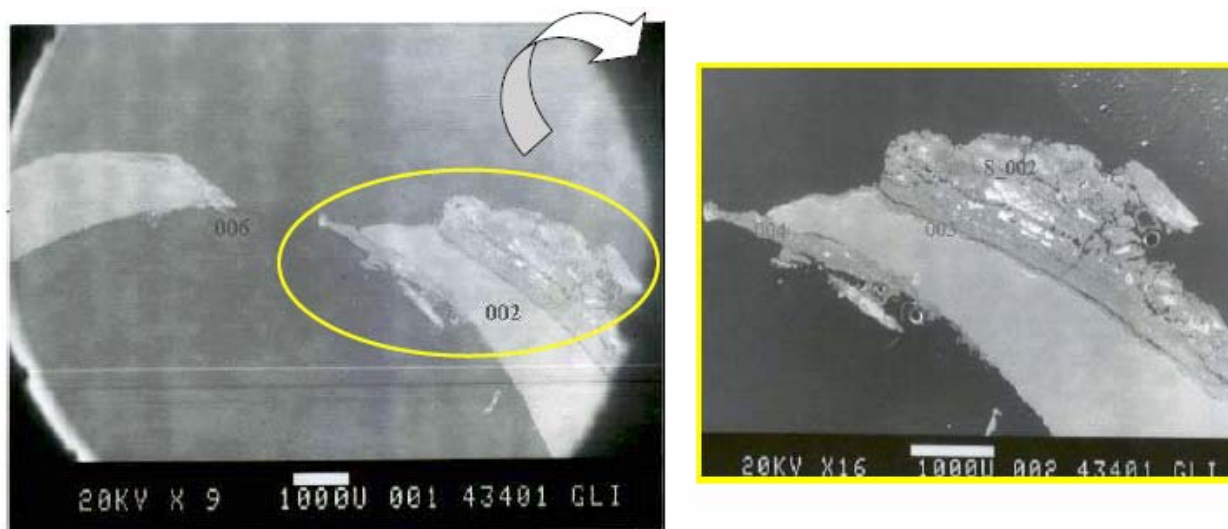
Item 9: Figure 25 from CCTL Report, page 23, showing interior and exterior corrosion deposits at the leak location of segment 10, mount 10-4B

SEM examination of mount 10-4B at the leak location identified corrosion deposits on both the exterior and interior surfaces of the pipe. Despite the presence of interior deposit, no documentation of the damage other than the SEM and EDS spectrum were presented in the CCTL Report.

Figure 25. SEM photomicrograph of Mount 10-4B at leak site. Note deposits on OD and ID surfaces. S-002 EDS spectrum is shown in Figure 27.

CCTL states on page 26 of the Report that, “The most plausible explanation for the ID corrosion is condensation near the leak location caused by local cooling of the steel wall due to the Joule-Thomson [*sic*] effect.” The Joule-Thomson refers to the change in temperature of a non-ideal gas that occurs when the non-ideal gas suddenly expands from a high pressure to a low pressure. The amount of corrosion observed on the interior of the pipe would require significant time to occur given this mechanism (i.e. condensation on the interior of the pipe wall). This indicates that leak had been present for some time, most likely prior to the reversal of the Vasa Park rectifier, which has been estimated by Kuang Chu of the Commission to have been mis-wired for at most sixty-four and not less than five days.

***We would agree that the ID corrosion was not the initiation of the leak, but that internal corrosion of the remaining ligament of the metal wall (see Item 9) may have increase the size of the hole and the gas leak rate as a function of time at a higher rate when taken in combination with external corrosion contributing factors.***
