**DOCKET NO. PG-041624**

**Letter from Kevin C. Garrity, PE of CC Technologies to Steven Secrist,  
Puget Sound Energy, "Spirit Ridge – Summary of Field Inspection of  
Seventy-five (75) and Metallurgical Analysis of Six (6) Service Risers – Spirit Ridge  
Subdivision (F4434-01G)," dated June 15, 2005**

*RE: Puget Sound Energy, Spirit Ridge – Summary of Field Inspection of  
Seventy-five (75) and Metallurgical Analysis of Six (6) Service Risers –  
Spirit Ridge Subdivision (F4434-01G)*

### **Field Inspection of Risers**

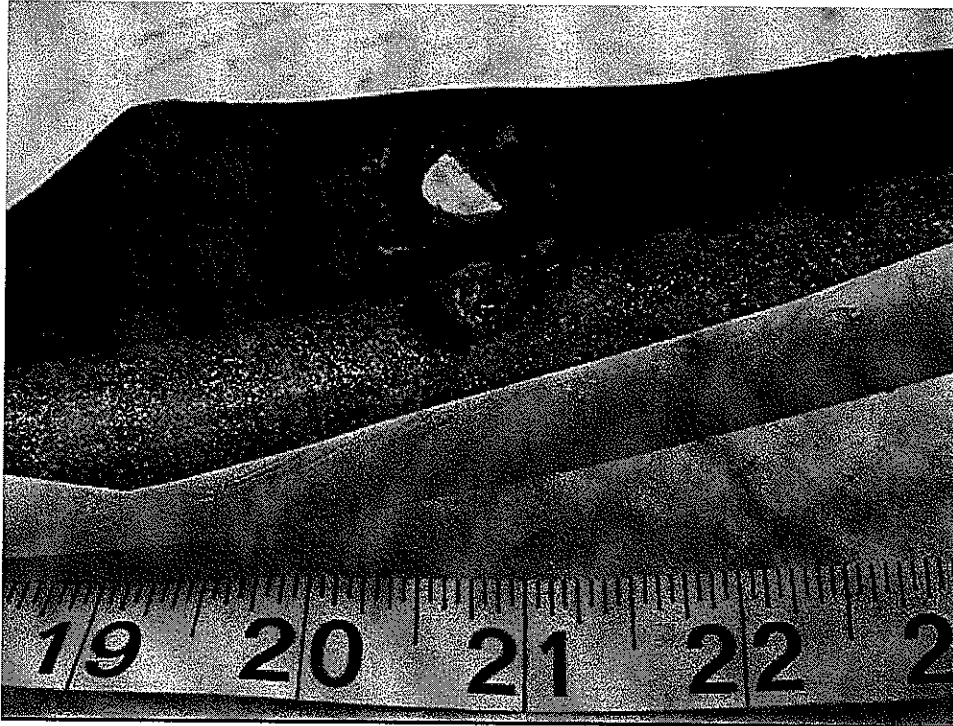
The visual inspection of the as-received pipe revealed two gouges in the extruded polyethylene coating located at 5.5-inches downstream and 21-inches downstream. The gouges were located upstream of the bend and on the downstream portion of the bend, respectively. After removing the coating, a pit approximately 0.4-inches in diameter was visible under the gouge at 21-inches. There was only minor surface corrosion located under the gouge at 5.5-inches and the rest of the pipe appeared to be free of corrosion product. Figure 1 is a photograph showing both the gouge in the coating and the pit in the pipe located at 21-inches.

Figure 1. Photograph showing the pipe after removing the coating around the gouge that was located 21-inches from the upstream end of the pipe.

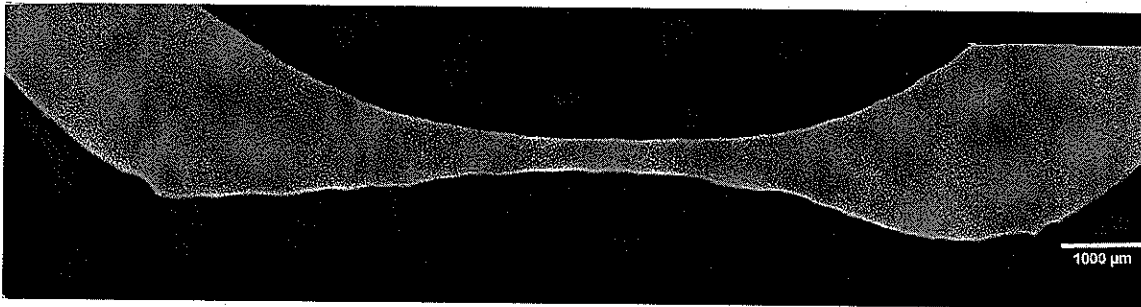
A metallographic cross-section through the deepest portion of the pit was mounted and polished. Figure 2 is a light photomicrograph of the polished sample showing the morphology of the pit. The pit was approximately 83-mils deep, which corresponds to an 81% wall penetration. The pipe was 0.5-inches in diameter and had a wall thickness of approximately 0.105-inches.

Figure 2. Light photomicrograph of the pit located at 21-inches.

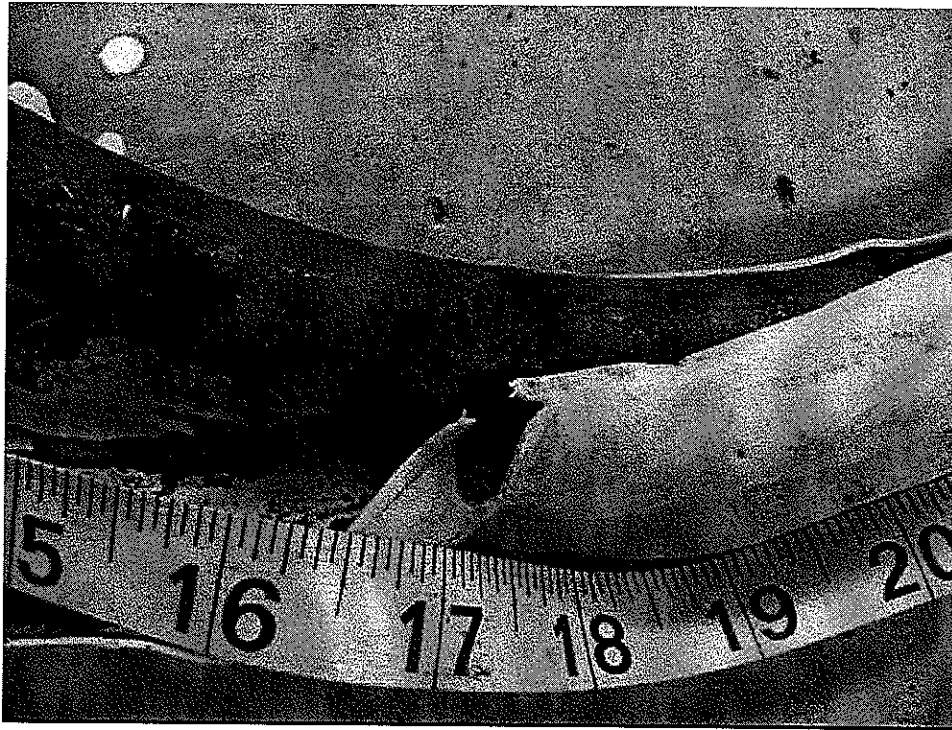
The visual inspection of the as-received pipe revealed four gouges in the extruded polyethylene coating located at 16-inches downstream, 17-inches downstream, 20.5-inches downstream, and 39.5-inches downstream. All four gouges were located either on the upstream or downstream portion of the bend. After removing the coating, a pit approximately 0.4-inches in diameter was visible under the gouge in the coating located at 17-inches. There was only minor surface corrosion located beneath the other three gouges and the rest of the pipe appeared to be free of corrosion product. Figure 3 is a photograph showing both the gouge in the coating and the pit in the pipe located at 17-inches.

Figure 3. Photograph showing the pipe after removing the coating around the gouge located 17-inches from the upstream end of the pipe.

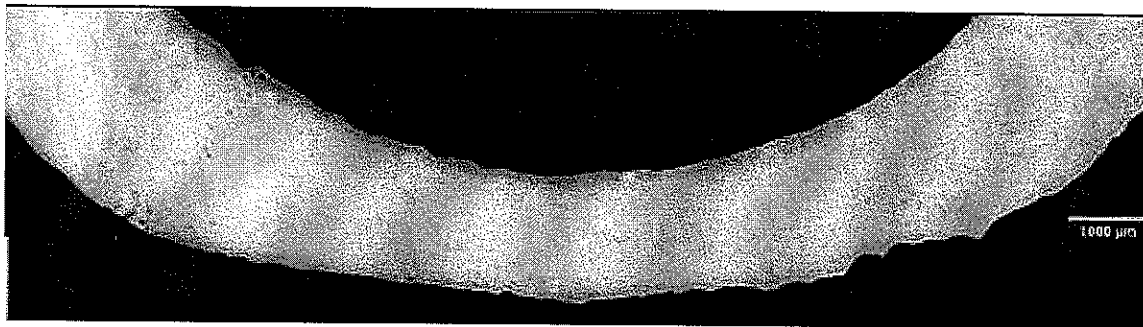
A metallographic cross-section through the deepest portion of the pit was mounted and polished. Figure 4 is a light photomicrograph of the polished sample showing the morphology of the pit. The pit was approximately 41-mils deep, which corresponds to a 39% wall penetration. The pipe was 0.5-inches in diameter and had a wall thickness of approximately 0.105-inches.

Figure 4. Light photomicrograph of the pit located at 16-inches.

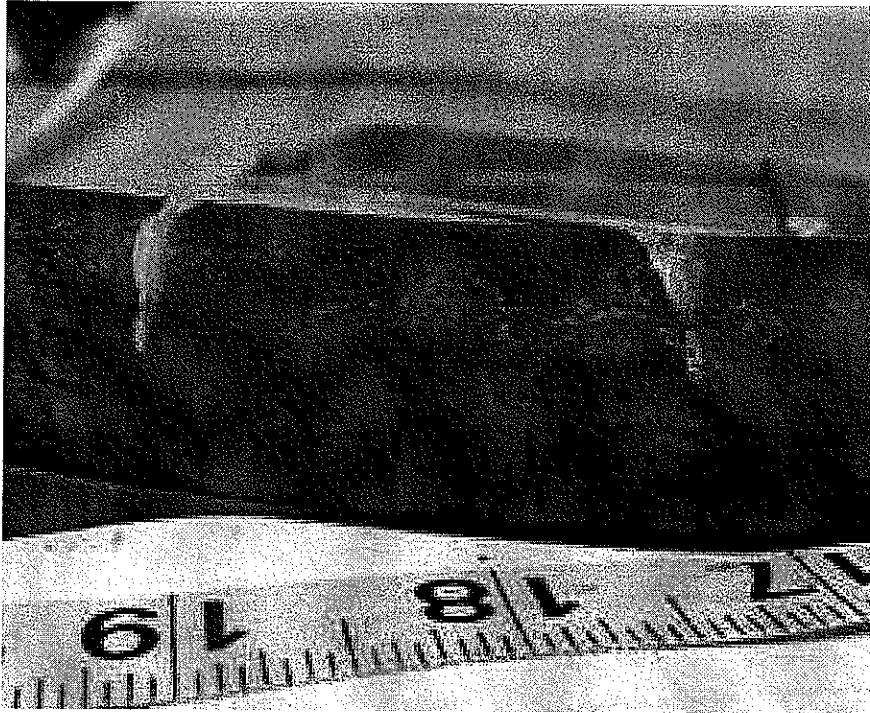
The visual inspection of the as-received pipe revealed 5 anomalies in the coal tar coating. There was a holiday in the coating located at 1.5-inches downstream and cracked/missing coating located at 18.5-inches, 22.5-inches, 24-inches and 26-inches downstream. The holiday was located on the upstream of the bend while the cracked/missing coating was located either on the upstream or downstream portion of the bend. After removing the coating, a pit approximately 0.2-inches in diameter and another small pit were visible under the cracked/missing coating located at 18.5-inches. There was only minor surface corrosion located beneath the other three gouges and the rest of the pipe appeared to be free of corrosion product. Figure 5 is a photograph showing the two small pits at 18.5-inches that were visible after removing the coating.

Figure 5. Photograph of the two pits located at 18.5-inches downstream.

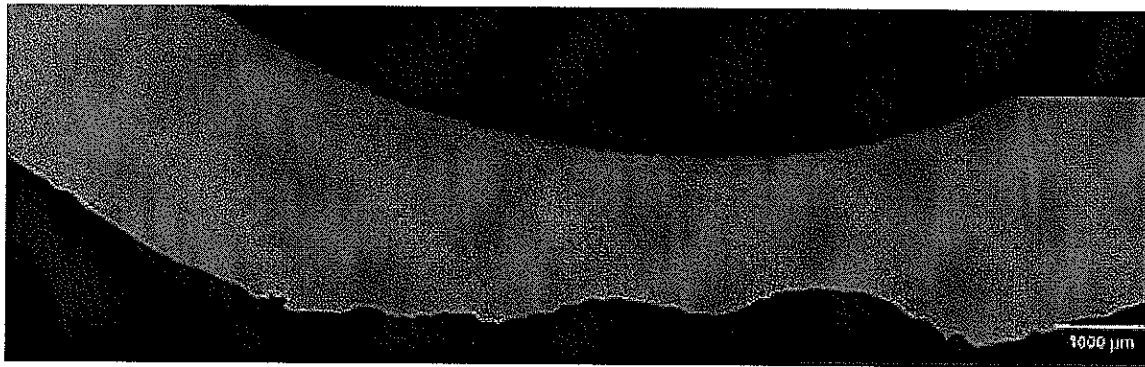
A metallographic cross-section through the deepest portion of both pits was mounted and polished. Figure 6 is a light photomicrograph of the polished larger pit showing the morphology of the pit. The pit was approximately 55-mils deep, which corresponds to a 47% wall penetration. The smaller pit was approximately 46-mils deep, which corresponds to a 40% wall penetration. The pipe was 0.75-inches in diameter and had a wall thickness of approximately 0.115-inches.

Figure 6. Light photomicrograph of the deepest pit.

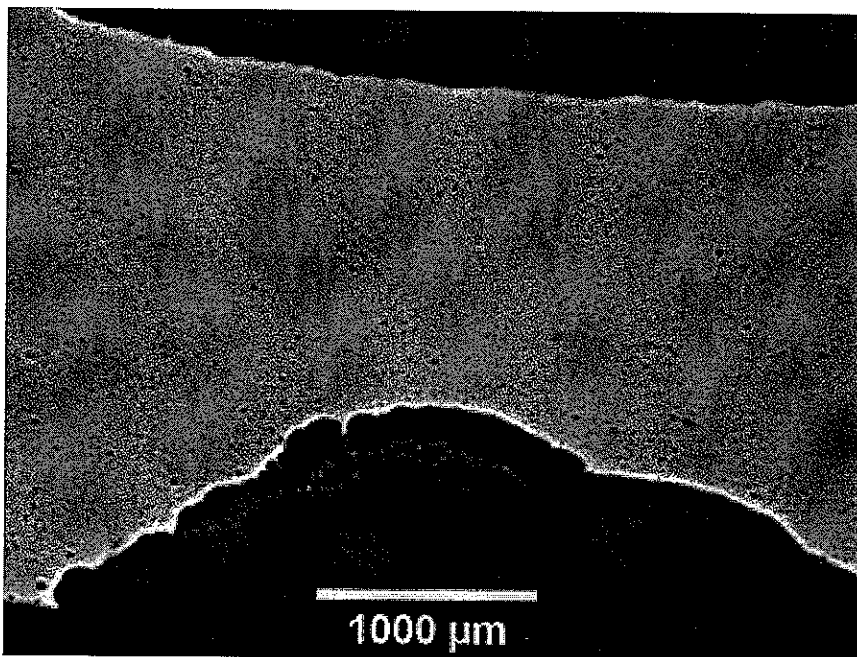
A metallographic cross-section through the deepest portion of the pit located at 22.5-inches and the largest pit at 31.5-inches downstream were mounted and polished. Figure 6 is a light photomicrograph of the pit located at 31.5-inches showing the morphology of the pit. The pit was approximately 51-mils deep, which corresponds to a 46% wall penetration. The pit located at 22.5-inches had a maximum pit depth of 31-mils corresponding to a wall penetration of 27%. The pipe was 0.75-inches in diameter and had a wall thickness of approximately 0.115-inches.

Figure 8. Light photomicrograph of the pit located at 31.5-inches downstream.

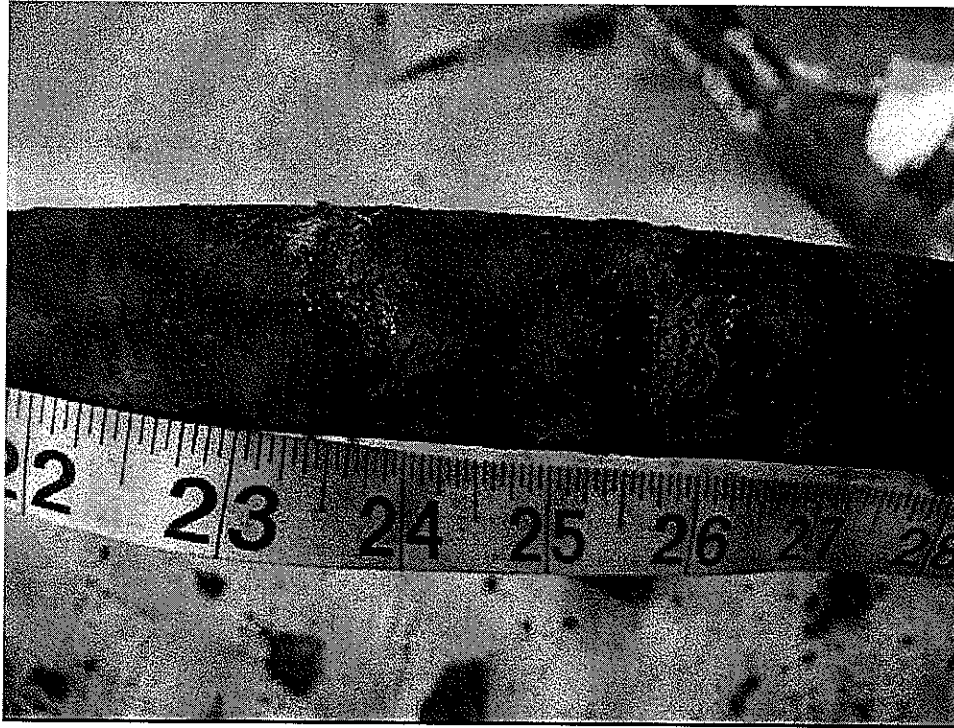
The visual inspection of the as-received pipe revealed three coating faults in the coal tar coating. There were two areas of missing coating located at 7-inches downstream and between 14-inches and 18-inches downstream. There was transverse cracking in the coating located between 21-inches and 27-inches downstream. The missing coating at 7-inches was located upstream of the bend while the other faults were located on the bend. After removing the coating, there were no visible areas of pitting. There were areas of corrosion beneath the cracking and beneath the missing coating. The rest of the pipe appeared to be free of corrosion product. Figure 9 is a photograph showing the corrosion product that was present between 22-inches and 26-inches.

Figure 9. Photograph showing corrosion product after the coating was removed located between 23 and 26" from the upstream end of the pipe.

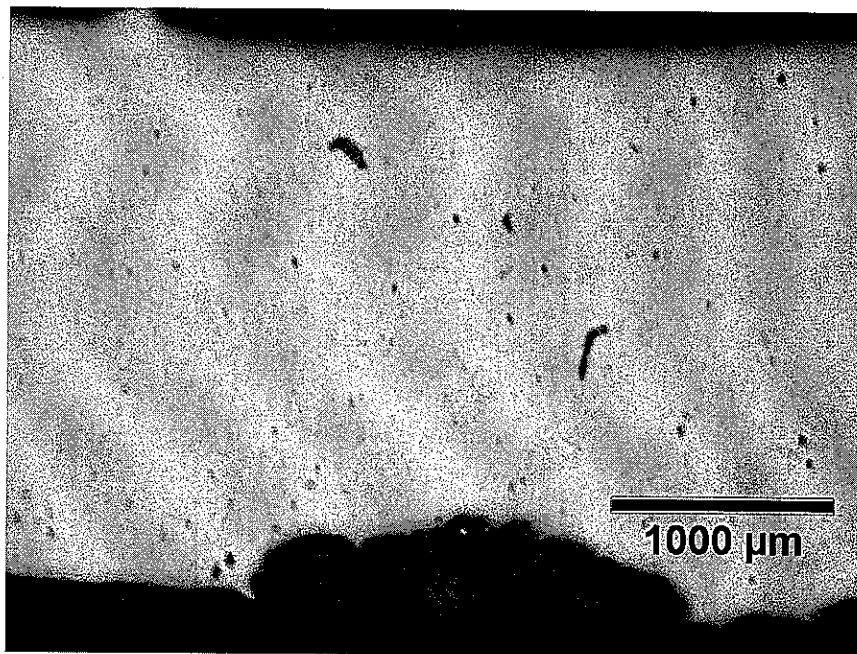
Two metallographic cross-sections through the corrosion product were taken at 16-inches and 25.5-inches downstream. After cutting, a small pit was visible in the mount at 25.5-inches. Figure 10 is a light photomicrograph of the polished sample showing the morphology of the pit. The pit was approximately 29-mils deep, which corresponds to a 26% wall penetration. The pipe was 0.75-inches in diameter and had a wall thickness of approximately 0.115-inches.

Figure 10. Light photomicrograph of the pit located at 25.5-inches downstream.
