**RE: 2008 Standard Inspection of Thurston/Lewis Counties Distribution System,
Docket PG-080032**

This letter is in response to the "2008 Standard Inspection of Thurston/Lewis Counties Distribution System" report dated June 26, 2008. In this report Staff identified six probable violations and one area of concern. Below are PSE's responses to these findings.

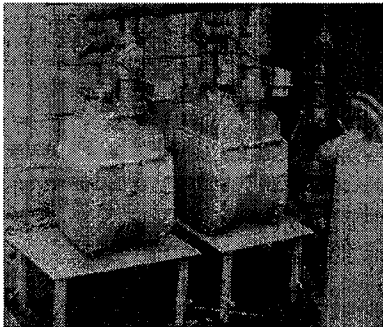
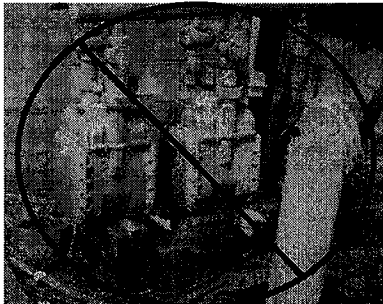
Natural Gas Meter Support Is Not To Be Taken Lightly

GOS 2525.2400, "Support and Anchor Requirements," requires each support on an exposed pipeline to be made of a durable, noncombustible material (this too is a federal pipeline safety rule). In addition, this standard requires that the support be designed and installed such that inspection for atmospheric corrosion can be accomplished. Therefore, only coded meter supports may be used unless a noncoded support is approved by the Manager Engineering and the Manager Standards.

The adjustable meter stand (**MID 8500610**) is coded and approved to provide permanent support for gas meter set assemblies. Pipe clamps with a channel strut and associated fittings are also approved for use and are required on specific meter sets in accordance with the Meter Set Assemblies section in the *Gas Design and Construction Standards* manual.

If, during normal operations and maintenance activities, you see an existing meter support that does not comply with this requirement, please report this condition on the Reporting Abnormal or Unusual Operating Conditions on Gas Facilities form (PSE Form 3704), aka "the blue card," in accordance with *GOS 2575.2700*, "Continuing Surveillance."
