July 15, 2011

David Lykken - Director of Pipeline Safety Program
 State of Washington Utilities and Transportation Commission
 1300 S. Evergreen Park Dr. SW
 P.O. Box 47250
 Olympia, WA 98504-7250

Subject: Response to Docket PG-110020

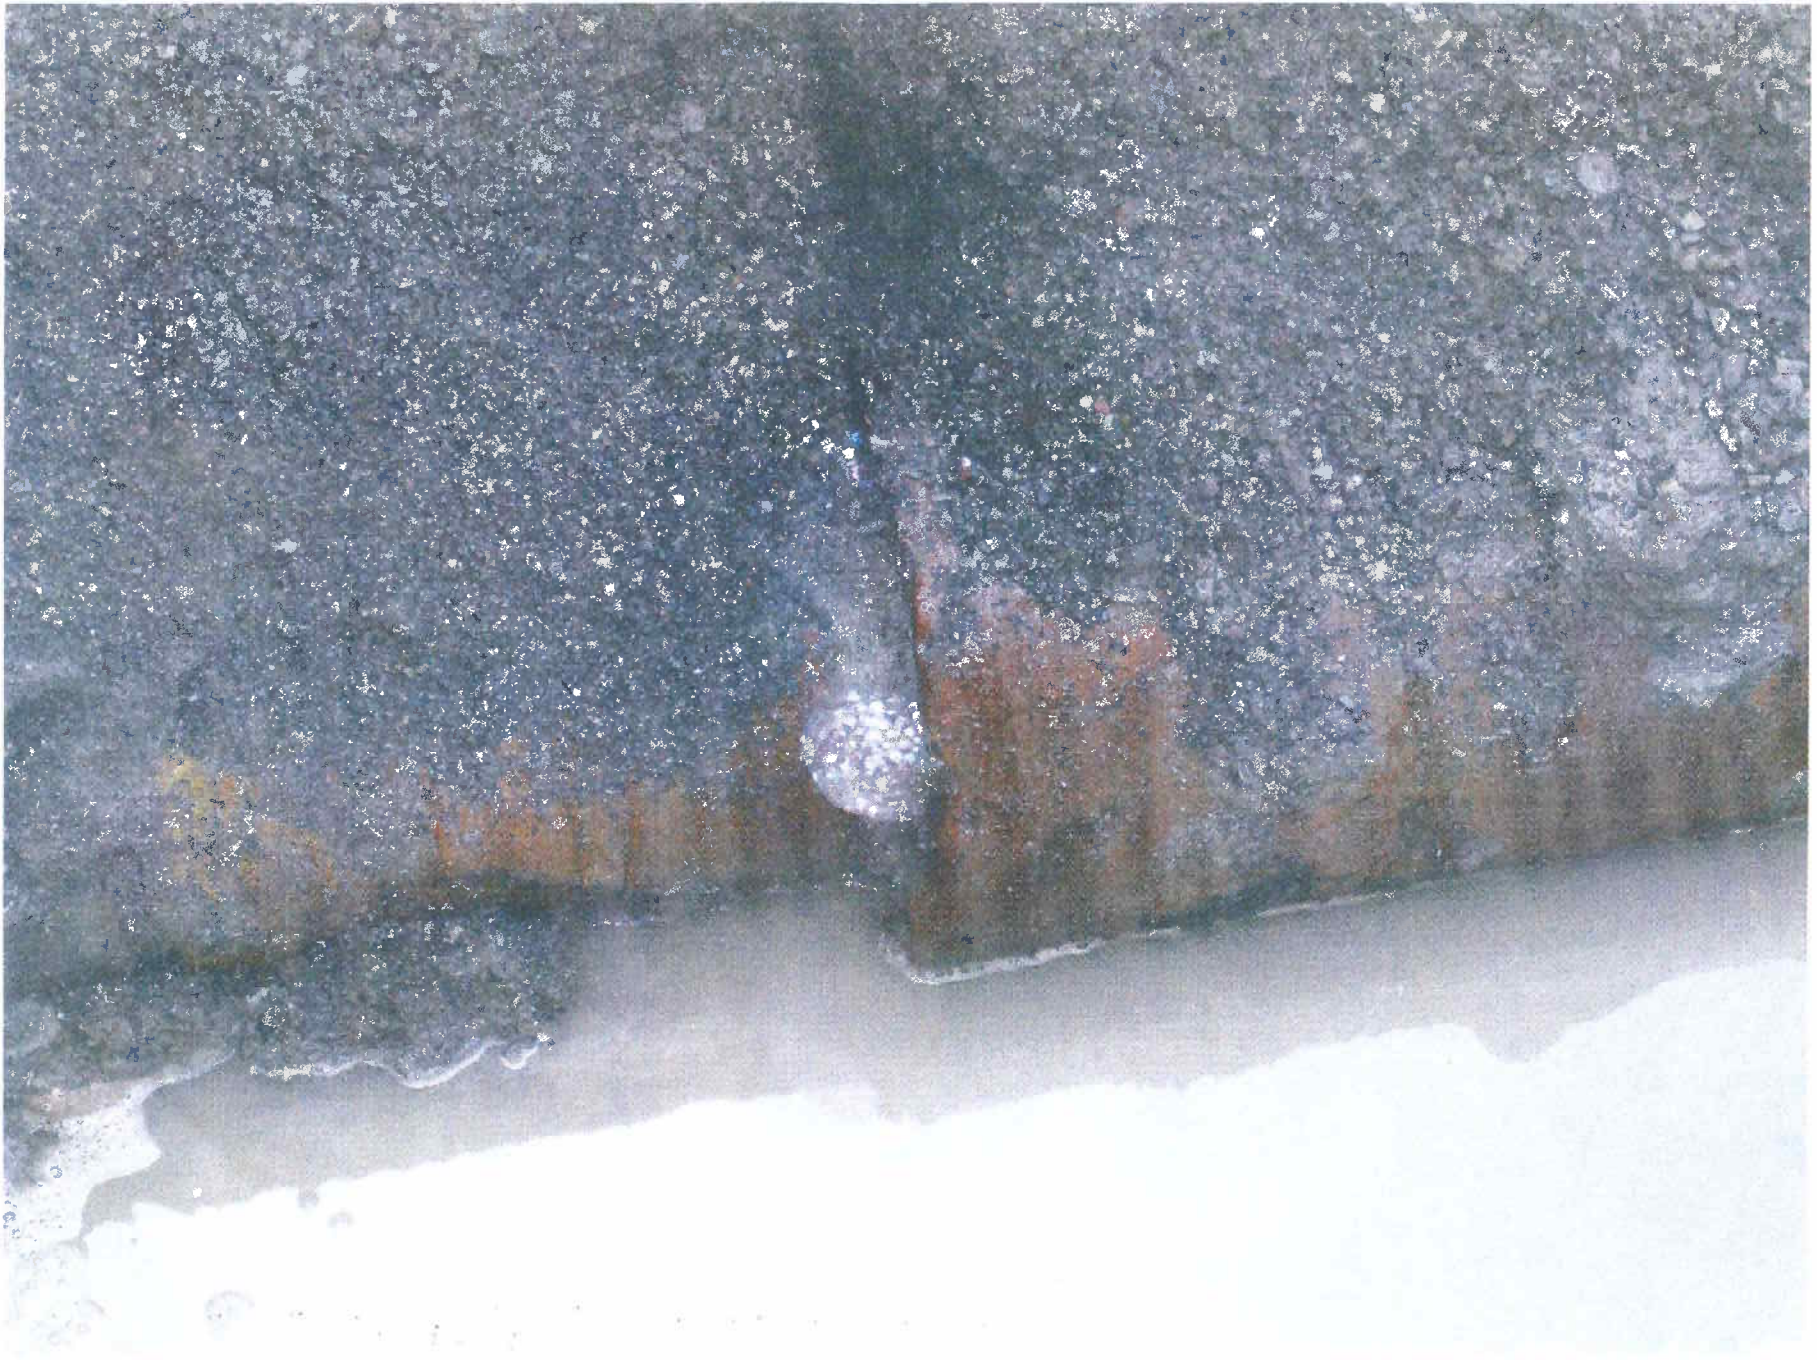
9/8-710/09 10" H.P. Leak investigation Dig Map Detail

*Casing shorted to 10" H.P. line. Casing + vent share same potential as carrier pipe
* -0.800 → -1.002 VDC

* Barrel length approximate
* Plated ends, no caps, leaking @ end exposed and sav-a-valve vent in middle

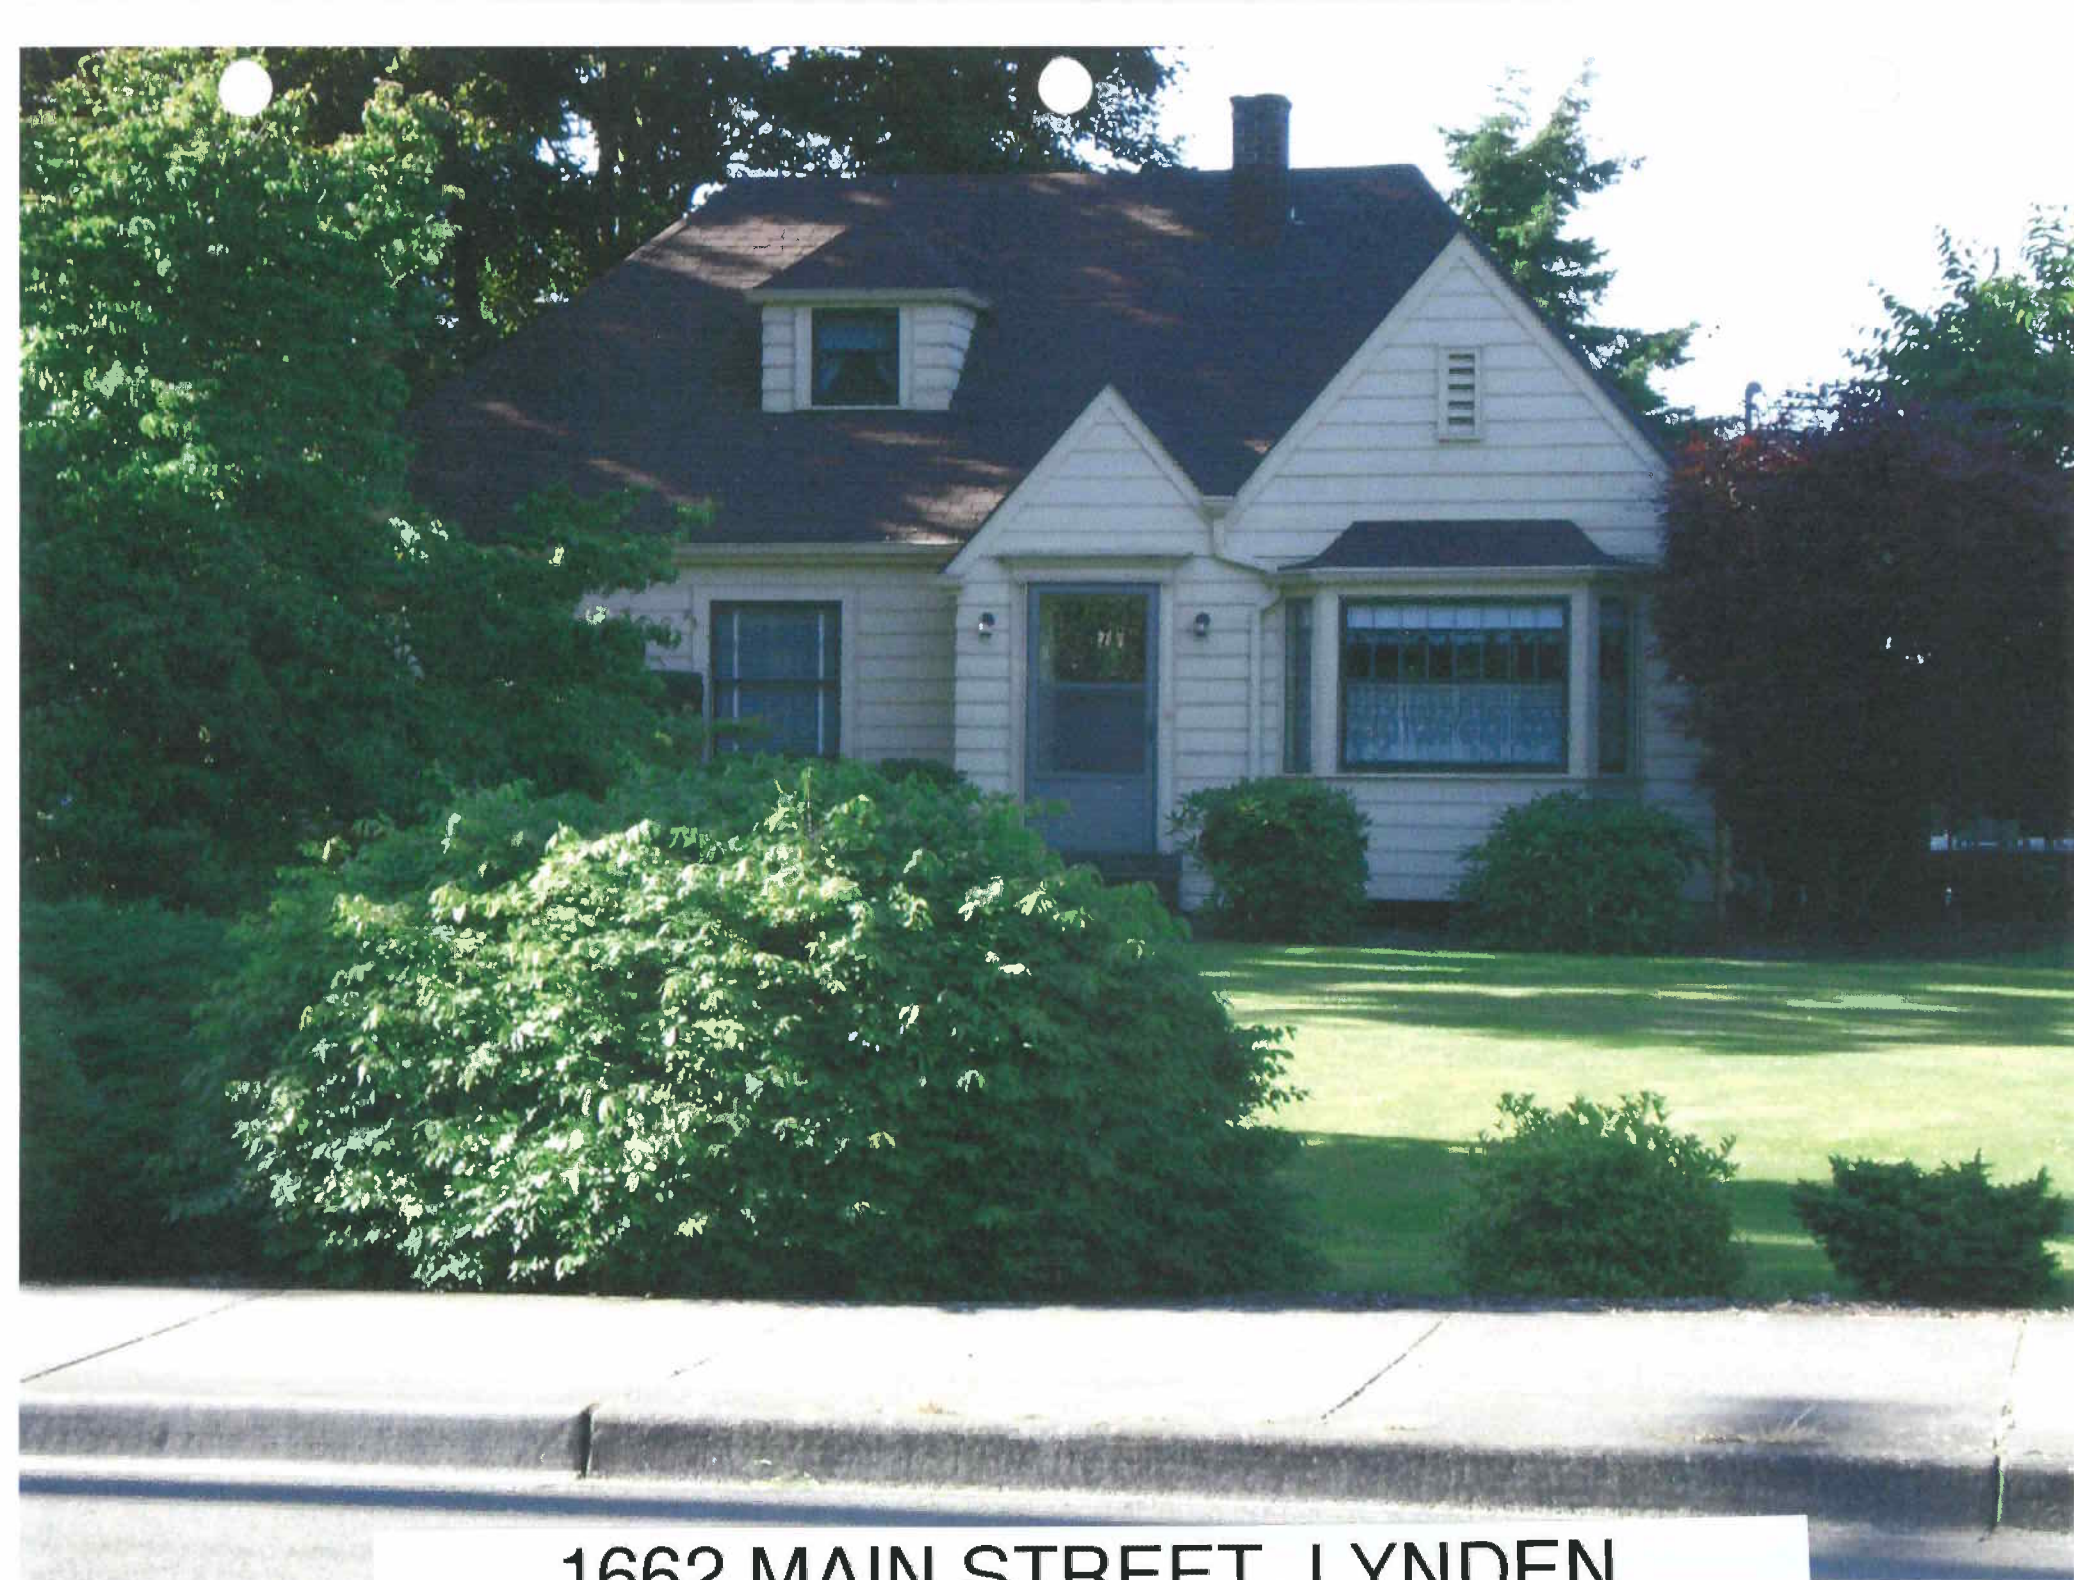
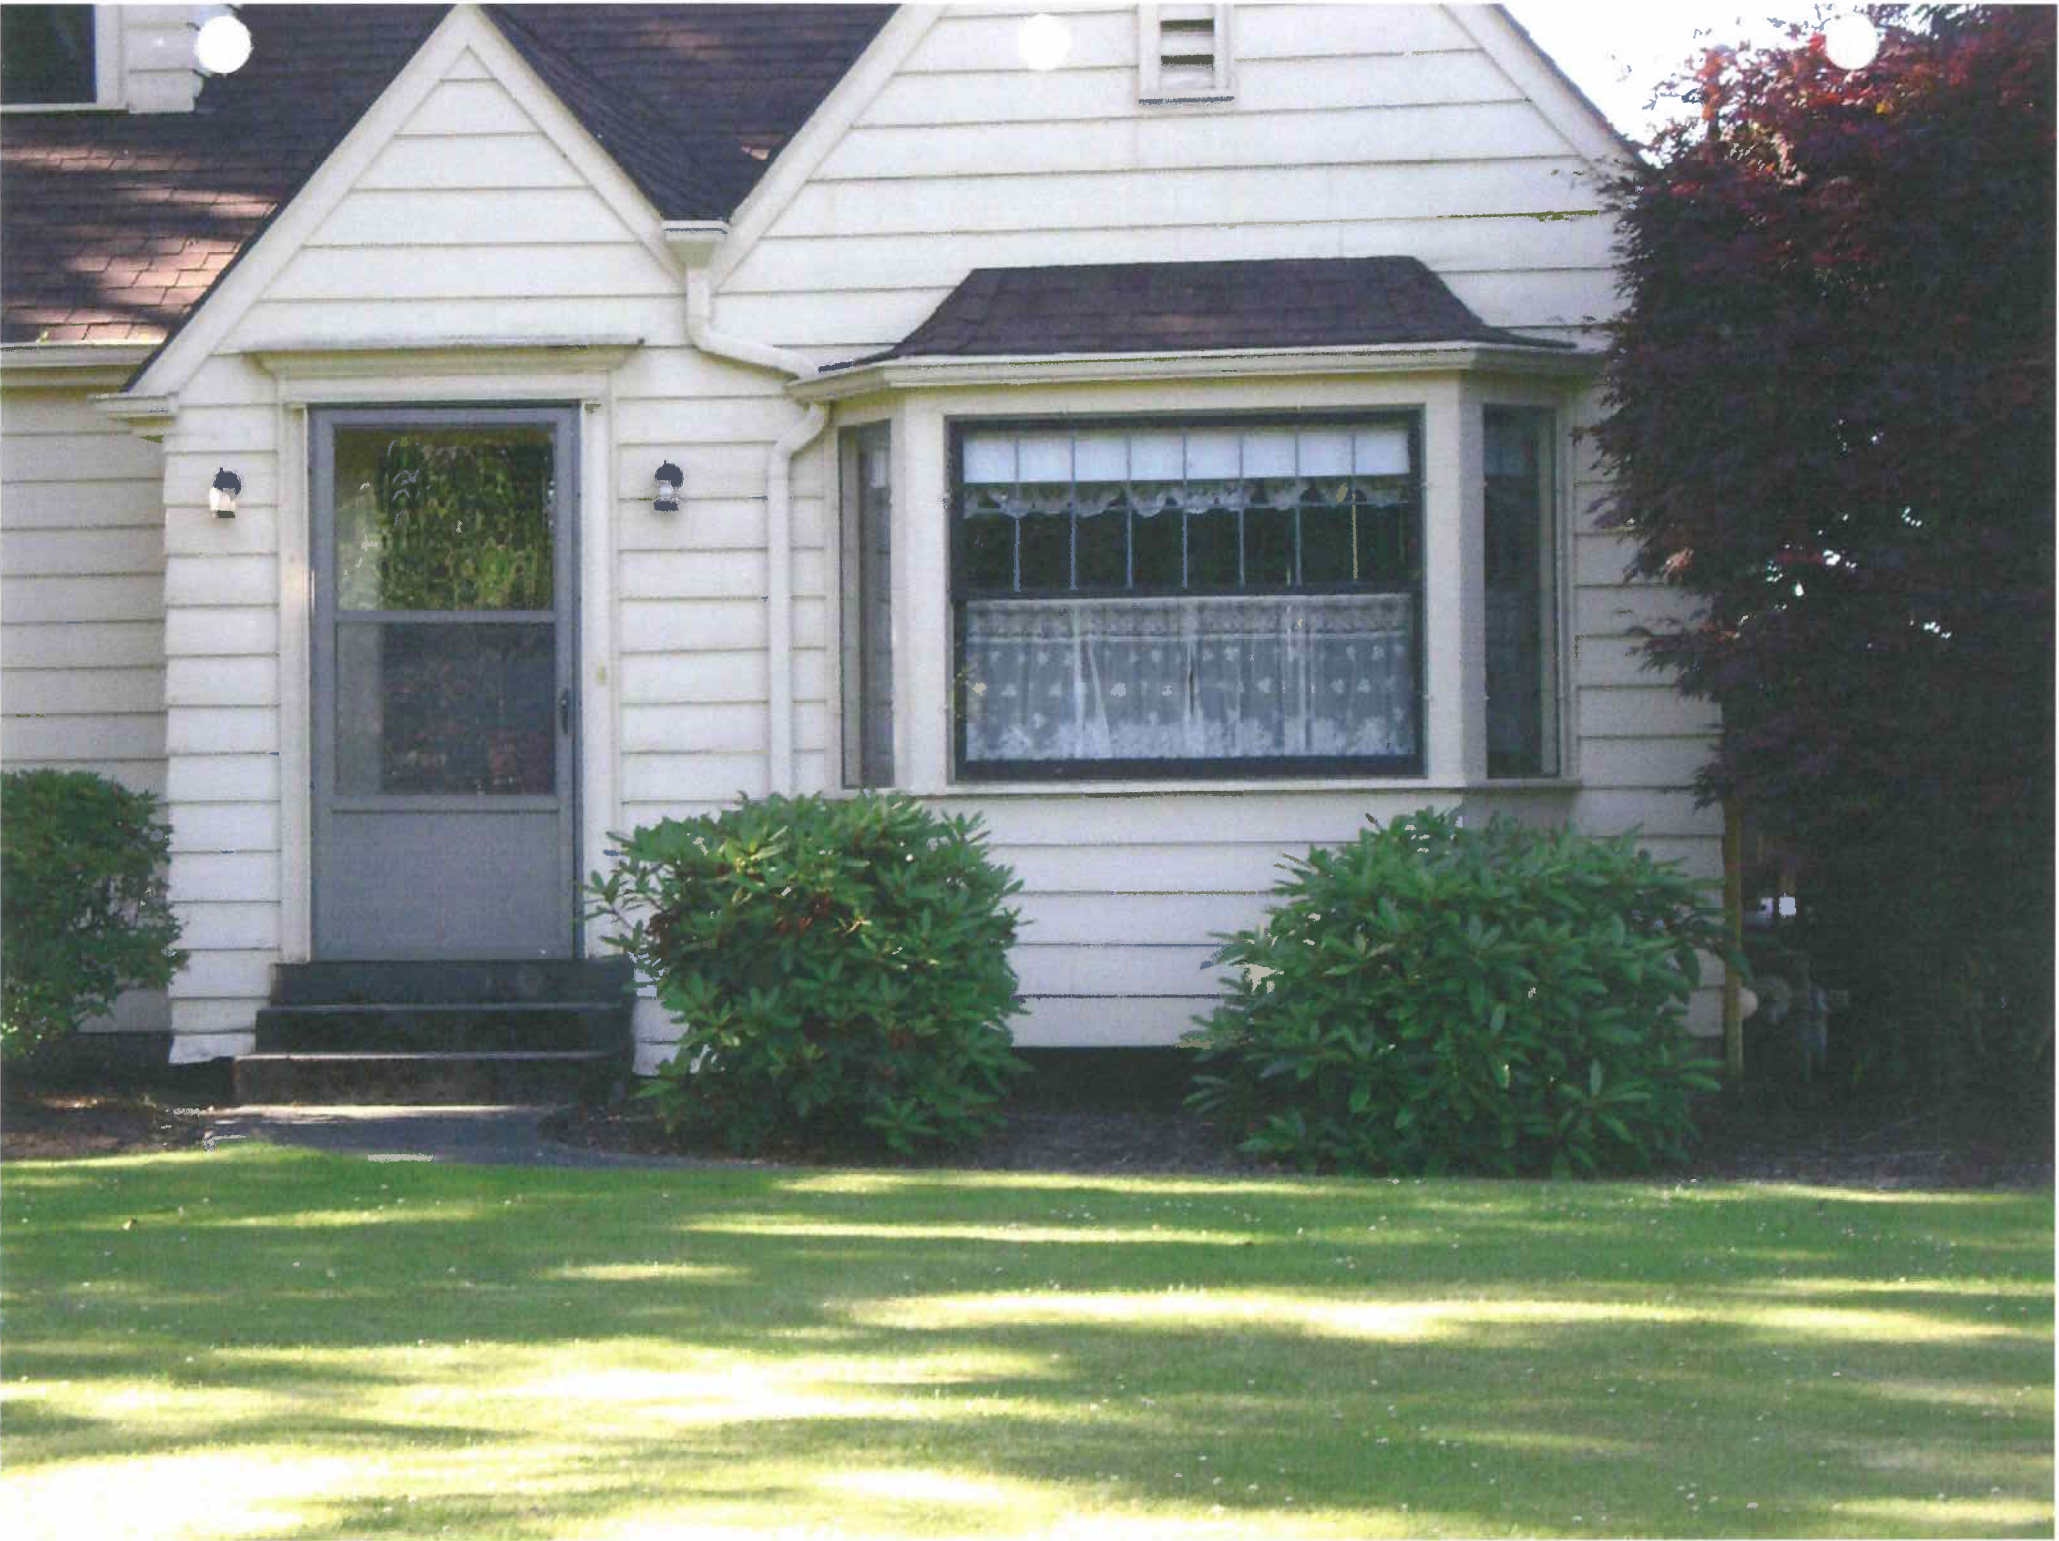
1662 MAIN STREET, LYNDEN

CNG does not have a surveillance procedure that adequately identifies hazardous and unusual operating conditions and action to correct. Above grade or aerial services spanning creeks and irrigation ditches in multiple locations along Main Street in Lynden were not identified as hazardous, unusual, or potentially hazardous and not scheduled for remediation/correction.

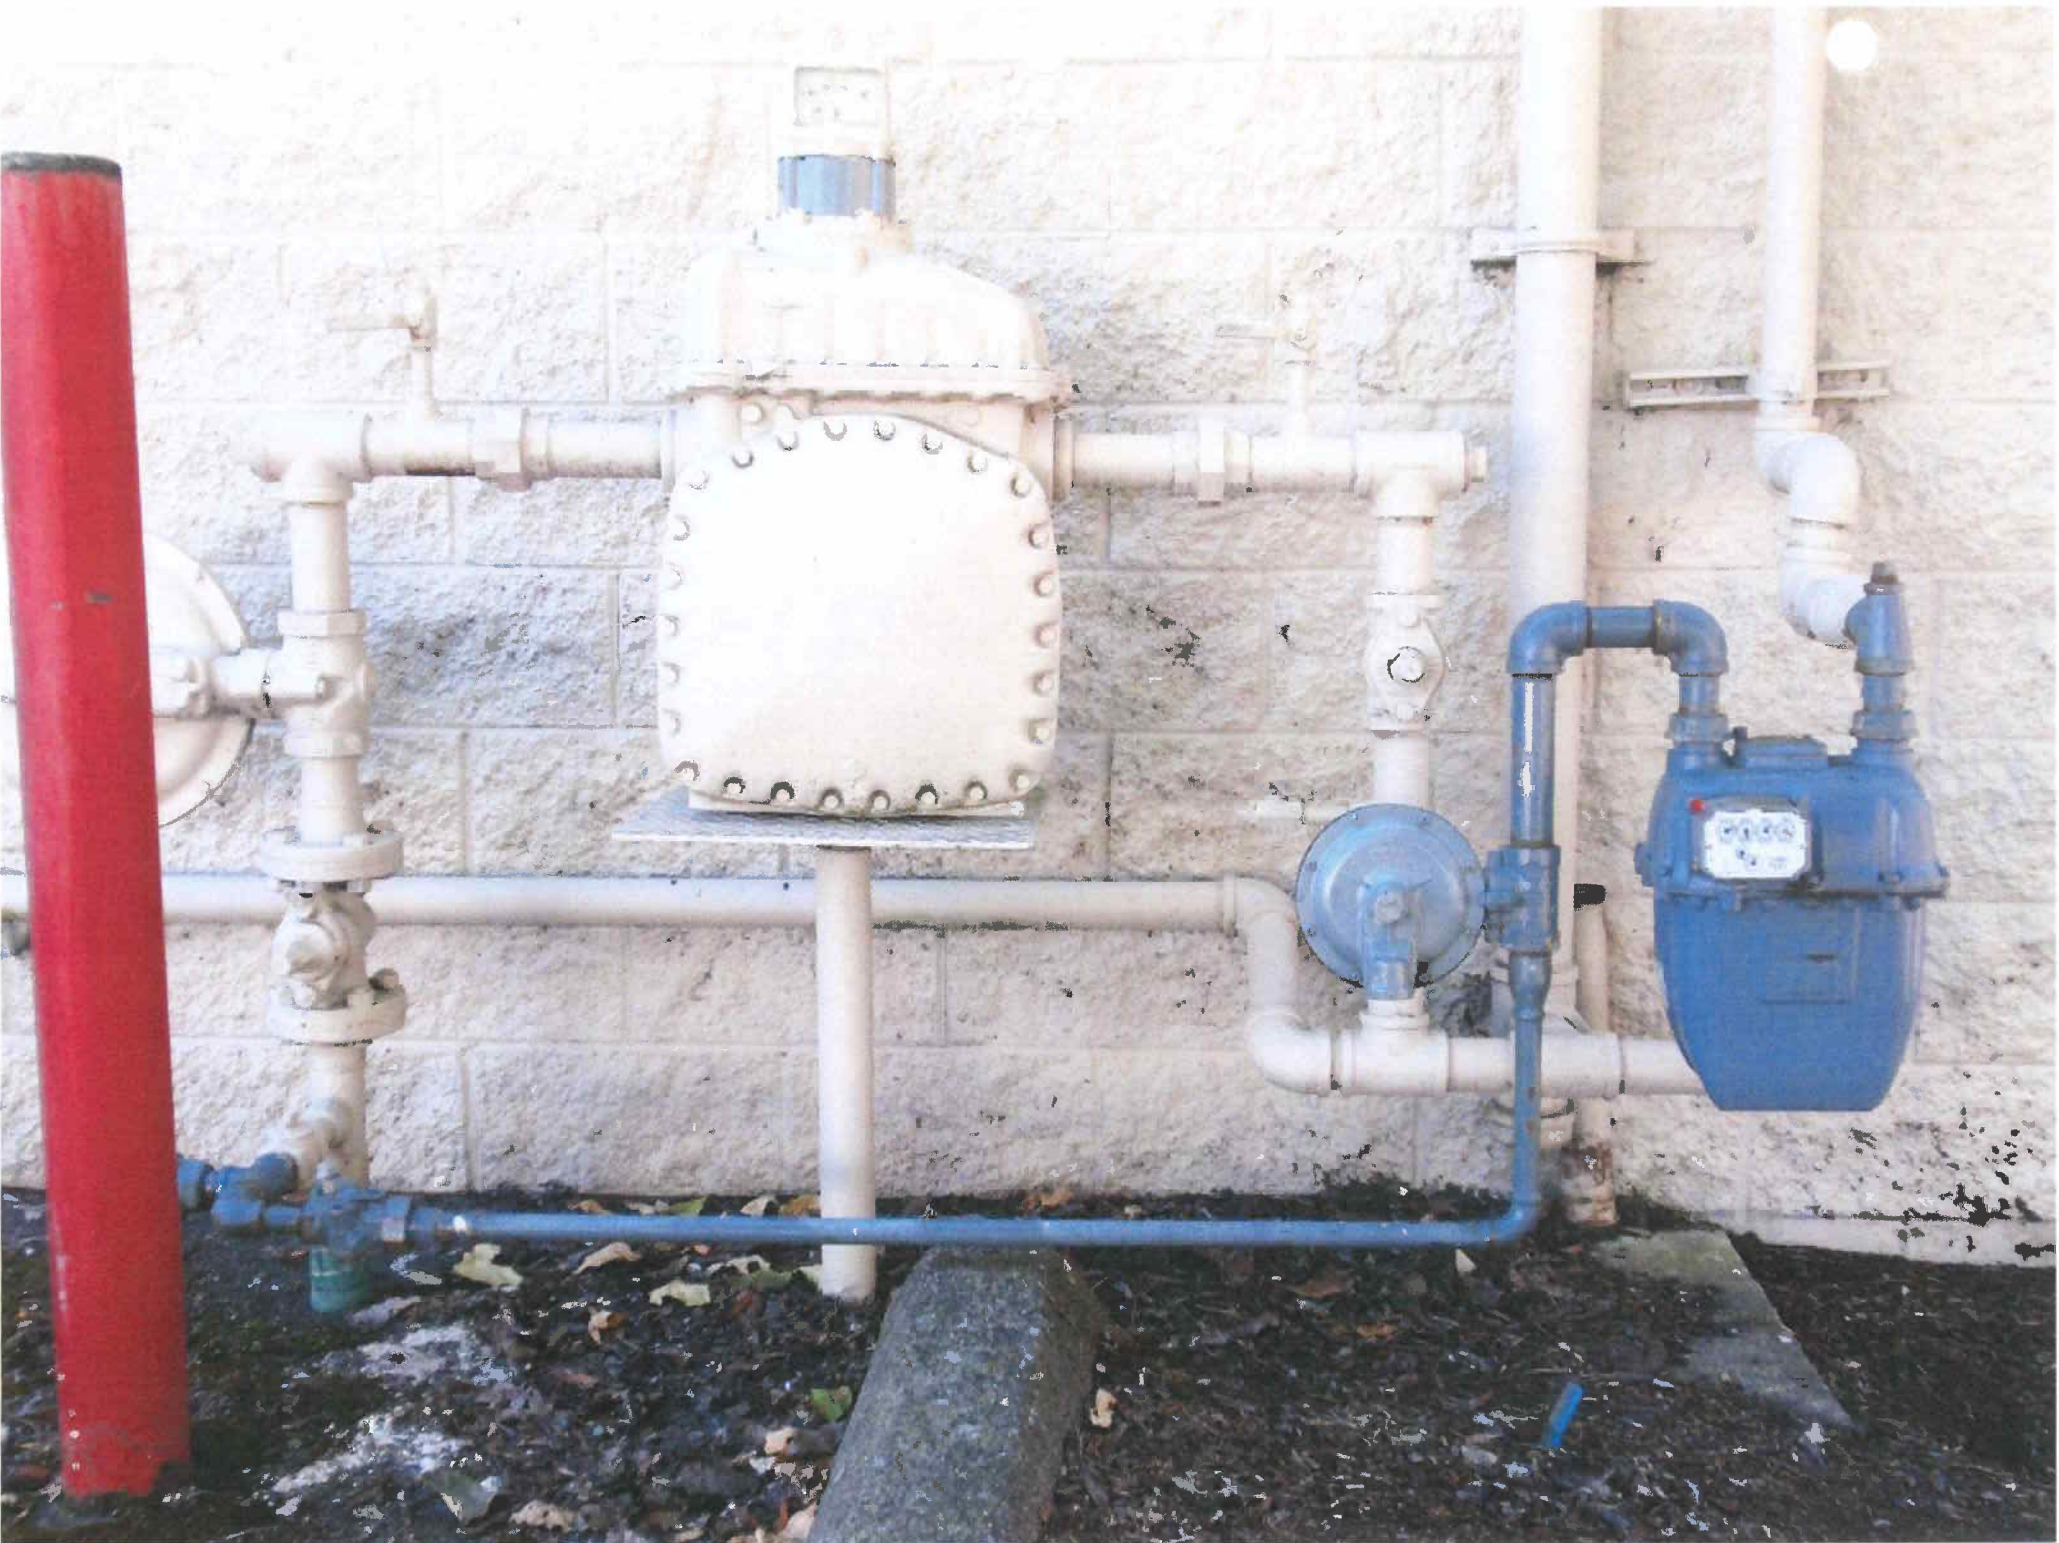
Before

CNG failed to prevent undue strain on their connected equipment located at Bellingham Fitness Center, Bellingham – Meter# 289198.

Corrective Action Taken: FABRICATED & INSTALLED SUPPORT UNDER 3/4" PIPE
