Report Reviewing CC Technologies'

Summary of Field Inspection of Seventy-five (75) and Metallurgical Analysis of Six (6) Service Risers – Spirit Ridge Subdivision (F4434-01G)

(Dated June 15, 2005)

M.J. Schiff & Associates, Inc.
Consulting Corrosion Engineers
431 West Baseline Road
Claremont, CA 91711
(July 18, 2005)

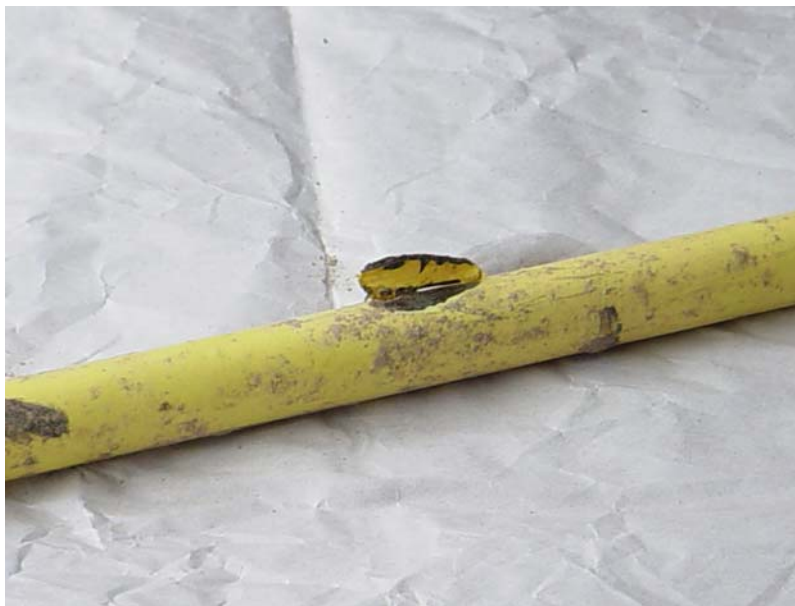
Most of the risers tested had complete coating coverage with some holidays. CCTL in many instances assumed that the holidays found were due to "rough" handling during excavation. Mr. Purtzer of MJS&A agreed that many "holidays" or defects were the result of removal excavation. The cuts seem to have been made by a sharp object such as a shovel. At places ("holidays") where the coating was sliced there was no dirt or corrosion product on the pipe surface as shown on Photo 1 below. This photo was taken by Mr. Purtzer of our firm (it is not contained in the Riser Study).

Photo 1: Photo of typical coating holiday attributed to "damaged during removal"

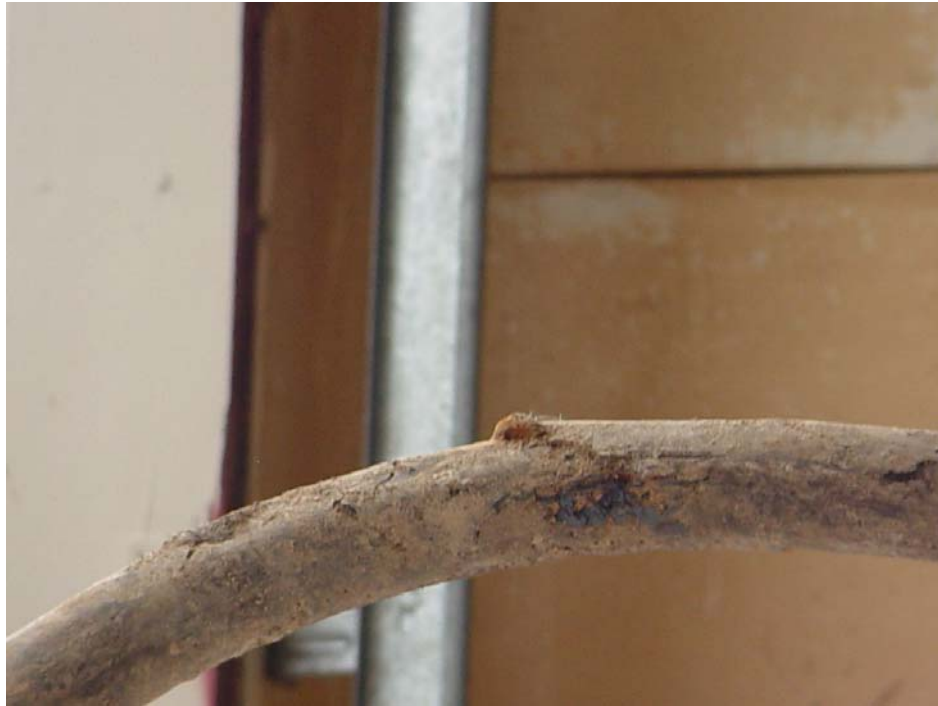
Our primary concern was coating damage due to field bending of the previously coal tar coated pipe. There were possibly six (6) pipes that displayed the tell-tale marks of being bent in the field. In some the cases, the coating integrity was not compromised near the bends. The following three photographs were taken by Mr. Purtzer of our firm. They are not contained in the Riser Study. Photos 2 and 3 below show coating damage at the riser bend. Photo 4 is an example of a riser with no damage at the riser bend.

Photo 3: Examples of coal tar coated and bent service risers from Spiritridge subdivision with visible coating holidays

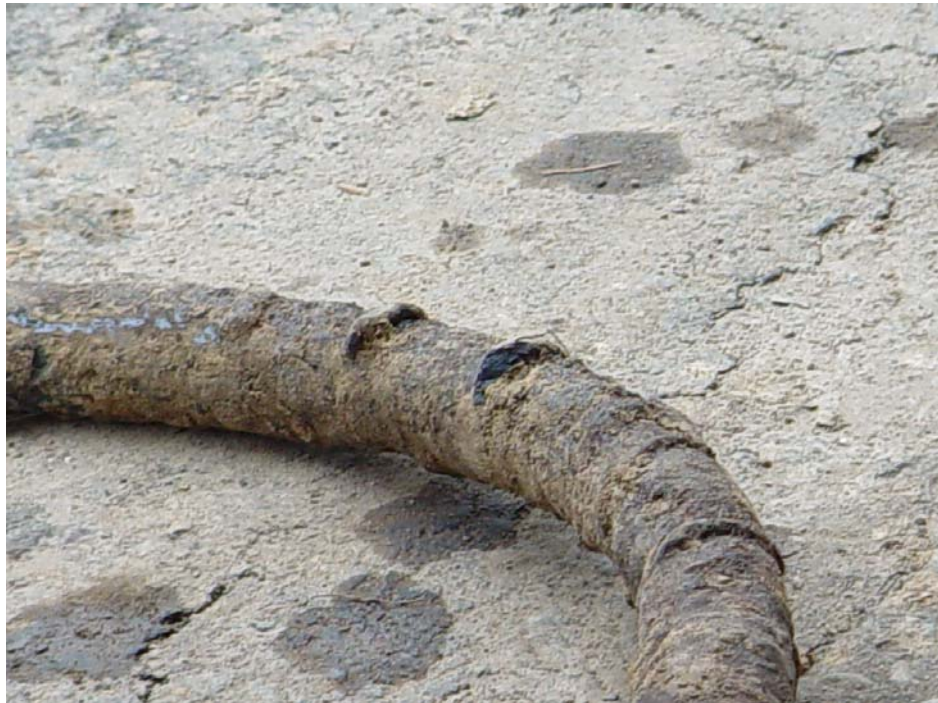
Photo 3: Examples of coal tar coated and bent service risers from Spiritridge subdivision with visible coating holidays

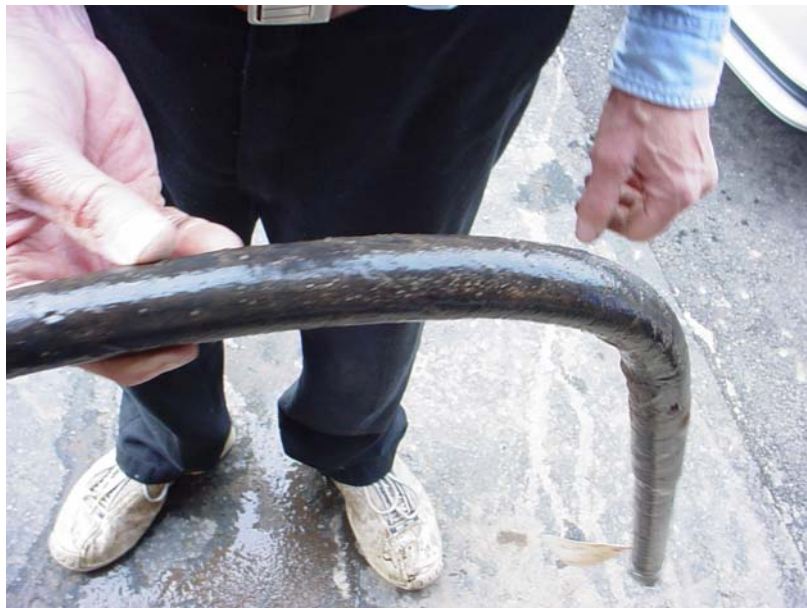
Photo 4: Example of bent coal tar service riser from Spiritridge with no visible coating holidays
