# McCHORD PIPELINE

Subject: Response to 2010 HAZ Liquid Pipeline Safety Standard Inspection (Docket PL-100012)

**ATTACHMENT #1  
FIELD INVESTIGATION REPORT  
AND PHOTOGRAPHS**

# FIELD INVESTIGATION REPORT

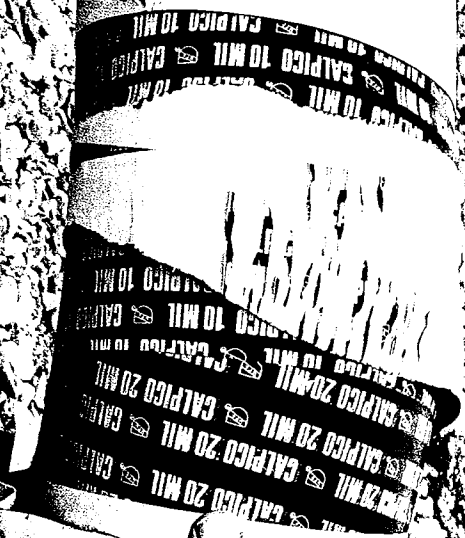
INVESTIGATION PERFORMED BY COMPANY	FOLLOWUP REQUIRED BY REGIONAL RAW AGENT: (Circle One) YES    NO    NOT SURE		
EMPLOYEE NUMBER	DATE	WORK HOURS	REMARKS OR LOG:
<u>Williamson</u>	<u>6/17/10</u>	<u>1.0</u>	<u>WRAP ON MPL AT STAKE # 134+53 ON MAFB</u>
<u>Calton</u>	<u>6/17/10</u>	<u>1.0</u>	<u>was found to be Disbonded. Removed WRAP</u>
			<u>cleaned pipe to Bare Metal, Reprimed &amp; wrapped.</u>
			<u>NO pitting Found only surface corrosion. SEE PHOTOS</u>
			<u>attached</u>

Dibanded  
wrap

McChord Pipeline recognizes the disbanded tape wrap. This area has been removed and an inspection has been performed. Surface rust was discovered; so this area was cleaned, primed, and re-wrapped to prevent atmospheric corrosion. See Attachment #1 for a field investigation report and photographs.

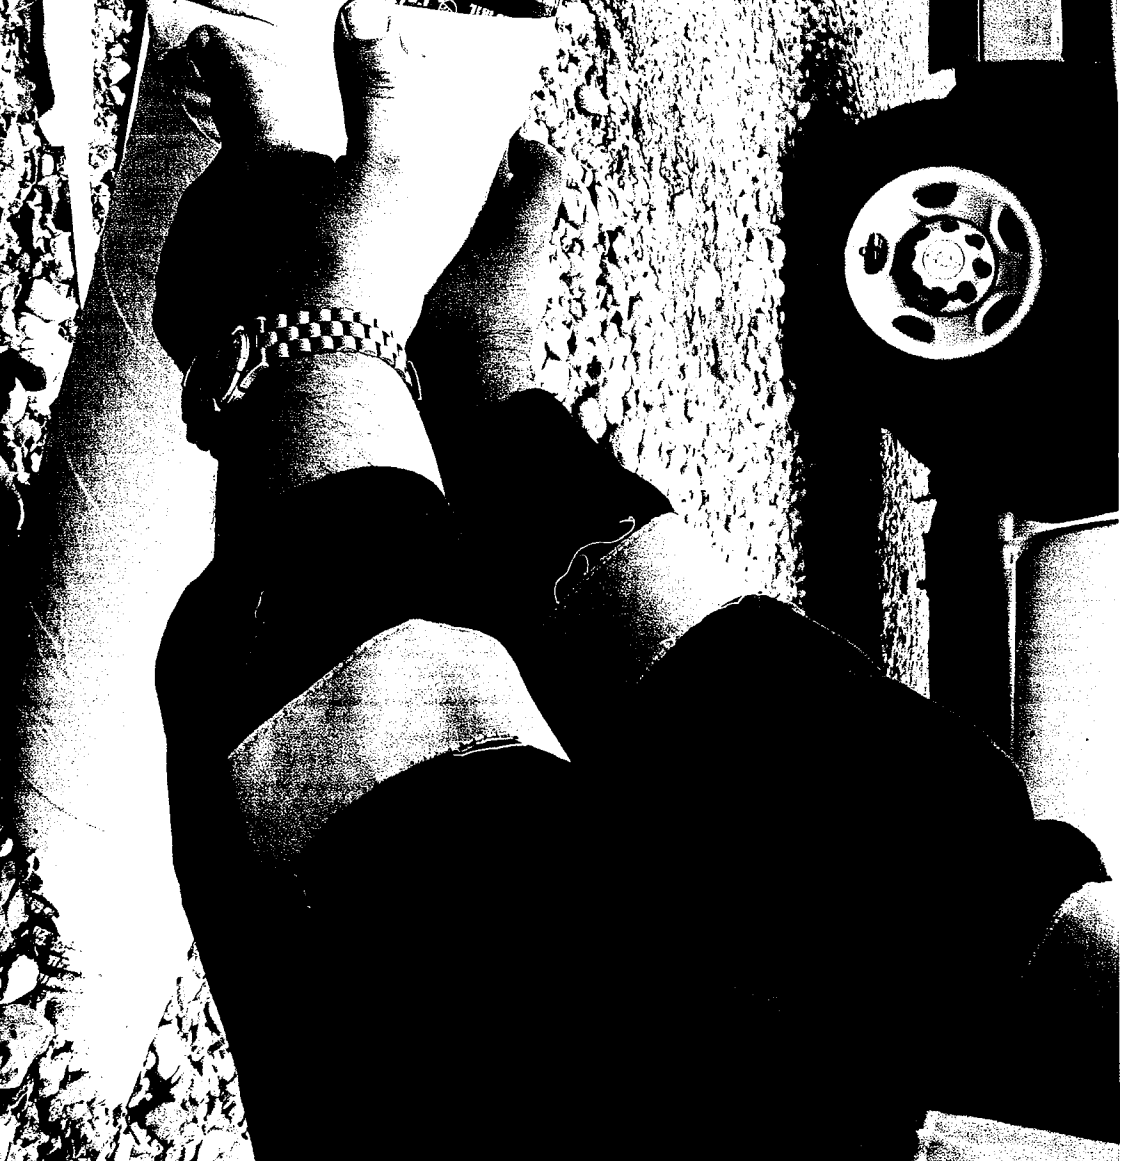
Surface  
Rust

New  
wrap
