CLARK COUNTY
WASHINGTON

TR-041671
PUBLIC WORKS

March 29, 2010

RE: NE 72nd Avenue Southbound Railroad Crossing Arm

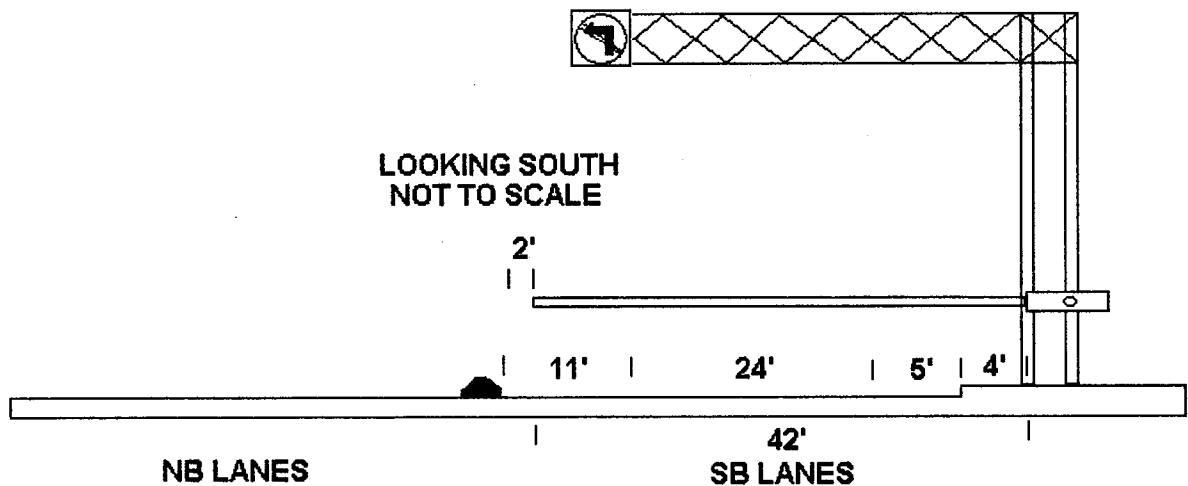
In mid-January 2010 the railroad crossing gate arm, serving southbound traffic on NE 72nd Avenue, snapped at the approximate mid-point of the arm. The arm was removed and below summarizes the project team's review of the damage, assessment and recommendation for replacement.

The cut sheet for the 45' crossing arm installed does not provide its allowable loadings so it is unclear whether this arm was appropriate for the site conditions. As noted above, it is significantly longer than the recommended crossing arm length and three feet longer than the maximum length typically manufactured.

The recommendation is to install a new, lighter and more ridged 42' Alumi-Lite crossing arm which is specifically designed for 80 mph wind conditions. The manufacturer of the proposed 42' crossing arm has a good reputation amongst the railroad community. The existing cantilever structure will also be fitted with a 10' length extension which will include an additional set of high wind brackets. The extension is designed by the cantilever structure manufacturer and we have documentation from the manufacturer that the structure will support the minimal additional weight. As mentioned above, the foundations are well under capacity and the additional loading incurred will be less than 10%. The 42' crossing arm will provide coverage of 90% of the travel way. Design guidance requires that the crossing arm provide sufficient coverage to block vehicles from traveling around the arm without crossing the center line. At this location the southbound left turn lane includes an overhead LED "NO LEFT TURN" sign that is activated with the gate also a C-curb which will not allow for vehicles to travel around the crossing arm.

The cost of the new crossing arm, extended mast arm and additional set of high wind brackets is \$2300, plus installation.
