**RE: 2008 Standard Inspection of Pierce County Distribution System,
Docket PG-080031**

This letter is in response to the "2008 Standard Inspection of Pierce County Distribution System" report dated December 23, 2008. In this report Staff identified 11 probable violations and two areas of concern. Below are PSE's responses to these findings.

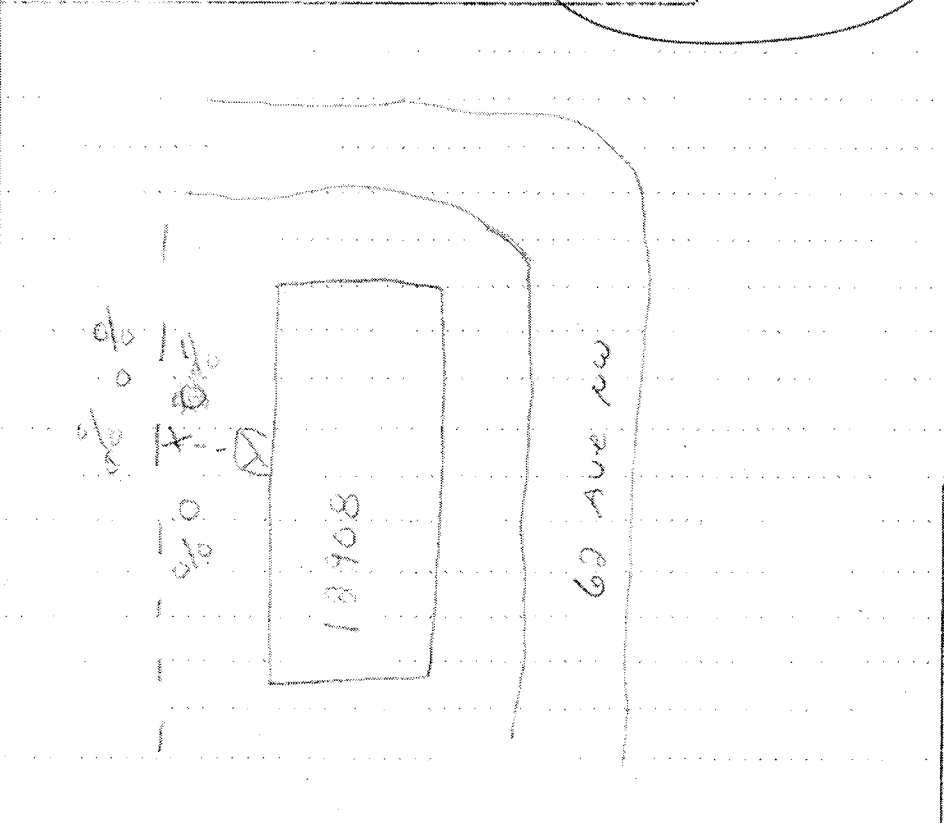
SECTION 3 - SKETCH CGI READS/LEAKS LOCATION

SECTION 1 - PROJECT DATA		PROJECT ID N0028824 <i>001 4</i>	COMPLETE ON OR BEFORE 2/19/08	PLAT MAP 223042
HOUSE 12808 62ND AVE NW # 1, 98332, GIG HARBOR	1/2	STREET	AREA	
INSTRUCTIONS RESPONDED TO BROKEN AND BLOWING				
LEAK HISTORY C.P. AREA: <input type="checkbox"/> YES <input checked="" type="checkbox"/> NO ORIG GRD A LK ORIG S METH DET B PRESS RPT SOURCE P MAIN SVC X BUS DIST? NO U/P? NO ORIG RPT DATE 2/19/2008				
CGI READS 72 FT WOL OF 62ND ST NW 53' SCL DRIVE WAY

CGI READS
72 FT WOL OF 62ND ST NW 53' SCL DRIVE WAY ZERO READS REMAIN SCOPE NUMBER 3002 PILOCHUCK FUS

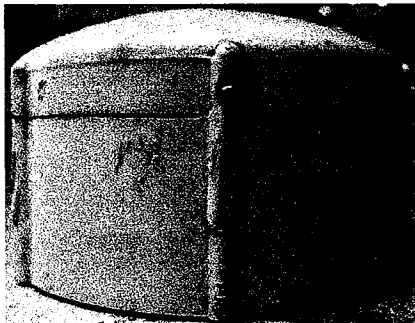
**Cause Code C:
Animal Damage**

C. Natural Force is the code used to indicate damage because of nature. Generally you will not be able to sue someone for negligence.

- Animal damage. Example: Hole in PE caused by rat.
- Vegetation. Example: Crushed by tree roots.
- Ground settling.
