**PROJECT 09-1176**  
**FINAL REPORT**

**Failure Analysis of**  
**PE Gas Pipe**

October 6, 2009

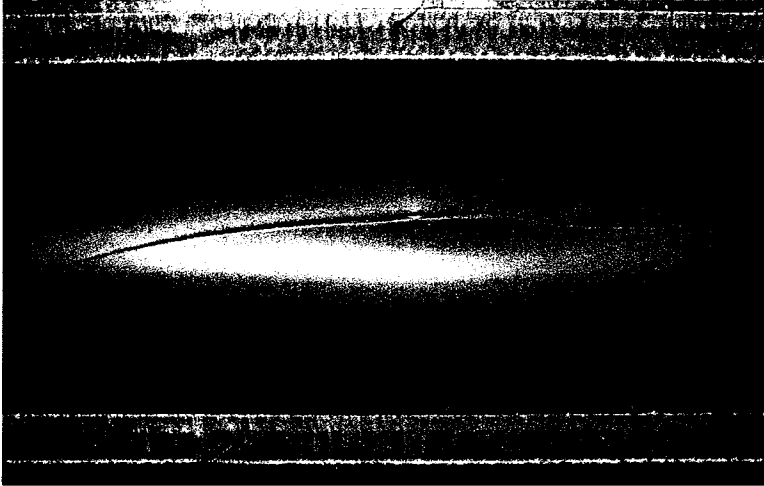
**Figure 4: Through-Wall Fracture at First Impingement Location**

The sample was examined further by bisecting the pipe into half-round sections and inspecting the inside surfaces. The appearance of the full-wall fracture coincident with the first impingement location is shown in Figure 4.

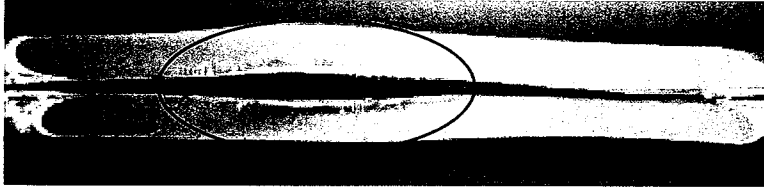
**Figure 6: Through-Wall Fracture at First Impingement Location**

The through wall fracture (the leak) was opened for further examination by cutting out the fractured portion and bending the pipe to open the fracture from inside out. The full fracture surfaces are shown in Figure 6, with the inside surfaces of the pipe at the top and bottom, and the outside surfaces adjacent to one another at the center. The general area of external impingement as well as the area of crack initiation are shown by the black oval.

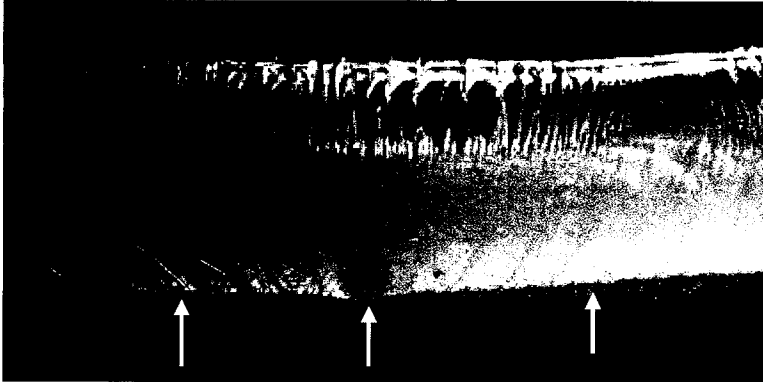
**Figure 7: Fracture Surface at Impingement Location - 7X**

One of the fracture surfaces is shown in detailed view in Figures 7 and 8. Figure 7 is a photograph of the full fracture surface taken by optical microscopy at 7X magnification. The inside surface is indicated by the arrows, with the center arrow indicating the area of fracture initiation.

Examination of the fracture surface of the through-wall crack showed it to be consistent with SCG. There is some evidence of micro-ductility, there is clear wall deformation due to apparent impingement, and there is no macro-ductility evident except at the inside and outside surfaces. The fracture initiated at the inside surface where the outside of the pipe was indented. These are all features associated with SCG fracturing of PE pipe initiated by external rock impingement.
