From: Maurer, Darlene [mailto:darlene.maurer@nwnatural.com]
Sent: Thursday, September 02, 2010 7:43 AM
To: Lykken, David (UTC)
Cc: Jones, Al (UTC); Huddleston, Jon; Colton, Cari; Baribault, Jim; Rogers, Roy
Subject: NW Natural Response to WUTC Inspection Report No. PG-100051 (Clark County)

September 2, 2010

Subject: 2010 Standard Pipeline Safety Inspection, Clark County, Washington
 Distribution System, Ref. No. Docket PG-100051

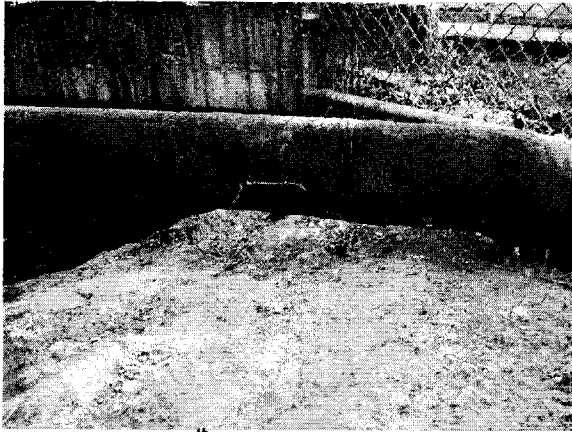
Inspections for atmospheric corrosion under pipe supports had not been conducted at concrete pipe supports for the aboveground water crossing at NE 11th Ave & NE Division; located in Camas. The 8-inch, high pressure main (250 psig) was constructed in 1956. The pipe under the supports needs to be evaluated for atmospheric corrosion or modifications made to prevent the formation of a corrosion cell.

Figure 1. NE 11th Avenue and NE Division water crossing, Camas, Washington: Pipe after concrete supports were removed.

In summary, NW Natural has taken corrective action to remove the concrete supports of the pipeline crossing to facilitate a full visual inspection of the pipeline in the future.

Comments: Removed concrete supports. Wax tap the pipe

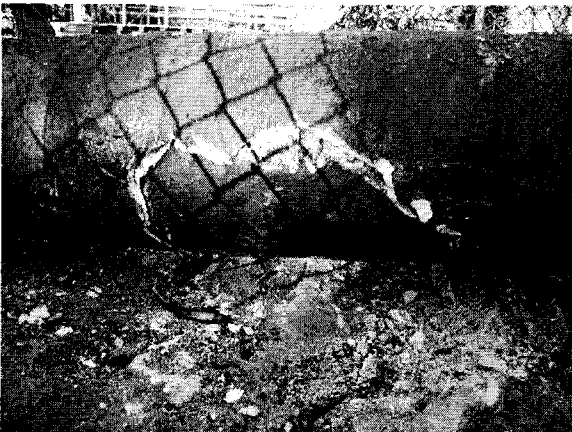
Figure 2. NE 11th Avenue and NE Division water crossing, Camas, Washington: Close-up view of pipe condition after concrete supports were removed.

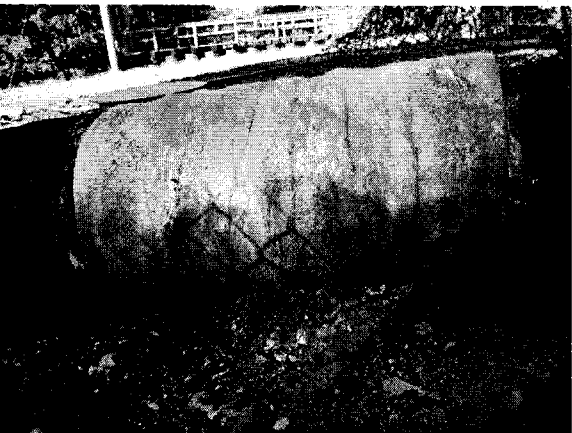
Figure 3. NE 11th Avenue and NE Division water crossing, Camas, Washington: Close-up view of repair to pipe coating at point where concrete supports were removed.

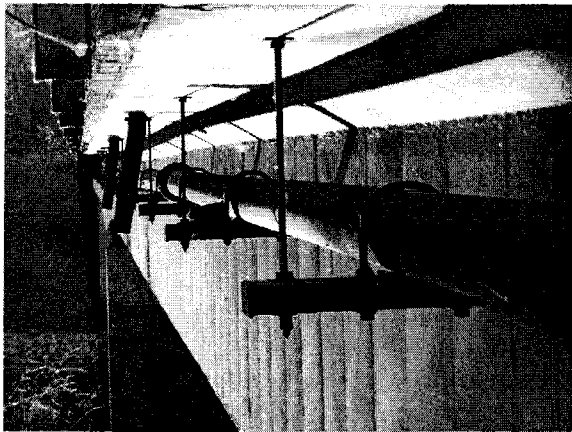
At the Washougal River crossing in Camas, the 1958 pipe supports on the bridge should be evaluated for structural integrity.

In response to Staff's recommendation for evaluating the structural integrity of pipe supports for the bridge crossing over the Washougal River in Camas, Washington (Identification Number 1-022-056-B-01-B-A), on August 18, 2010, NW Natural individually inspected a total of 43 pipe supports on this crossing. Results of the inspection indicated all pipe supports were in very

good condition. A copy of the inspection record is enclosed (Enclosure 3). Also included in this report are photographs of the as found condition of the pipe supports (see Figures 4-6).

Figure 4. Washougal River Bridge Crossing: View of as found condition of pipe supports.

Checked all 43 pipe supports, all are in good condition. Dressers were checked with Sensit Gold SN 9111 no leaks found. Gas main and supports are in good condition.

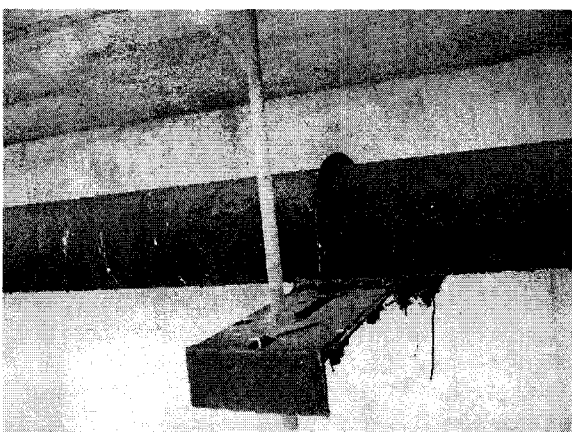
Figure 5. Washougal River Bridge Crossing: Close up view of as found condition of pipe supports.

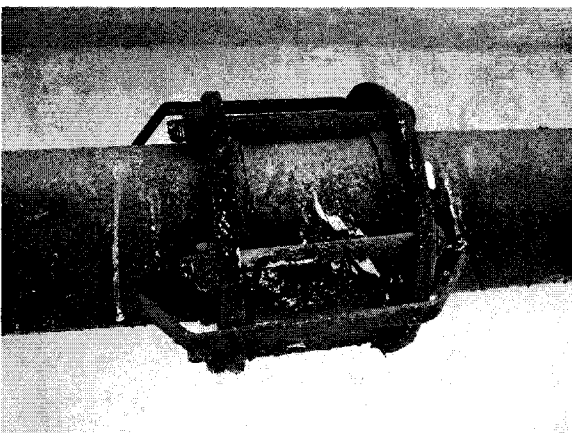
Figure 6. Washougal River Bridge Crossing: Close up view of as found condition of pipe supports.
