BEFORE THE WASHINGTON UTILITIES AND TRANSPORTATION COMMISSION

# Avista Utilities Asset Management

## Proposed Protocol for Managing Select Aldyl A Pipe in Avista Utilities' Natural Gas System

February 23, 2012

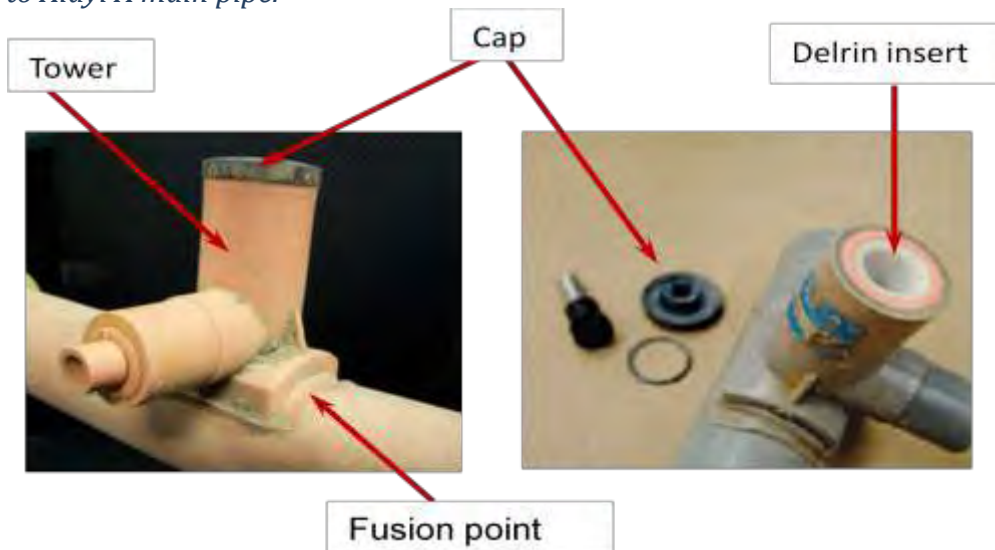
The largest percentage of material failures in the sample occurred in Towers and Caps, referring to failure of the service tapping tee itself, shown below in Figure 2. In these cases, the pressure applied to the tee as the cap was tightened onto the body during initial installation has resulted in slow crack growth and failure of the tower body, the cap, or the Delrin® insert many years later. Additionally, the saddle fusion point of the tower to the main pipe is another frequent point of failure in this assembly. The unavoidable stresses created during standard installation (using factory recommended procedures) have led to brittle cracking in these components many years later. This phenomenon clearly demonstrates the susceptibility of certain resins of Aldyl A piping to tend to fail by brittle cracking due to the slow crack growth initiated during installation.

Figure 2. External features and internal components of a typical Aldyl A service tee, as fused to Aldyl A main pipe.

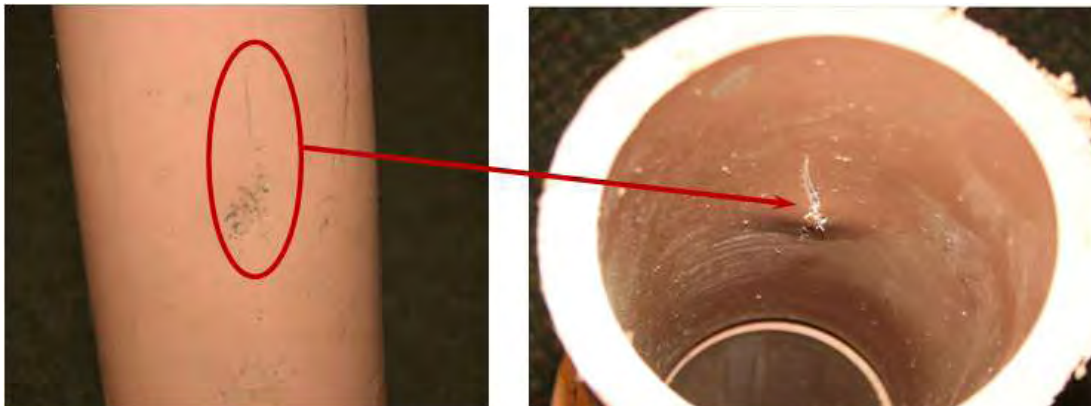
The second-most common material failure observed in Avista's Aldyl A pipe was due to localized, brittle cracking in Aldyl A mains that resulted from rock impingement – rock pressure directly on the pipe, or places where 'squeeze-off' was applied over the pipe's service life. These failures are very typical for certain resins of Aldyl A main pipe, having been consistently reported by other utilities since before the time of DuPont's 1986 letter. As described earlier, when these external stresses (rock impingement or squeeze-off) cause the pipe to fail, it always begins with crack initiation on the inside surface of the pipe wall, eventually resulting in slow crack growth that propagates toward the outer wall of the pipe, and finally, through-wall failure. These failures generally appear as short, tight cracks in the outer wall of the pipe that run either parallel, or slightly off-parallel with the length of the pipe. A typical failure in Aldyl A main pipe, showing a crack through the pipe wall as it appears on both the inner and outer surfaces, is shown below in Figure 3.

*Figure 3. Typical brittle-like crack through the wall of Aldyl A pipe, resulting from rock contact directly on the pipe.*

Although the duration of the stress caused by rock contact with the pipe is very different from that associated with squeeze-off, they both result in the same pattern of crack initiation and slow crack growth leading to failure of the pipe. Other sources of external stress that can result in brittle failure of Aldyl A pipe, as mentioned earlier in the report, include bending of the pipe, soil settlement, dents or gouges to the pipe, and improper installation of fittings.

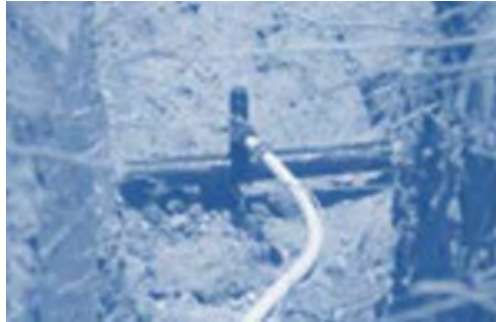
*Figure 4. Typical polyethylene service tapped from a steel main.*

It is at this transition point, between the rigid steel fitting and the more-flexible Aldyl A service pipe, that brittle-like cracking has been observed. This failure mode in older plastic pipe is well understood, and was one of the three study objectives reported by the National Transportation Safety Board in its 1998 bulletin, summarized earlier in this report.

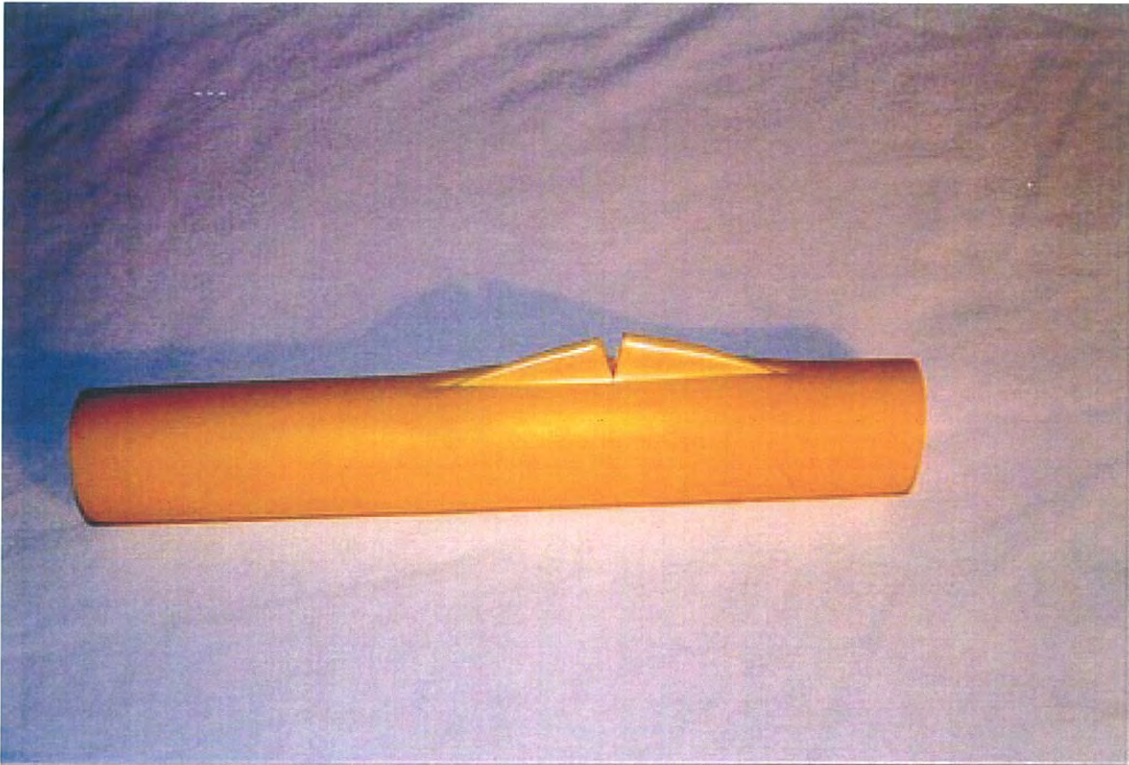
**Figure 4 -- Ductile fracture resulting from stress rupture test. Note substantial deformation (ballooning) at the failure.**

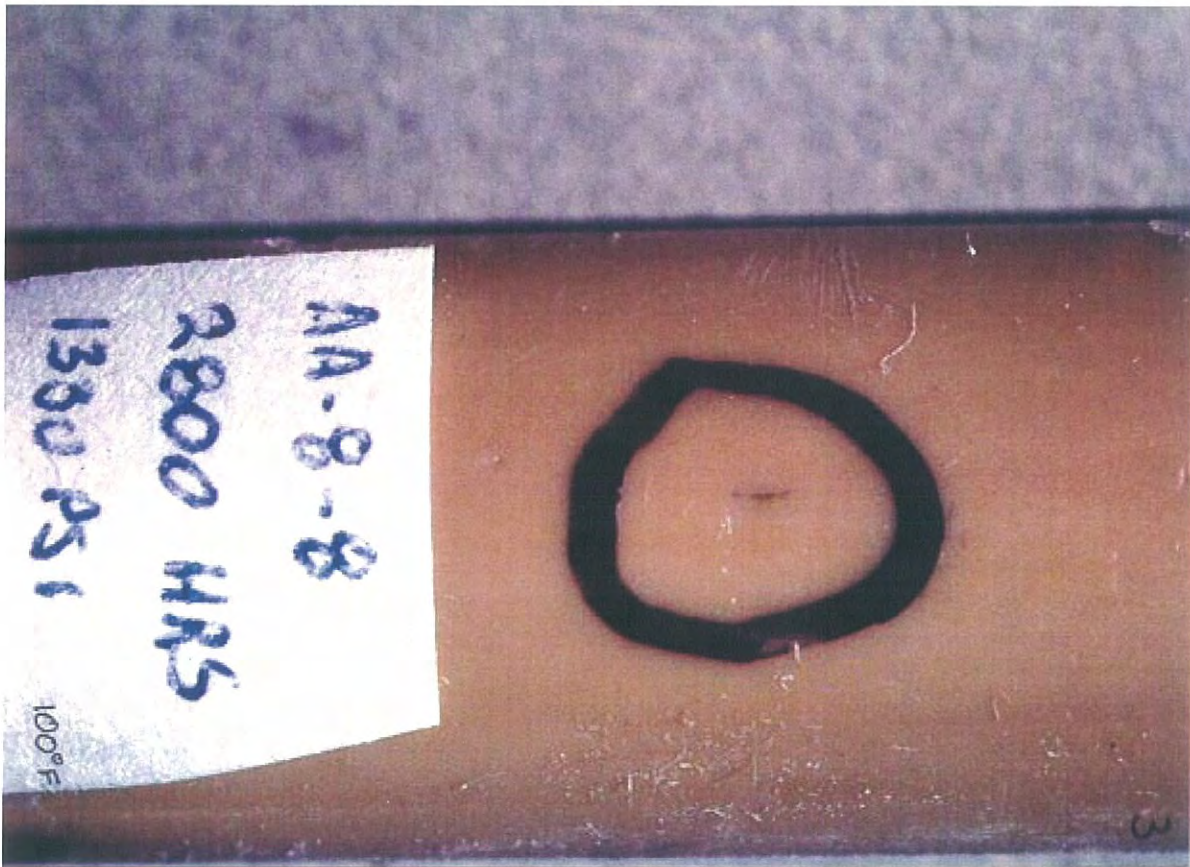
**Figure 5 -- Slit fracture resulting from a stress rupture test conducted at 100 °F. Note lack of deformation visible in the fracture. This pipe was manufactured by DuPont in 1977. After failing Minnegasco's incoming inspection tests, the pipe was subjected to stress rupture testing.** (Source: Henrich, R.C., and Funck, D.L., "Effects of ESCR Variation on Some Other Properties of Plastic Pipe." *Proceedings, Eighth Annual Plastic Fuel Gas Pipe Symposium, 1983.*)

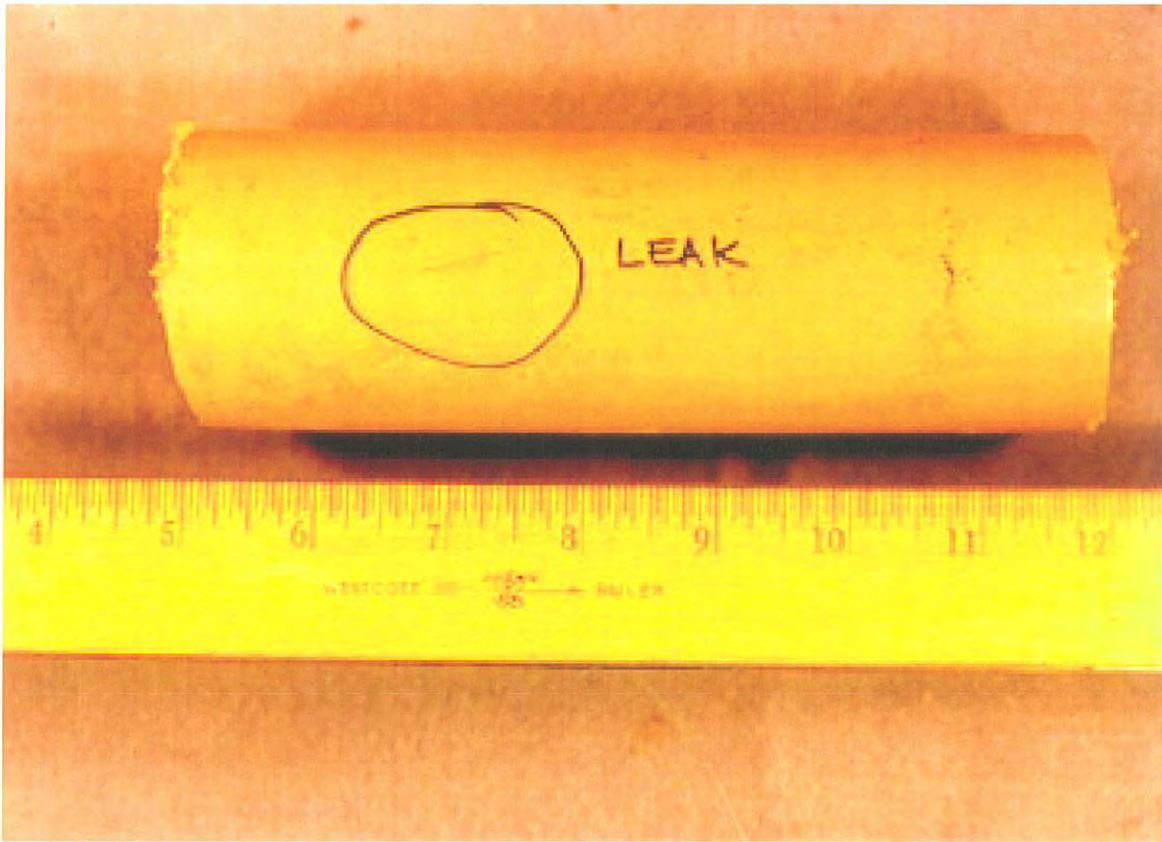
**Figure 6 -- Slit fracture on a polyethylene pipe manufactured by DuPont that was found leaking and removed from a gas piping system.**

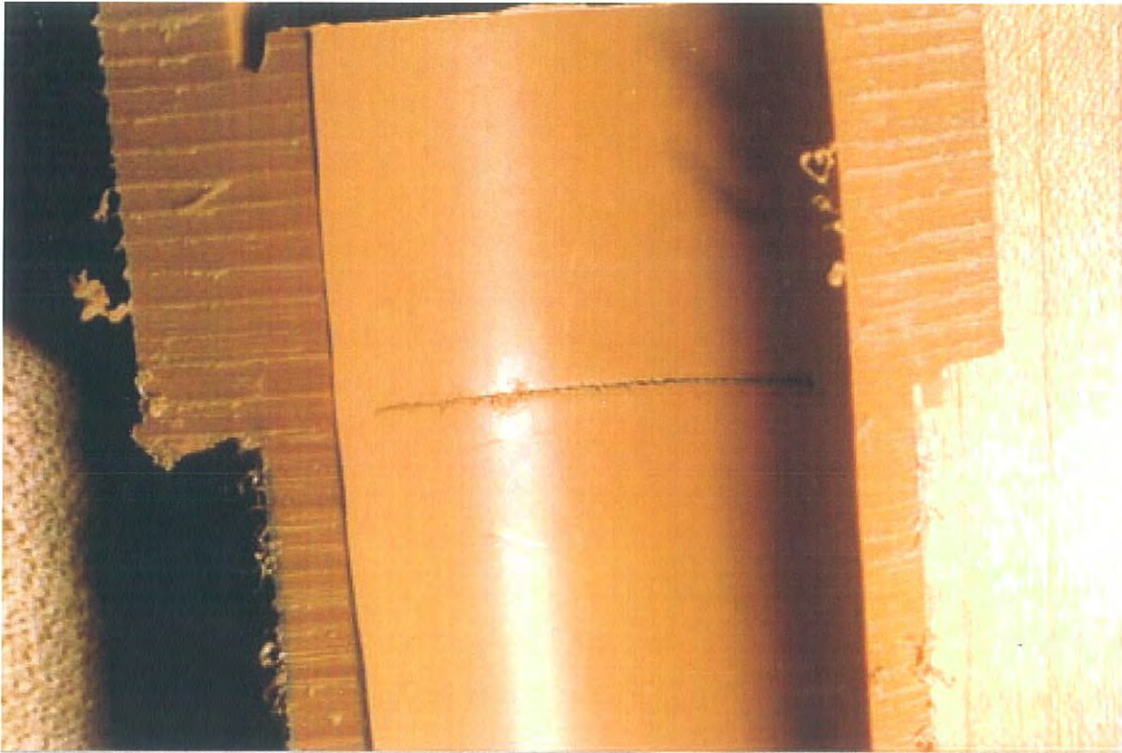
**Figure 7 -- Interior of polyethylene pipe from San Juan pipeline accident showing brittle-like crack with no visible deformation.**

Figure 7 illustrates brittle-like cracking that was found in a plastic pipe involved in the fatal propane gas explosion in San Juan, Puerto Rico, in November 1996. That pipe was manufactured in 1982 by E. I. du Pont de Nemours & Company, Inc., (DuPont) at its Pencador, Delaware, plant. Apparently, differential settlement resulting from inadequate support under the piping generated long-term stress intensification that led to the formation of brittle-like cracks in the pipe.

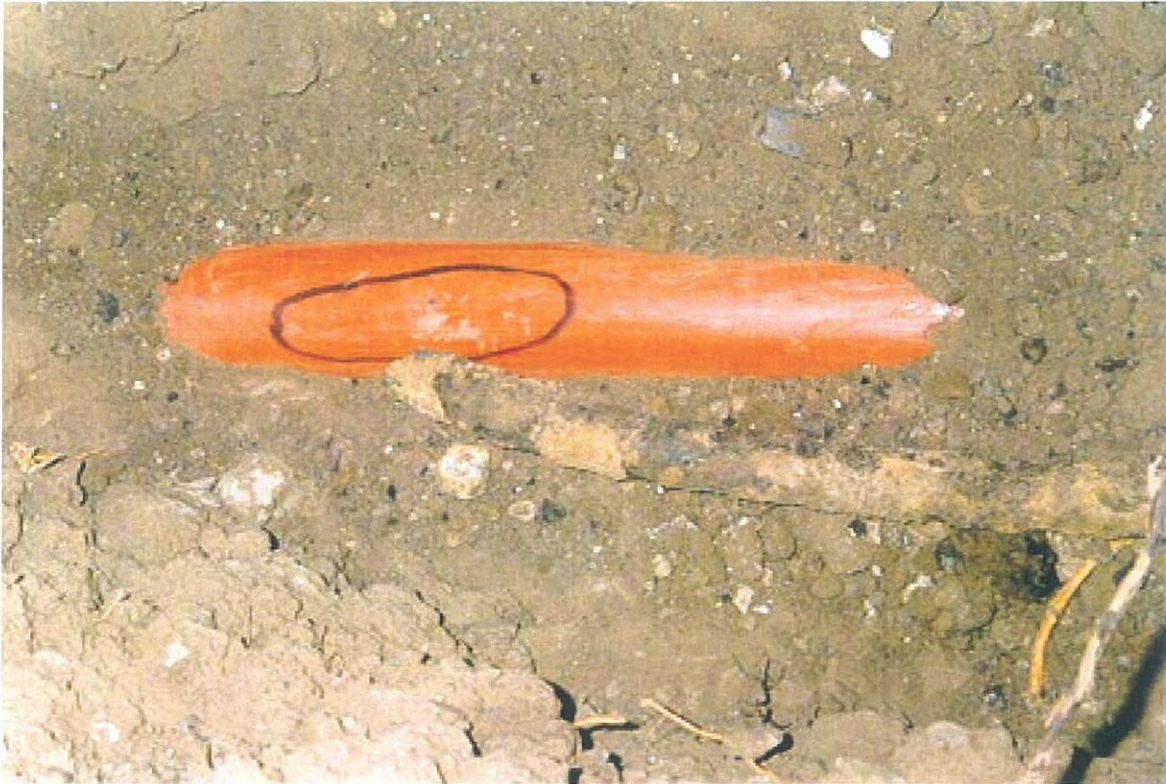
**Figure 8 -- Brittle-like crack in pipe involved in August 1997 accident in Lake Dallas, Texas. The crack extends from the left to upper right of the area defined by the ellipse.**

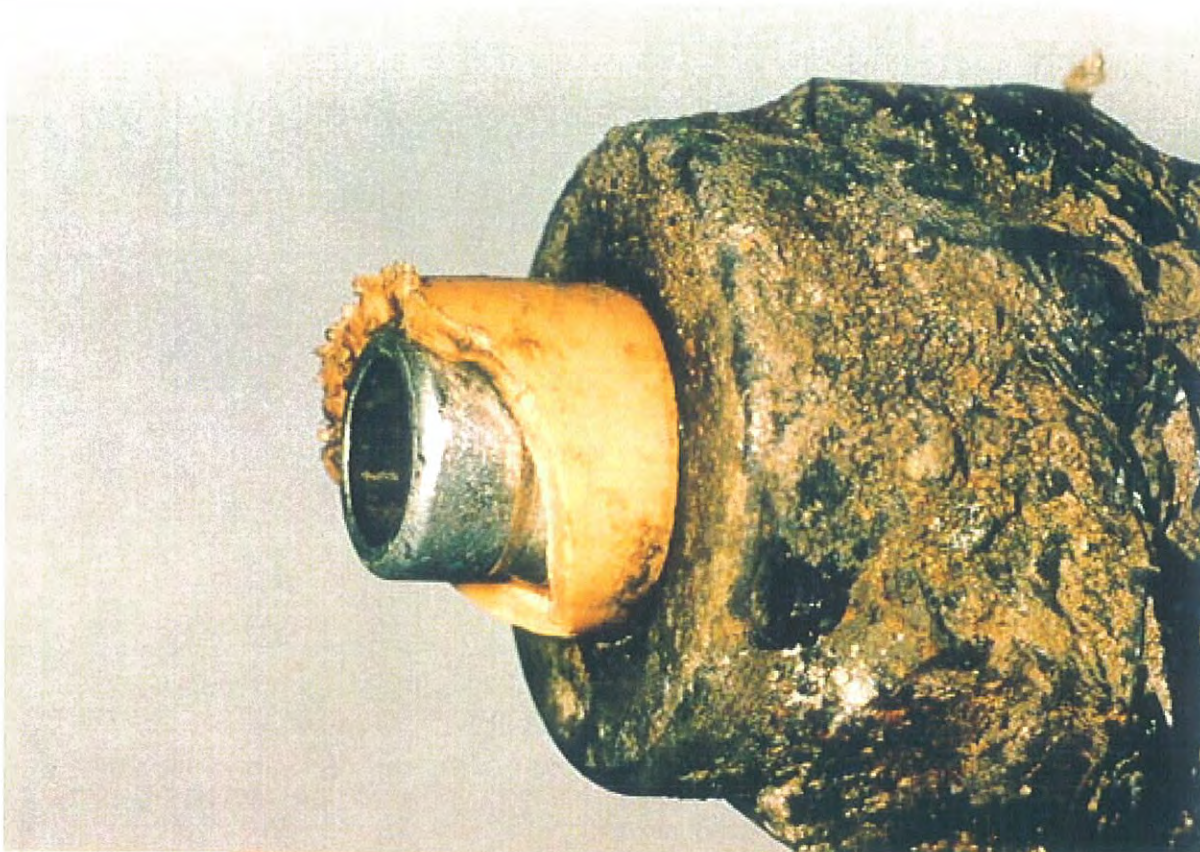
**Figure 10 -- Close-up view of failed plastic pipe connection to steel tapping tee from site of Waterloo, Iowa, accident. A portion of the fractured plastic service line (light-colored material) remains attached to the tee.**

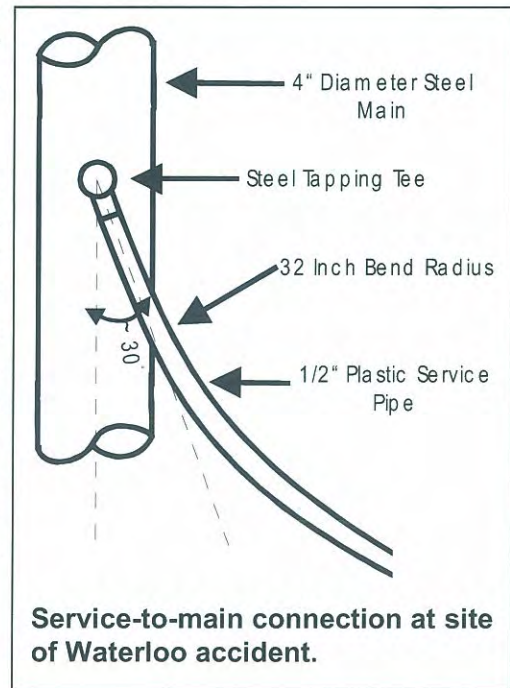
MidAmerican Energy estimated that the steel tee on the steel main was installed so that the polyethylene pipe exited the tee at an approximate 30° angle to the steel main. (See figure.)

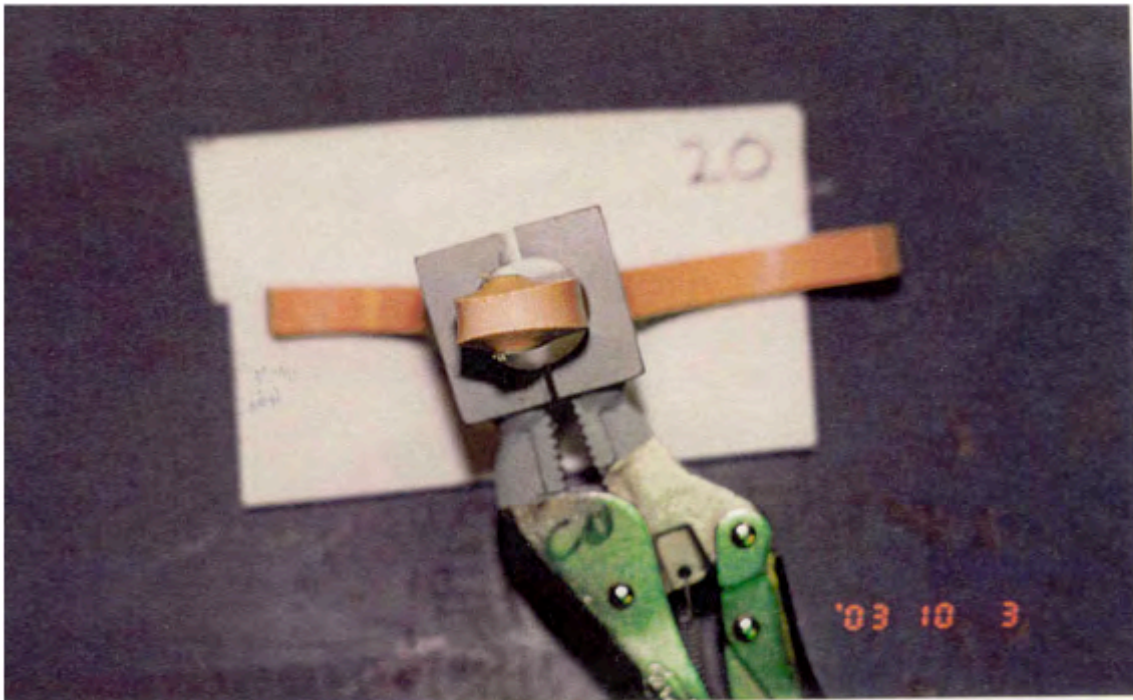
When Avista exhumes Aldyl "A" pipe manufactured during 1970 to 1972 (year codes F, G and H), they should first determine if it has an LDIW surface. This can be accomplished with a reverse bend test on a 1/2" strip of Aldyl "A" pipe. If the inside surface is smooth and shiny, then it is likely normal production Aldyl "A" pipe. If the inside surface has cracks or crazes, as shown in the photo below, then it is likely an LDIW inner surface.
