**ATTACHMENT "B"**

**PSE's February 6, 2015, Comments in Docket No U-140621**

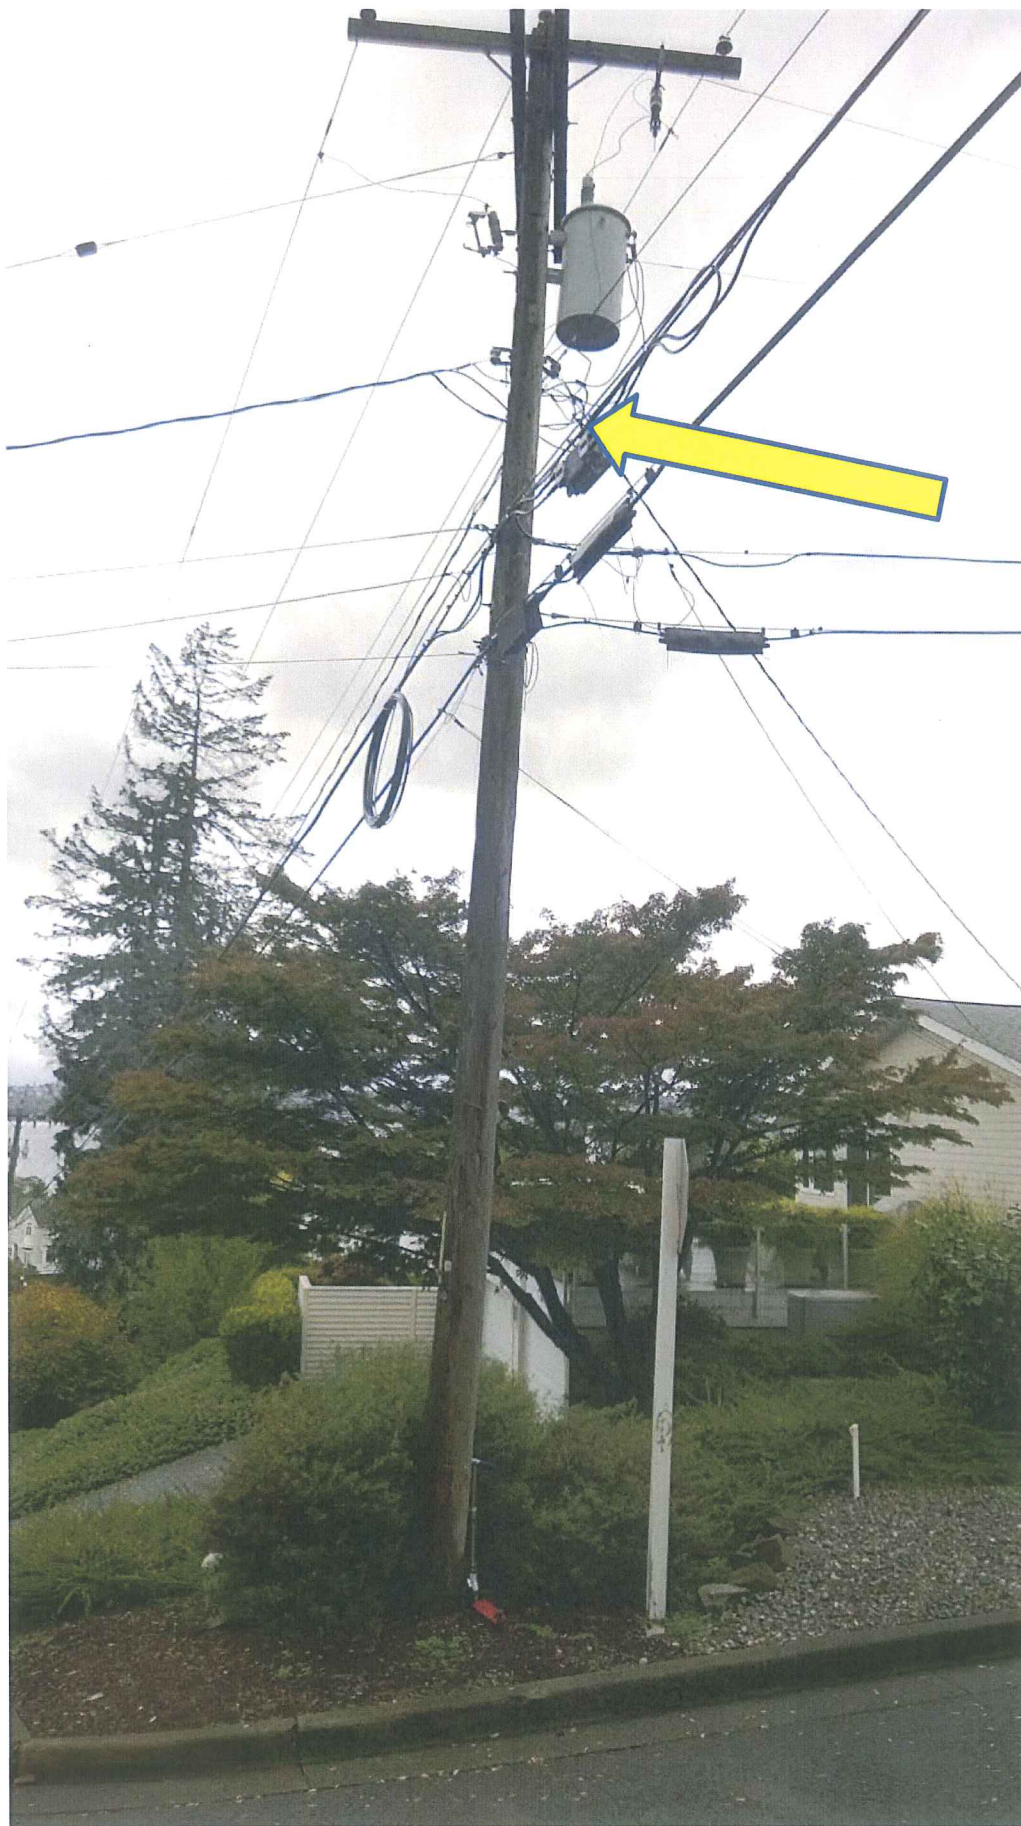
Both communications are too close to power. Lowest power is the bottom of the drip loop. Overlashing had occurred one week prior to this picture being taken.

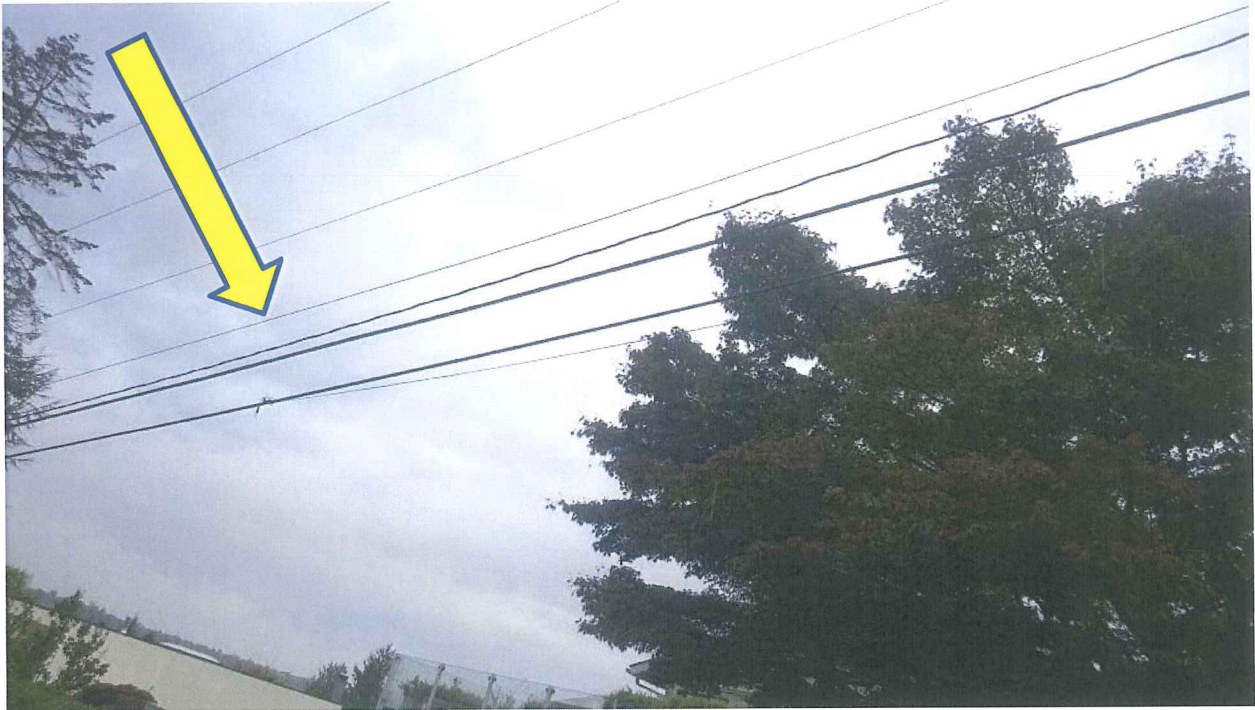
To close to power at mid-span. 30 inch minimum separation required.

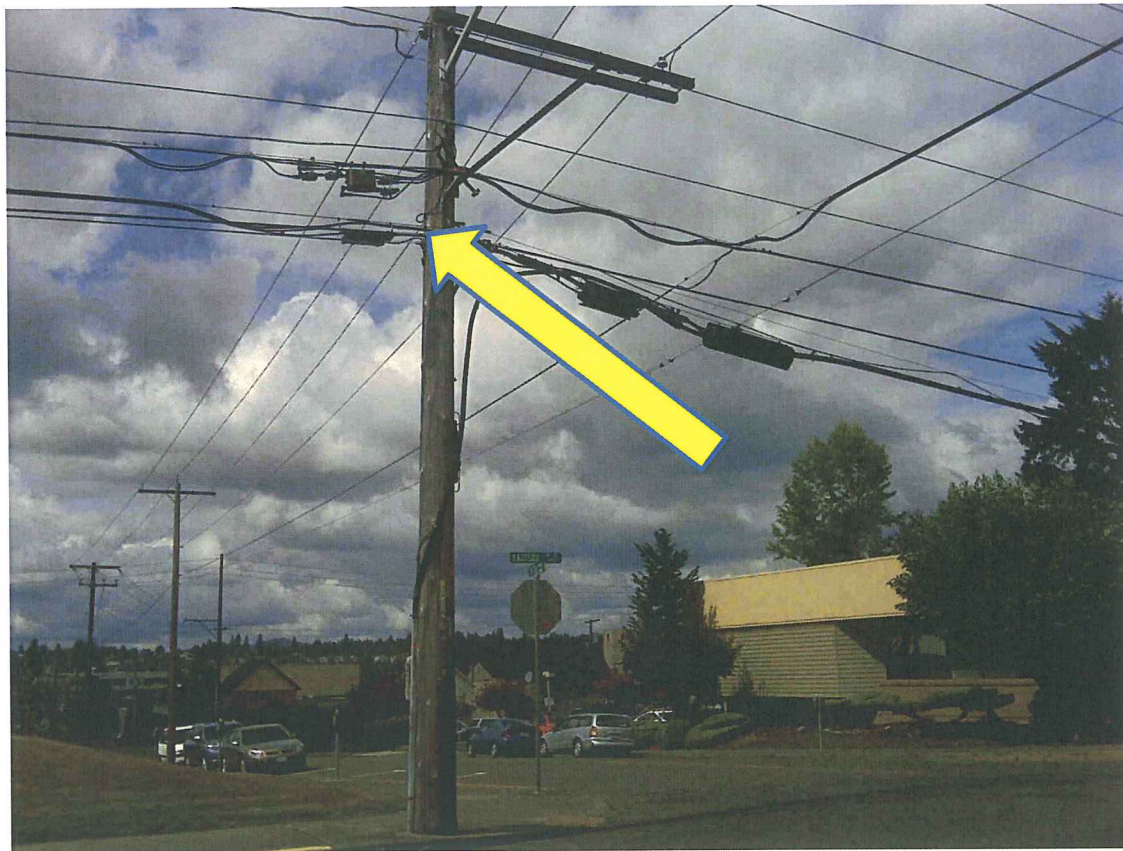
Too close to power. Incorrect build/install.

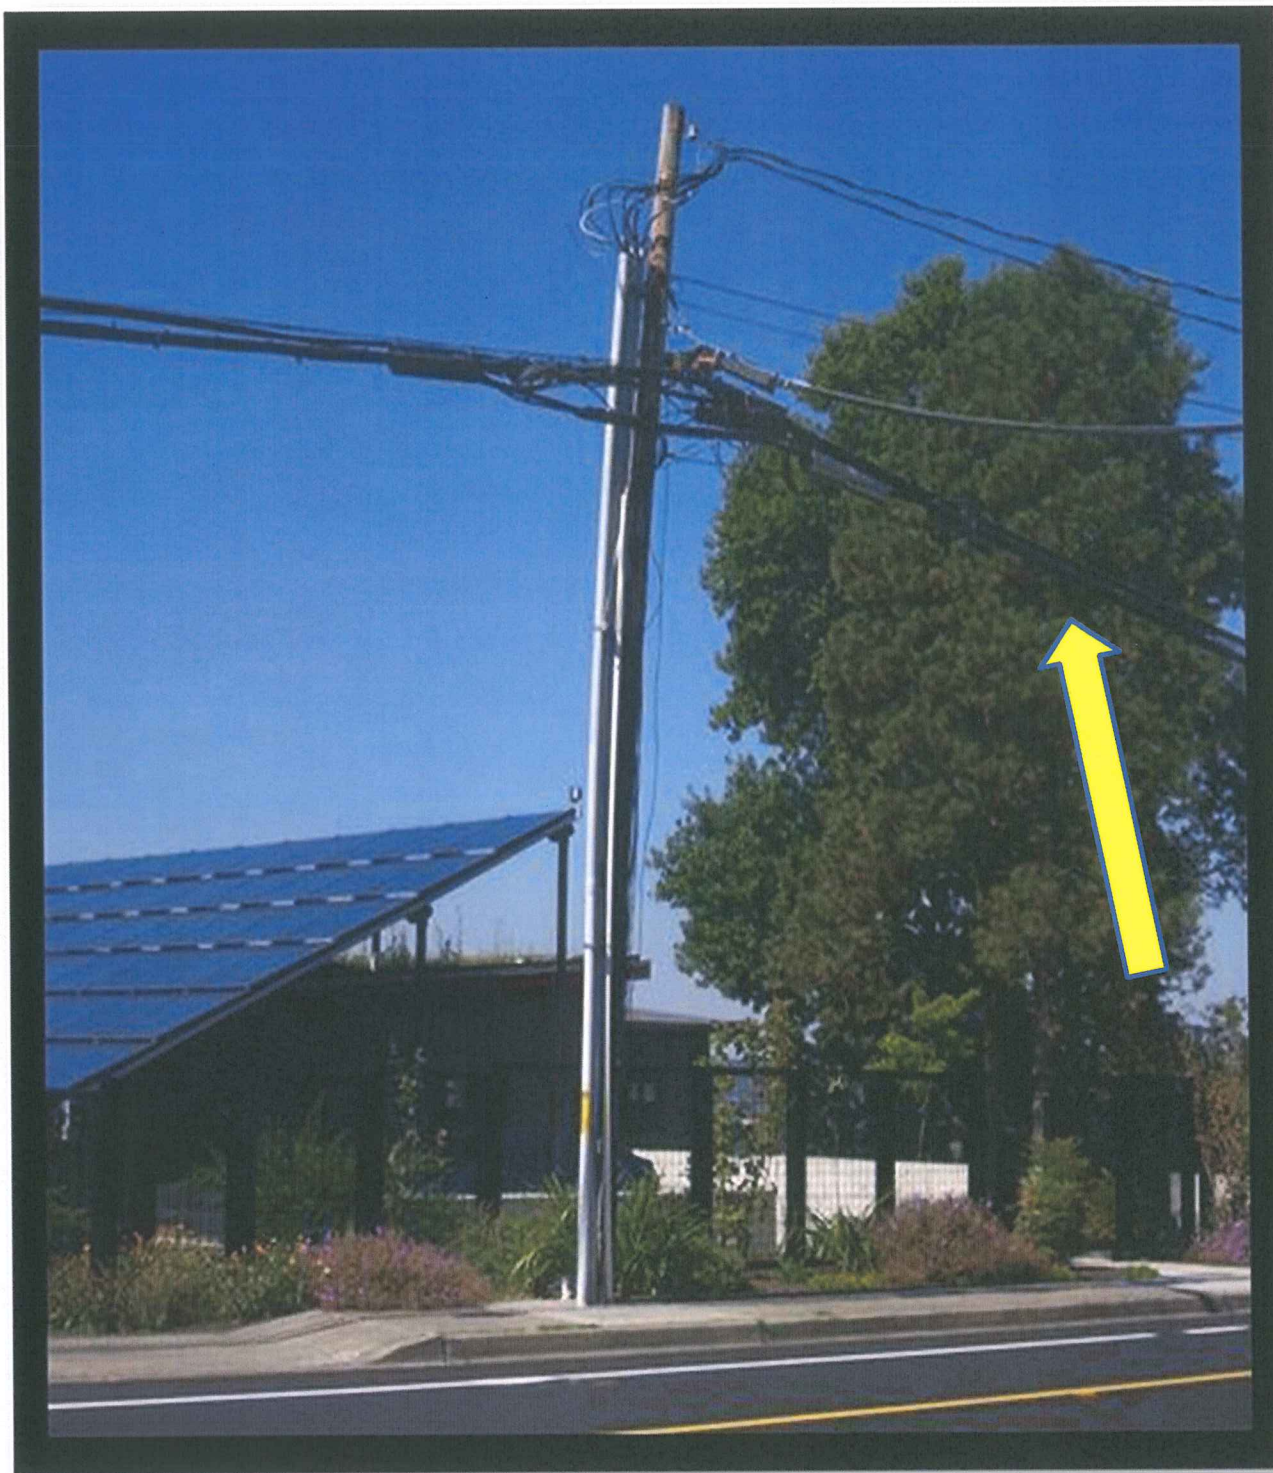
Note how overlashing can impact a pole.

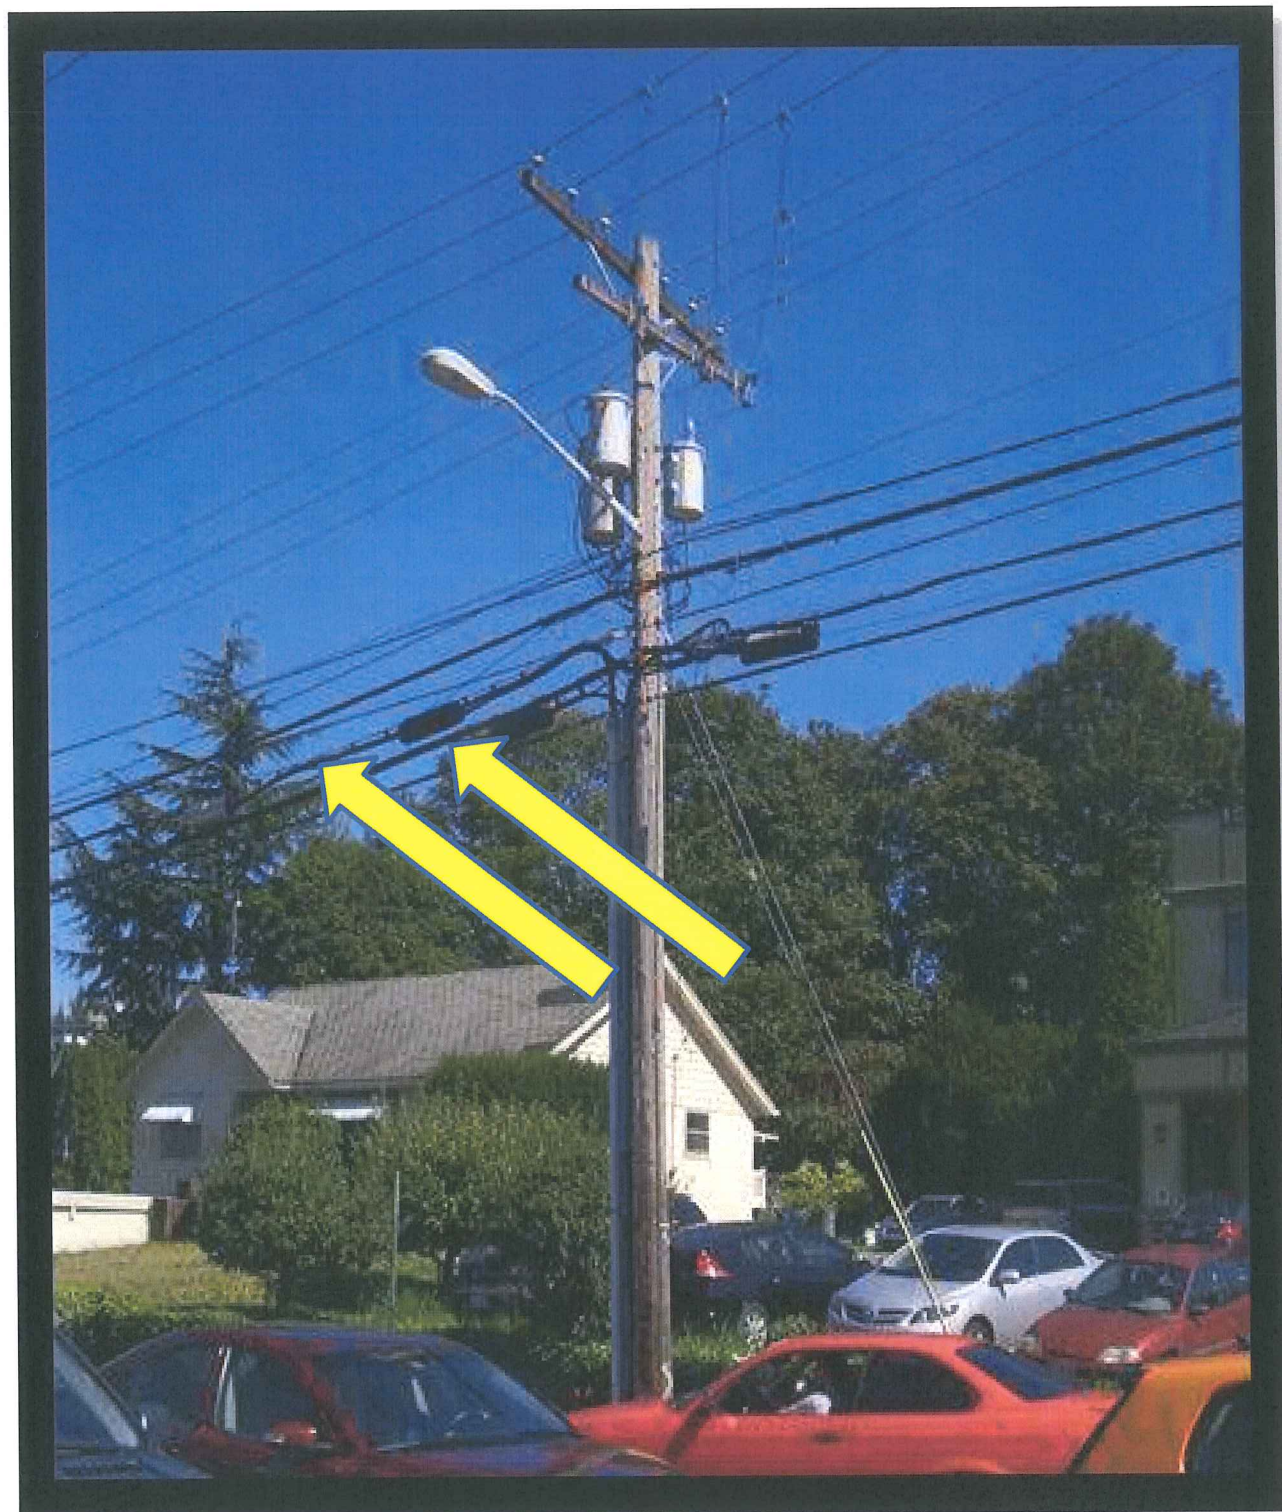
Note size of conductor bundles that are overlashed.

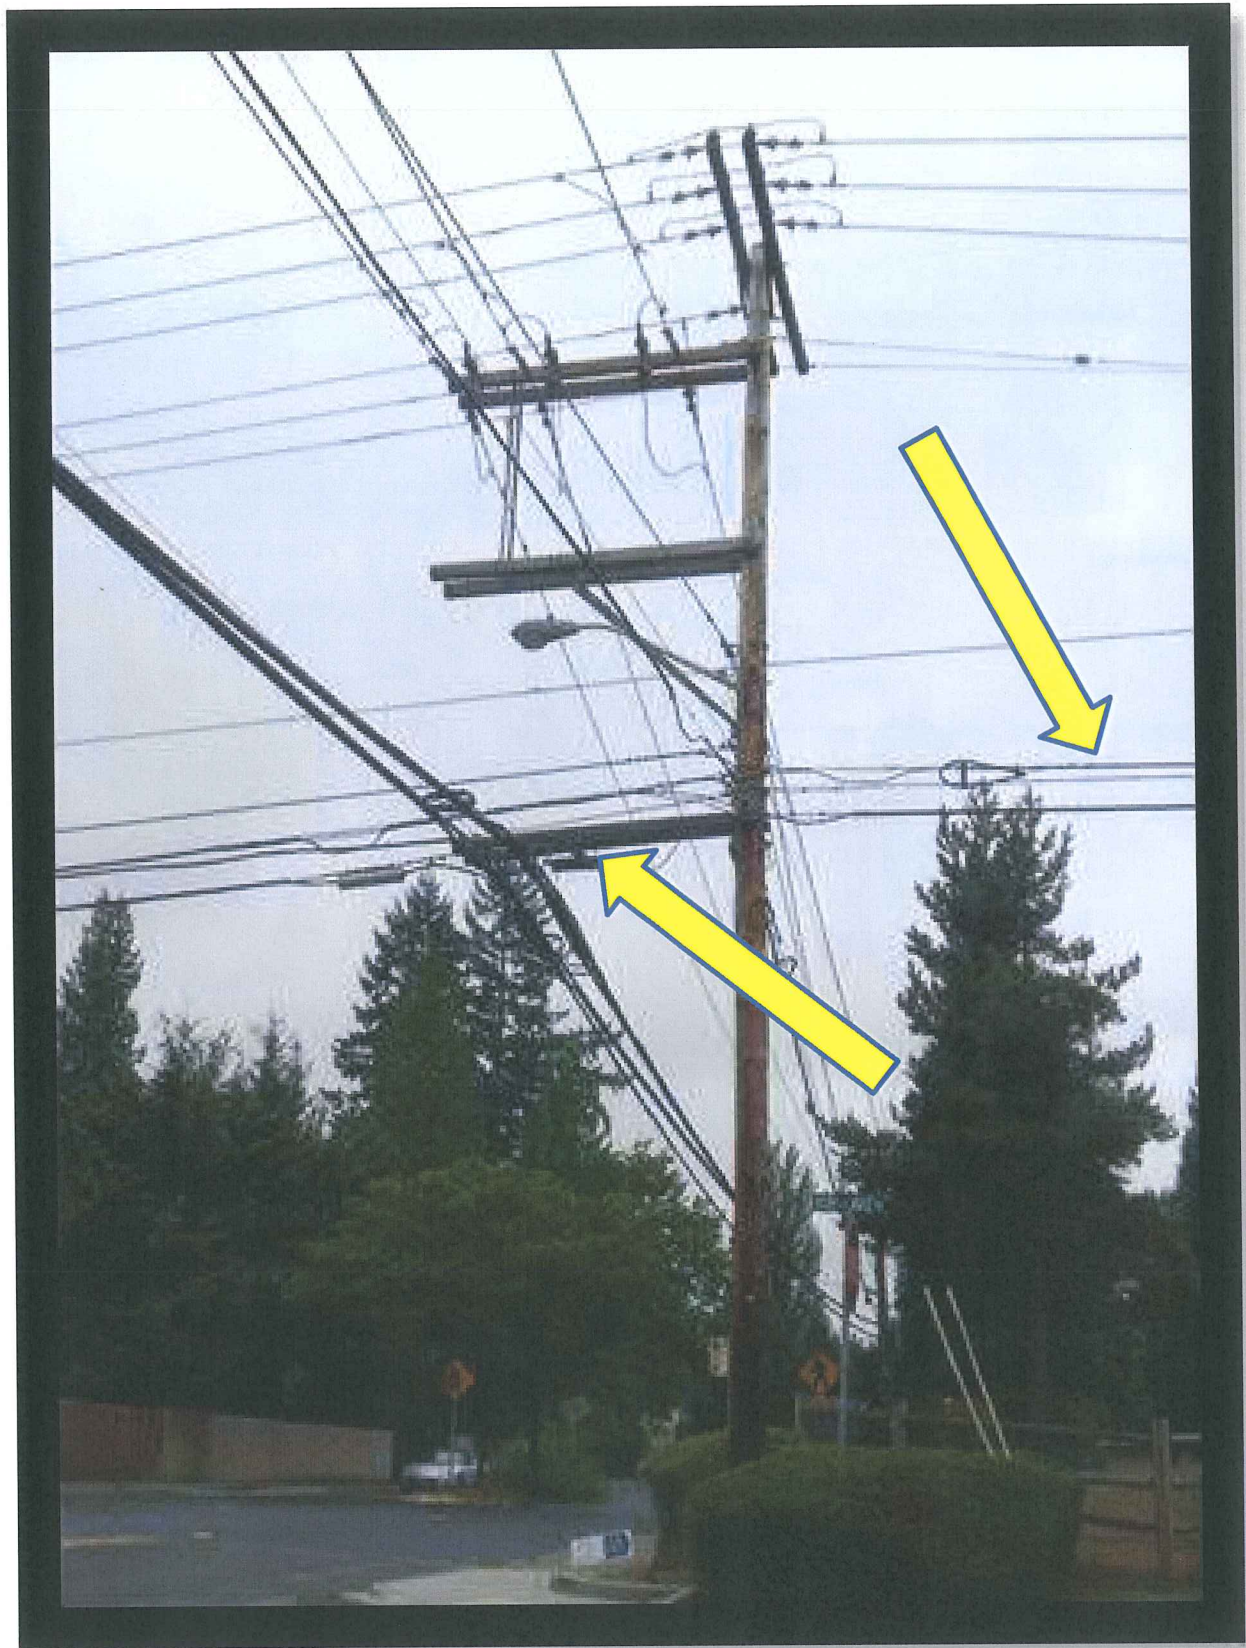
Note amount of overlashing and size of overlashed conductor bundles and installation of stand-off bracket. Also, note the impact on the pole.

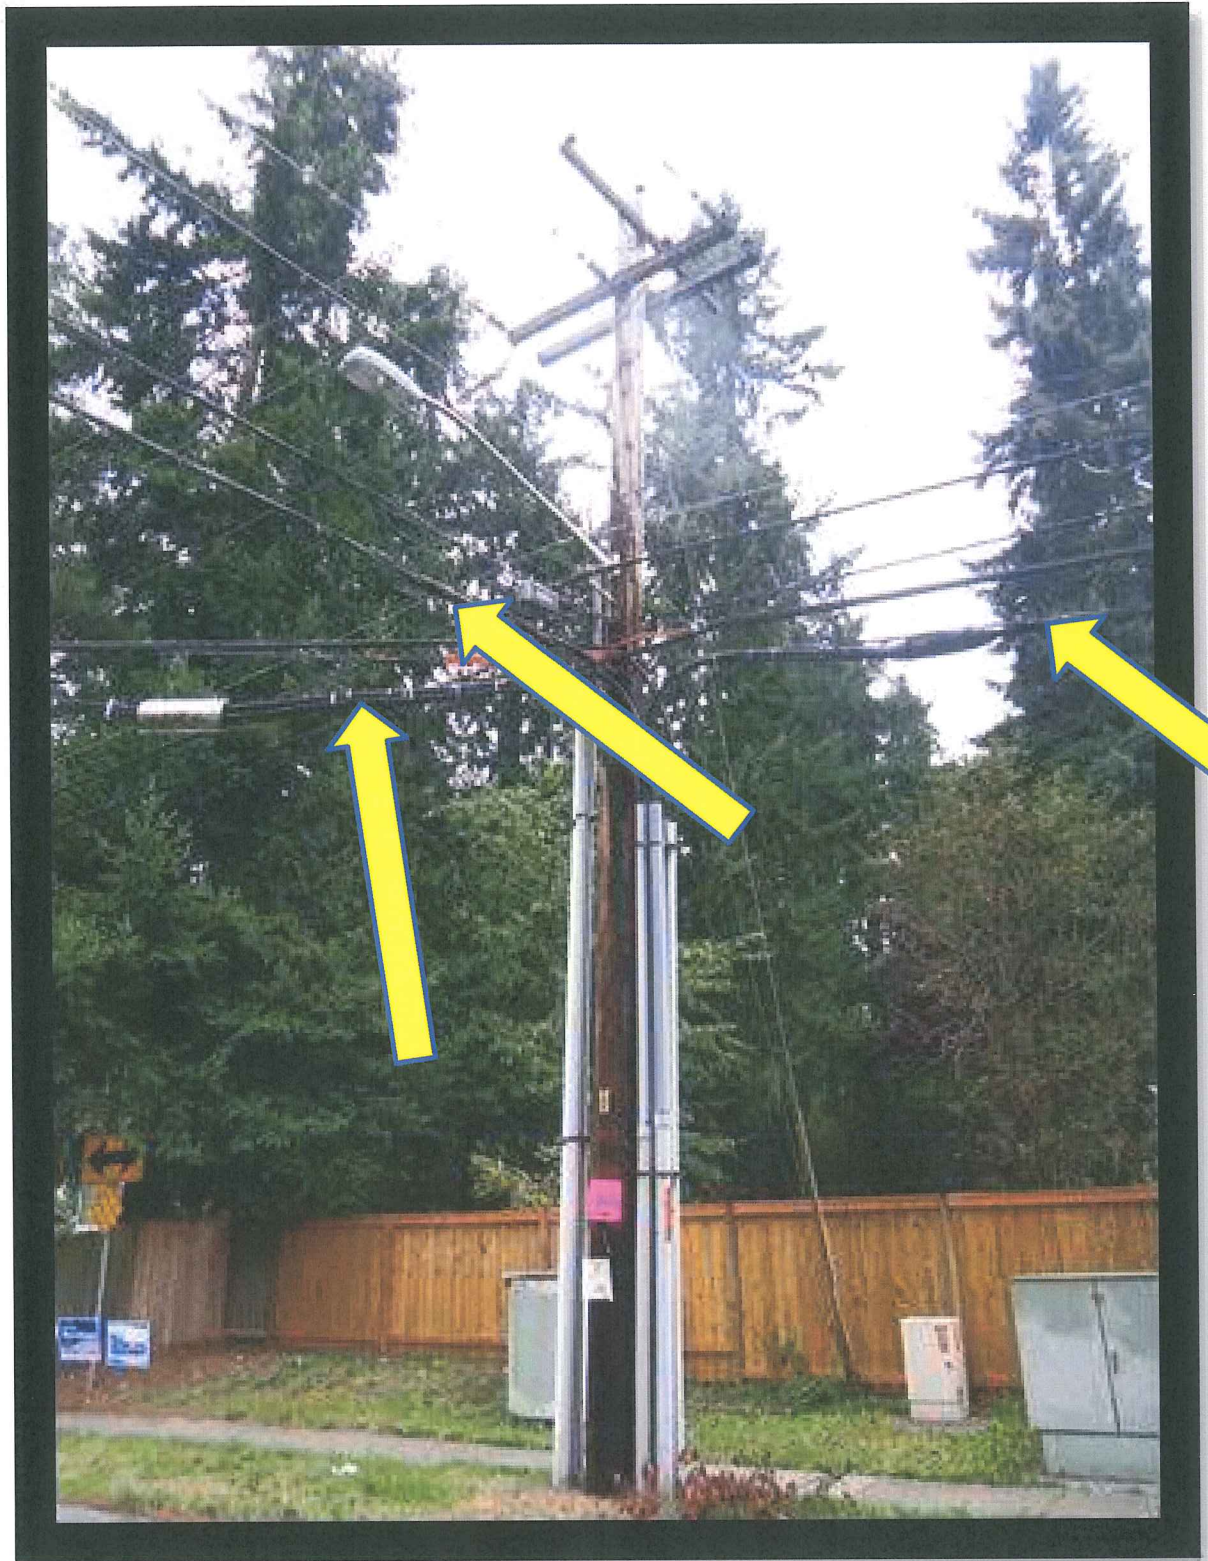
Note amount of overlapping and size of bundles.
