THE WASHINGTON UTILITIES AND TRANSPORTATION COMMISSION

Commission Staff Investigation Report on Explosion and Fire

12312 5th Avenue N.E., Seattle

DOCKET PG-111723

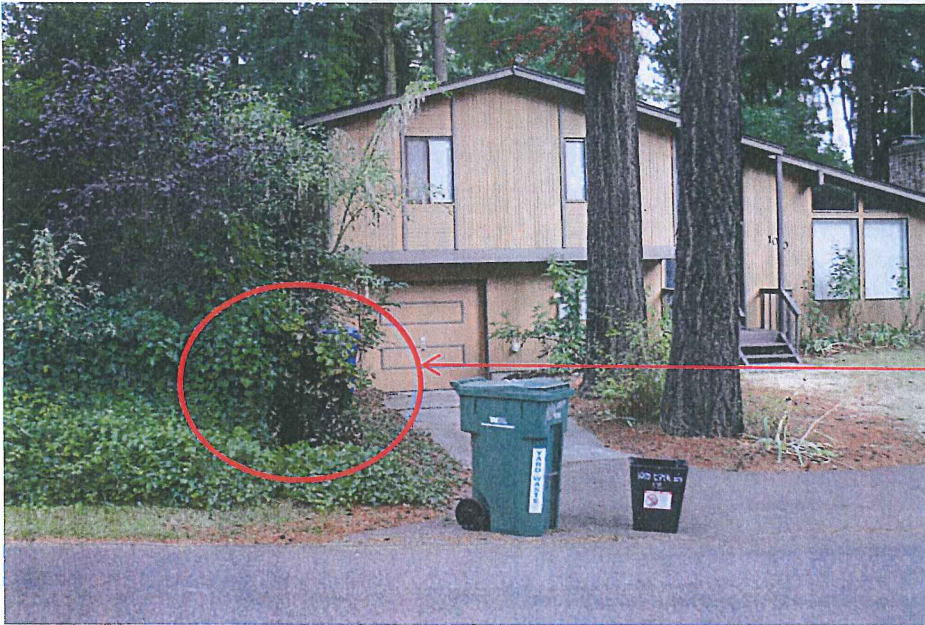
Location of fire at fence

Photo 2: View of where the high voltage line energized the fence post and caused a brush fire. Photo taken September 30, 2011, by Kuang Chu, UTC engineer

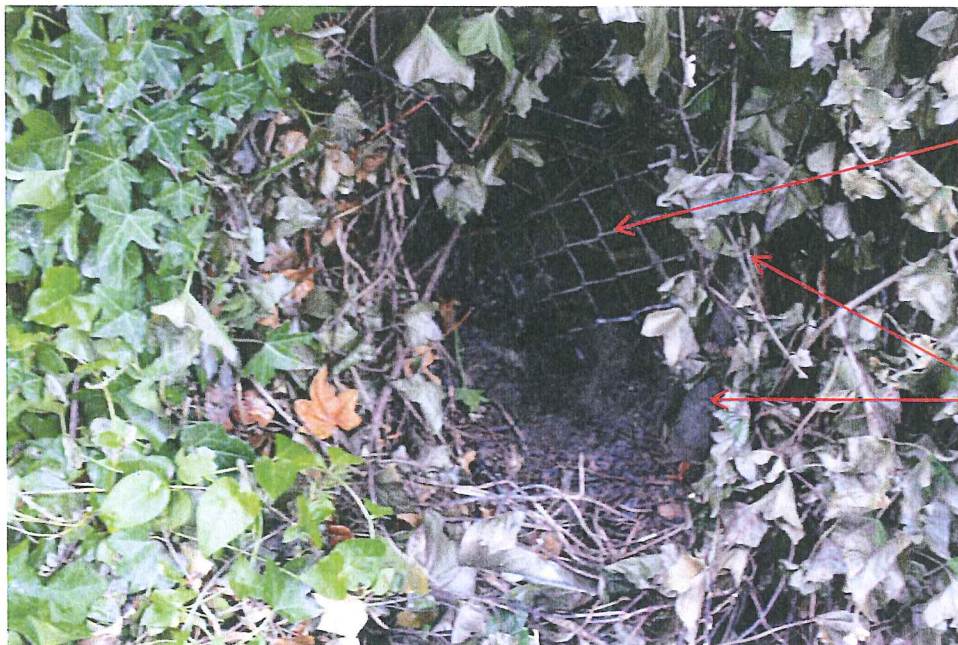
Photo 3: View of fence post, fencing, and fire debris. Photo taken September 30, 2011, by Kuang Chu, UTC engineer

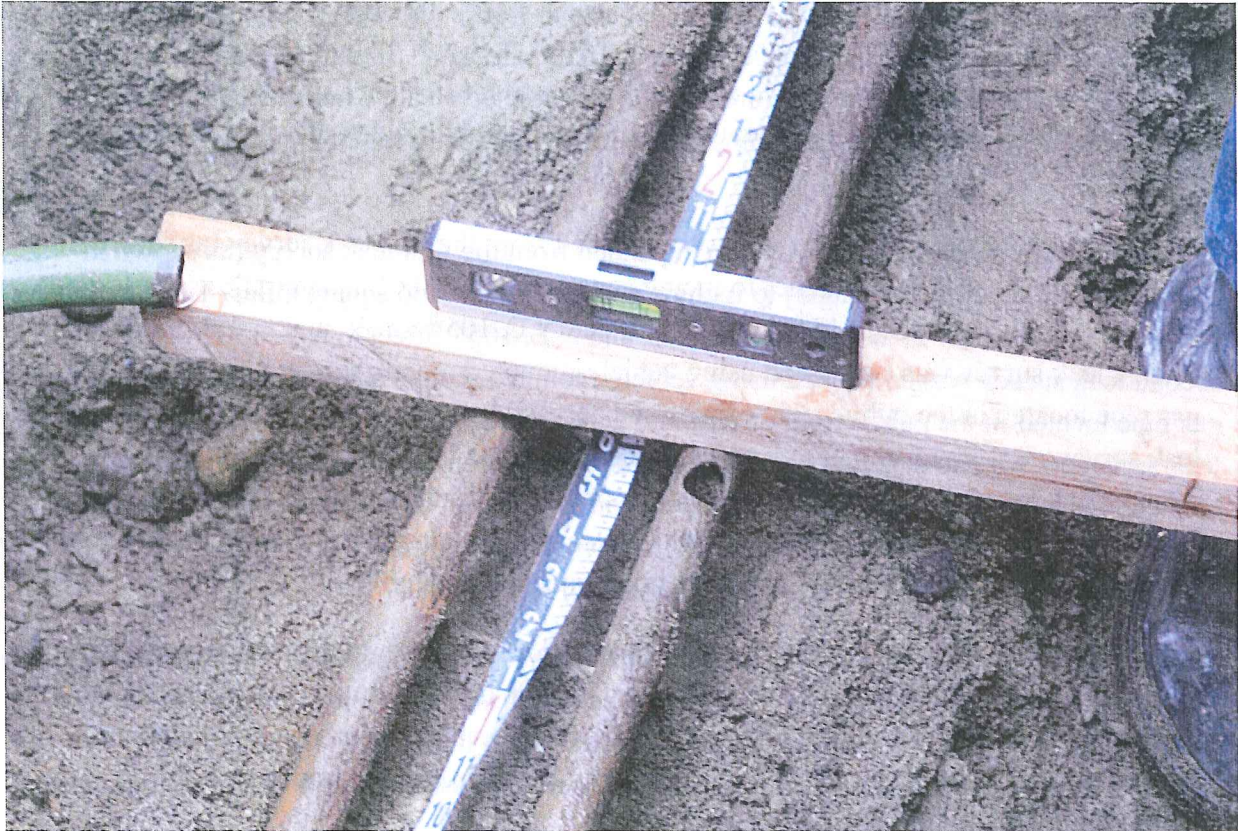
3. 7:55 p.m., 1020 N.E. 127th Street (See photo below) – gas service pipe crossing abandoned water pipe - Heath Consultants, a leak survey team working for PSE, reported to a PSE dispatcher an immediate leak repair where the electrical energy first entered the gas distribution system. This location is near where the electrical wire fell on the steel fence post.

Photo 5: View of service pipe at 1020 N.E. 127th Street, where the high voltage passed from the abandoned water pipe (rust colored line with a hole) to the gas service pipe (green coated pipe). The damaged gas service pipe had been removed at the time this photo was taken. Photo taken October 20, 2011 by David Cullom, UTC engineer.

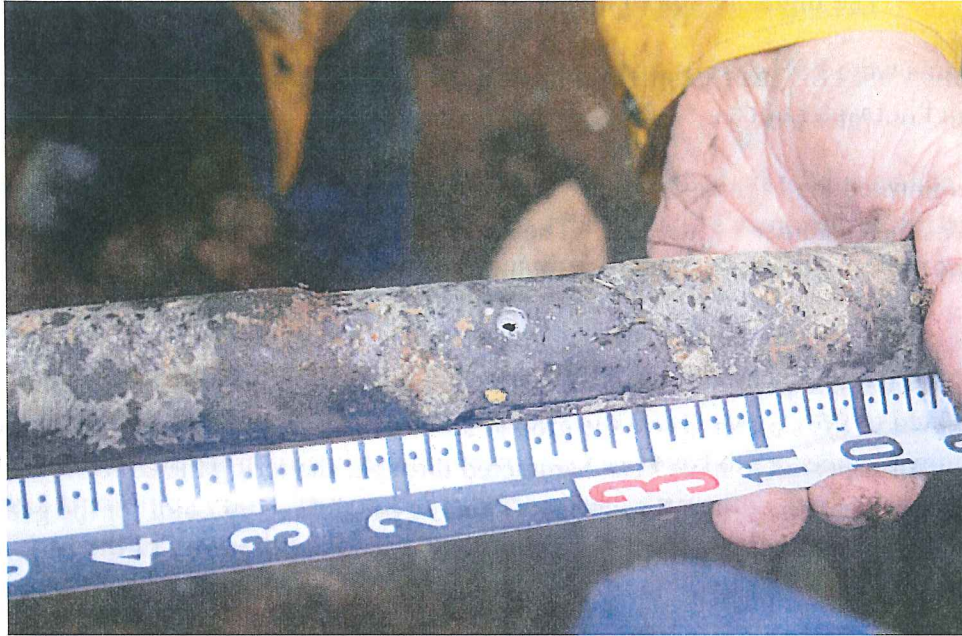
On the PSE gas service pipe, the coating was missing on the lower half of the pipe where the hole was located. There were no visible signs of general corrosion or corrosion pitting on the exposed metal surface of the gas service pipe (see Photo 8, below). The wall thickness of the service pipe was approximately one-eighth inch which is within an acceptable wall thickness range for a pipe of this age. The hole in the service pipe was cone-shaped. The exterior and interior diameters of the hole were approximately one-fourth inch and one-eighth inch, respectively.

Photo 8, on the next page, is a photograph that shows the bottom surface of the section of the Inghams' gas service pipe that was located above the sewer pipe, with the through-wall hole in the pipe.

Photo 8: View of the hole in gas service pipe to Inghams' home located on bottom side of the pipe where it crossed over the sewer pipe. Photo taken September 26, 2011, by Al Jones, UTC engineer.

The metallurgical analysis shows a melting and re-solidification of the metal caused by an electrical arcing process. The holes in each of the gas pipes analyzed showed a shiny, smooth and regularly shaped hole, with no blisters or flaking. This is entirely consistent with the electrical arcing phenomenon discussed above.

This eliminates corrosion as a cause of the holes in these pipes, because corrosion by oxidation of a ferric metal reduces the metal to a lower state of energy, such as ferrous oxide, and it results in a condition that is irregular in shape, reddish brown in color, blisters and easily flakes off. That was not the situation here.

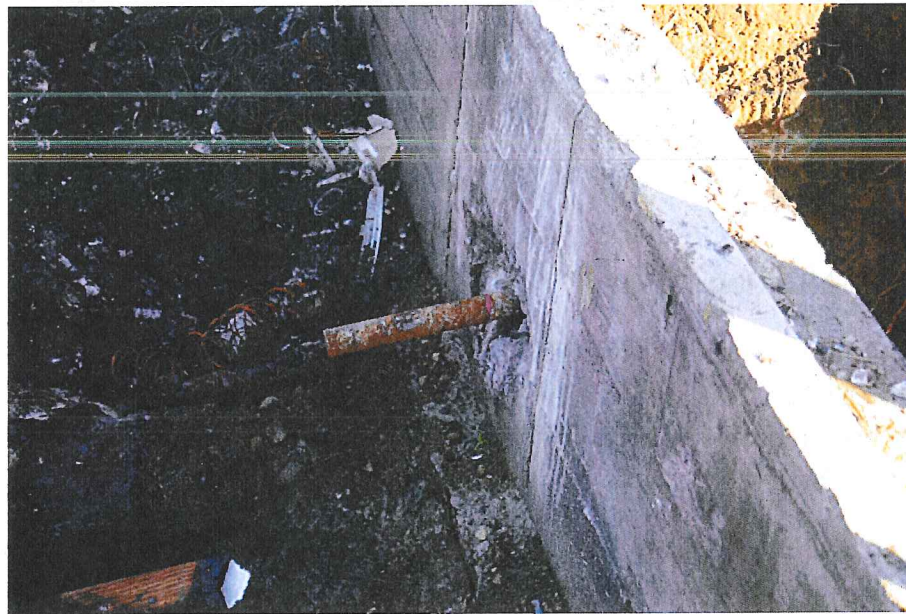
The Inghams' fuel line passed through the concrete foundation wall below the ground surface, and connected to PSE's meter above the ground surface. The fuel line's entry point through the foundation wall appeared to have been hammered through, shattering the concrete on the inside wall surface and reducing the wall thickness. This is a possible entry point for the gas to migrate into the crawl space. Photo 9, below, is a photograph showing the entry of the fuel line into the crawlspace of the Ingham house.

Photo 9: View of the gas fuel pipe entry into crawl space through east foundation wall. The vertical saw cuts in the concrete wall were made after the incident. Photo taken October 18, 2011, by Dennis Ritter, UTC engineer
