**BEFORE THE  
WASHINGTON UTILITIES AND TRANSPORTATION COMMISSION**

**THIRD EXHIBIT TO THE PREFILED DIRECT TESTIMONY OF  
JAMES HOGAN (NONCONFIDENTIAL)  
ON BEHALF OF PUGET SOUND ENERGY, INC.**

**PUGET SOUND ENERGY  
PIPE SEGMENT INTEGRITY STUDY  
IN THE VICINTIY OF THE VASA PARK RECTIFIER**

**June 21, 2005**

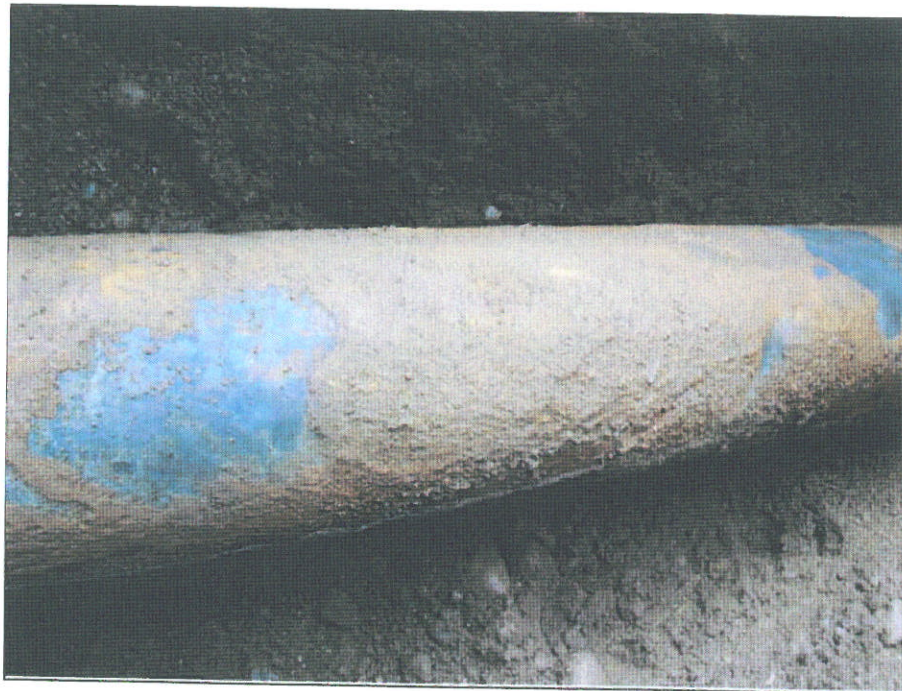
### Examination Site 2

This site exhibited minor pitting at a large coating holiday. The coal tar enamel coating damage was attributed to third party excavation. The coating is tightly bonded to the pipe. A crusty material adhered tightly to the exposed pipe steel surface at the holiday. The cross-section of the incrustation exhibited a thin white colored layer adjacent the pipe surface covered by a thicker layer with a rust colored matrix embedded with backfill material. The incrustation is an indication that the corrosion at this site had not occurred recently. Enough time had elapsed since the pitting occurred for ions to migrate to the pipe and form an incrustation on the exposed steel pipe surface as shown in the following photograph. Cathodic protection promotes ion migration in the electrolyte<sup>2</sup>. It is very likely this process commenced with the application of protection in the 1980's and the corrosion predates this event.

Two pits were discovered at the holiday. Their dimensions were 1/2" x 1/8" and 30 to 40 mils deep. The soil resistivity measured at the site is 150,000 ohm-centimeters. The laboratory resistivity measurement in a saturated condition is 50,000 ohm-centimeters. Both resistivity values indicate the soil is not very corrosive at this site and the degree of corrosion supports this conclusion. The soil is sandy with round rock up to 6" diameter.

This incrustation at Examination Site 2 was typical of that found at most of the coating holiday sites exposed during the investigation.

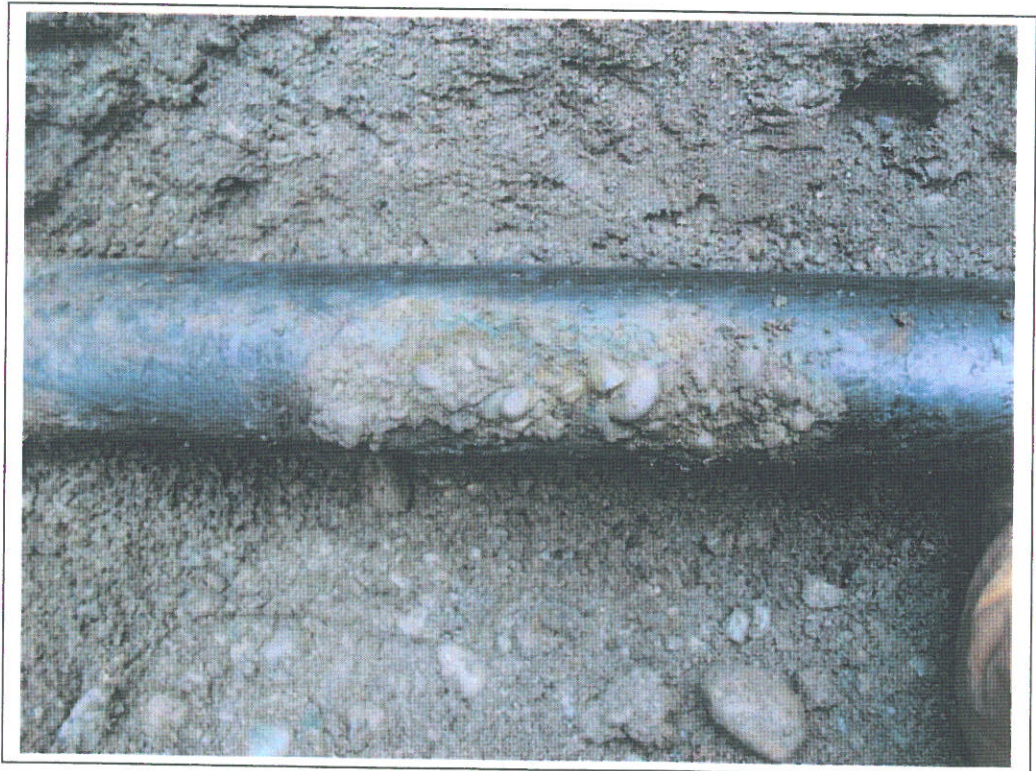
**Examination  
Site 14**

A moderate sized coating holiday was discovered at this site with dimensions of 2" wide by 11" long axially oriented on the pipe at about 3 o'clock. The cause of the coating damage could not be determined. The coal tar enamel coating is tightly bonded to the pipe surface. The bare steel at the coating holiday was covered with a tightly adherent crust which had round rock, up to 3 inches in diameter, embedded in it. Removal of the incrustation exposed minor pitting to 10 mils deep in a 3-inch diameter area. Within the corroded area is 30 mils deep x 1-1/8" diameter pit. The formation of a crust over the pitted area and the lack of corrosion product, suggests the corrosion did not occur recently and is not active. The EDS analysis indicates a sample taken from the incrustation is composed of silicon, aluminum, and iron with minor constituents of calcium, potassium, magnesium oxygen and carbon, elements typically found in soils.

The soil adjacent to the corroded area is sandy with round rock up to 3 inches diameter. This soil has a resistivity of 32,000 ohm-centimeters. Soil within 2 feet of the corroded area is blue colored clay with a resistivity measured in the field of 8,000 ohm-centimeters. The laboratory resistivity measurement is 5,100 ohm-centimeters. The resistivity values are typical of moderately corrosive soils. The clay is more corrosive than the sandy material and the change in resistivities of adjacent soils is characteristic of a local corrosion cell.

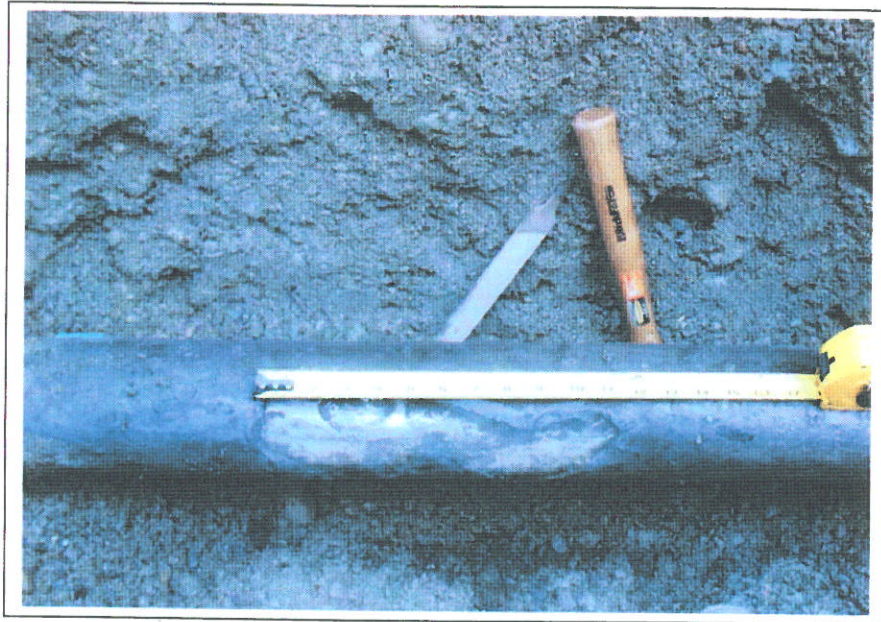
The incrustation at the coating holiday found at Examination Site 14 exhibits round rock cemented to the pipe surface. Removal of the incrustation revealed minor pitting in a 3-inch area as shown in the following photograph.

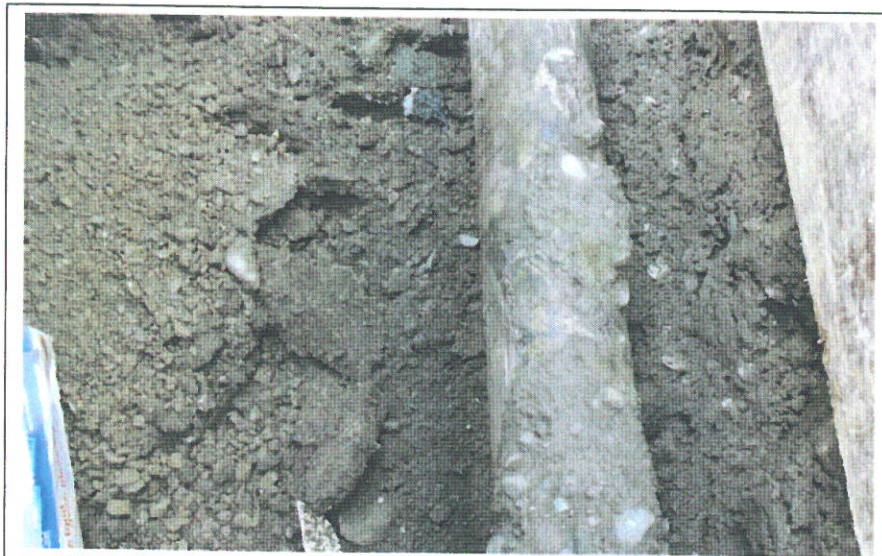
**Examination  
Sites 28 and 31**

Six coating holidays were discovered at this site located at 12 and 1 o'clock. The locations suggest a third party caused the damage. The holidays were heavily encrusted. Rocks up to 1 inch in diameter were embedded in the incrustation.

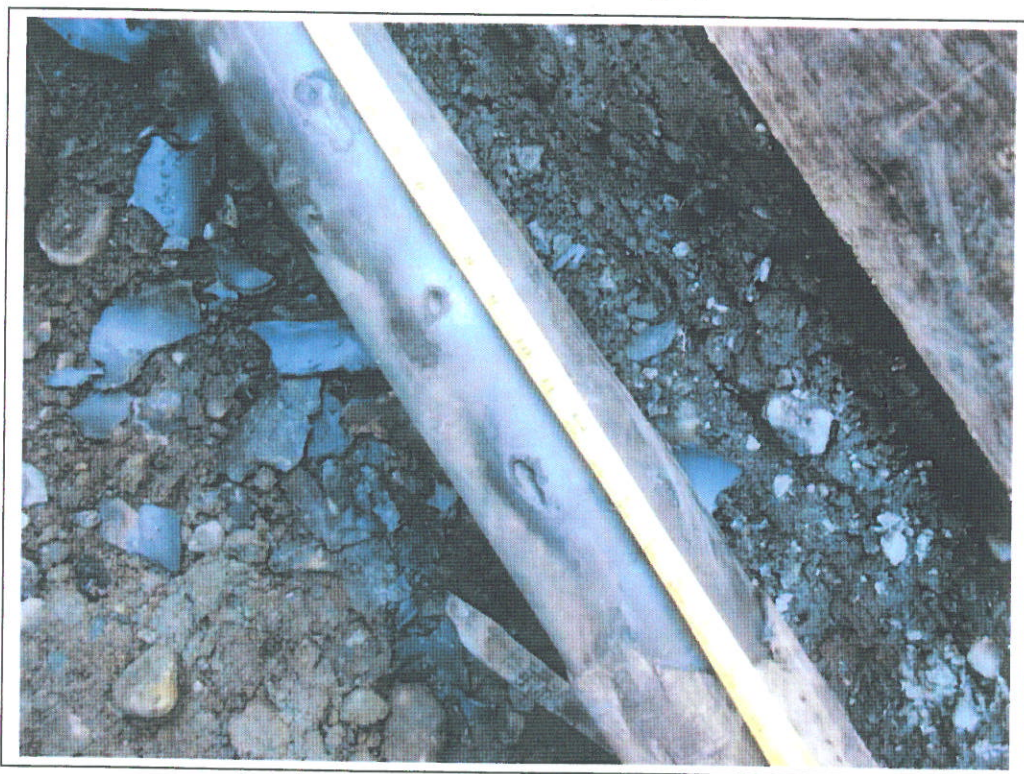
Four pits, which had penetrated the 0.188" thick pipe wall, were discovered under the incrustation. Pitting was observed within the larger pits.

A black, moist substance was removed from the pit closest the bottom of the photograph above. It was analyzed using EDS technology. Two spectra were recorded. One run had major peaks for iron, sulfur, silicon, sodium, and aluminum with minor peaks of potassium, calcium, oxygen and manganese. These elements are characteristic of corrosion. Another run exhibited major peaks for the elements silicon, aluminum and iron with minor peaks of sulfur, potassium, calcium, carbon and oxygen. The elements detected in the latter portion of the sample are typical of soil. This substance indicates corrosion may have been actively occurring in the pit.

The soil is sandy blue clay with rounded rock up to 6 inches in diameter. The resistivity measured in the field is 7,000 ohm-centimeters and that in the laboratory is 6,600 ohm-centimeters. These values are typical of moderately corrosive soil.
