**SECOND EXHIBIT TO THE PREFILED DIRECT TESTIMONY OF
KEVIN C. GARRITY (NONCONFIDENTIAL)
ON BEHALF OF PUGET SOUND ENERGY, INC.**

FINAL REPORT

**LABORATORY-BASED EVALUATION OF FAILED SERVICE LINE
BELLEVUE, WASHINGTON**

PREPARED BY
CC TECHNOLOGIES LABORATORIES, INC.

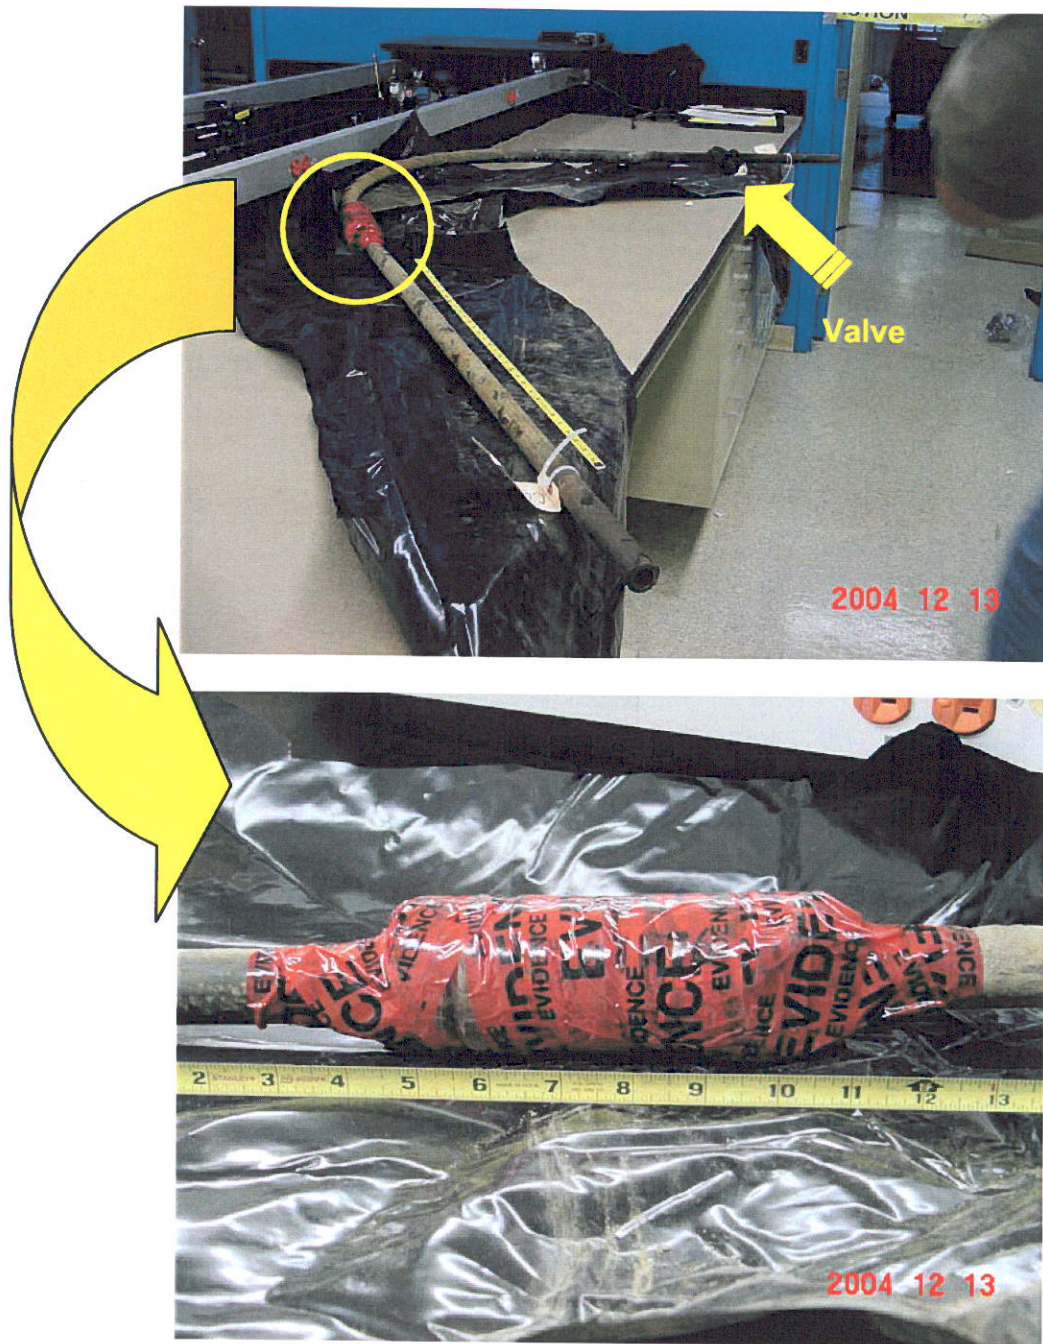
The leak site was contained within Segment 10; the Segment contained a curved pipe portion ("riser") with the valve. The region with the failure site on Segment 10 had been covered with an additional plastic protector (see Figure 6).

Figure 6. Segment 10 after removal of the protective wrapping for shipping. Lower photo shows the additional protector covering the failure site.

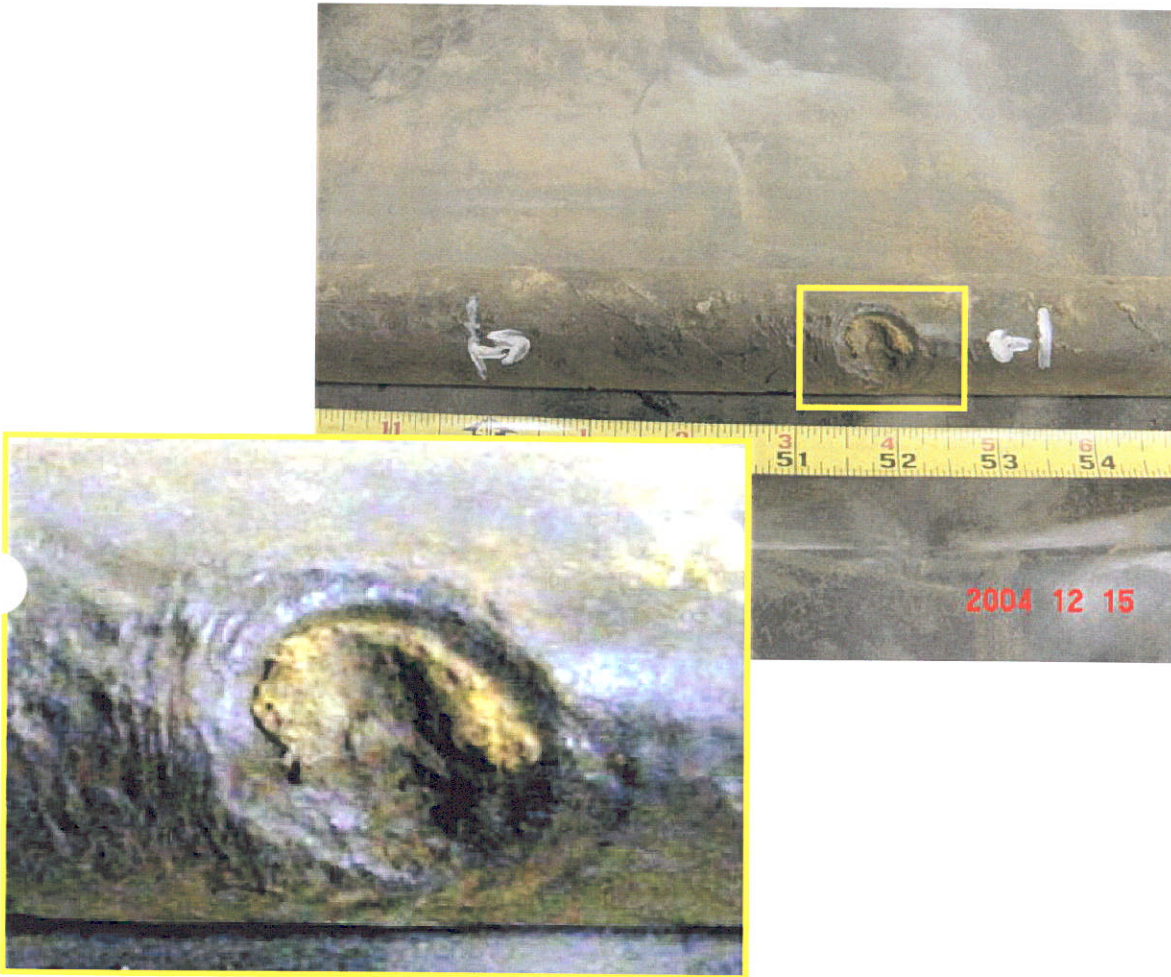
Figure 7. Photograph of Segment 4 showing a coating deformation at the 52-inch location. Inset shows a close-up of view of the region denoted by the yellow rectangle.

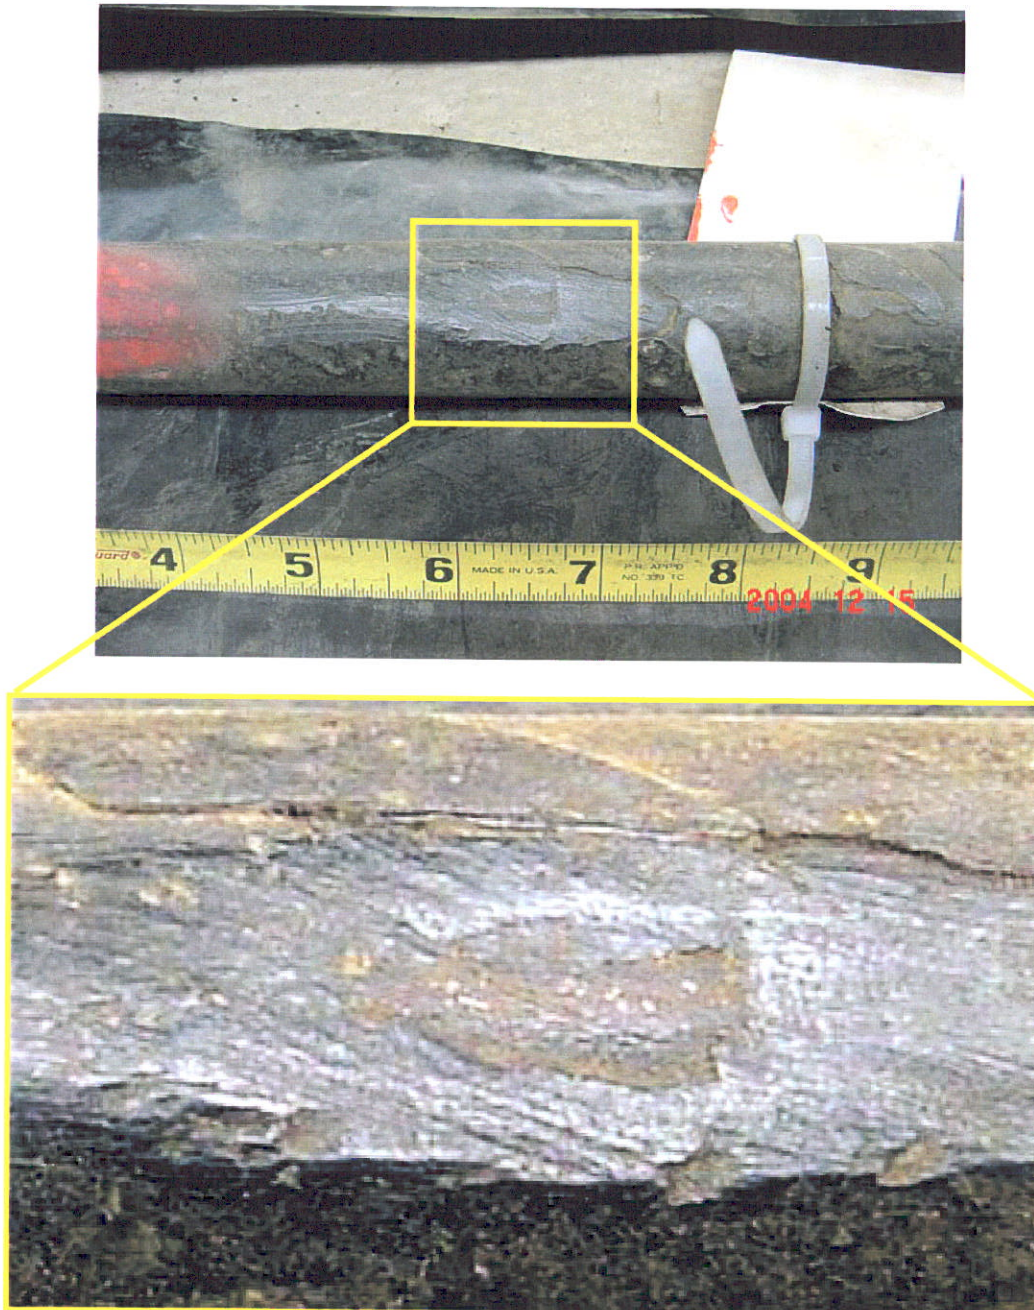
Figure 8. Photograph of Segment 7 showing gouge in coating from the 6-inch location to the 7.5-inch location with a 0.5-inch bare coating spot in the middle. Inset shows a close-up of view of the region denoted by the yellow rectangle.

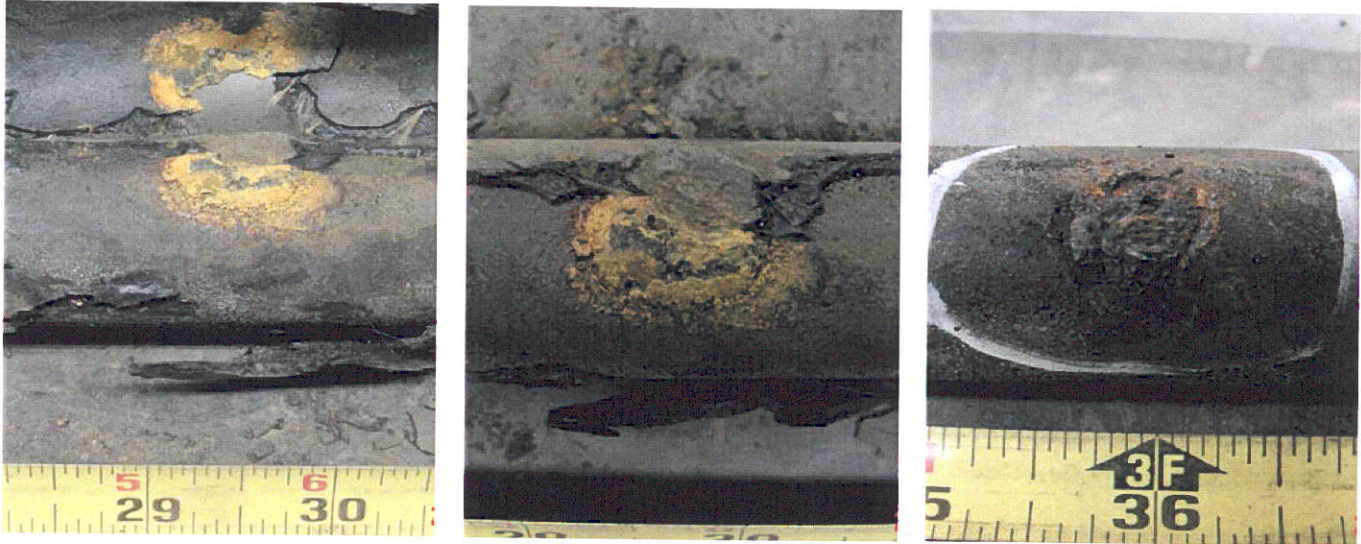
Figure 9. Example of external coating damage removal to expose the underlying steel condition (Segment 9).

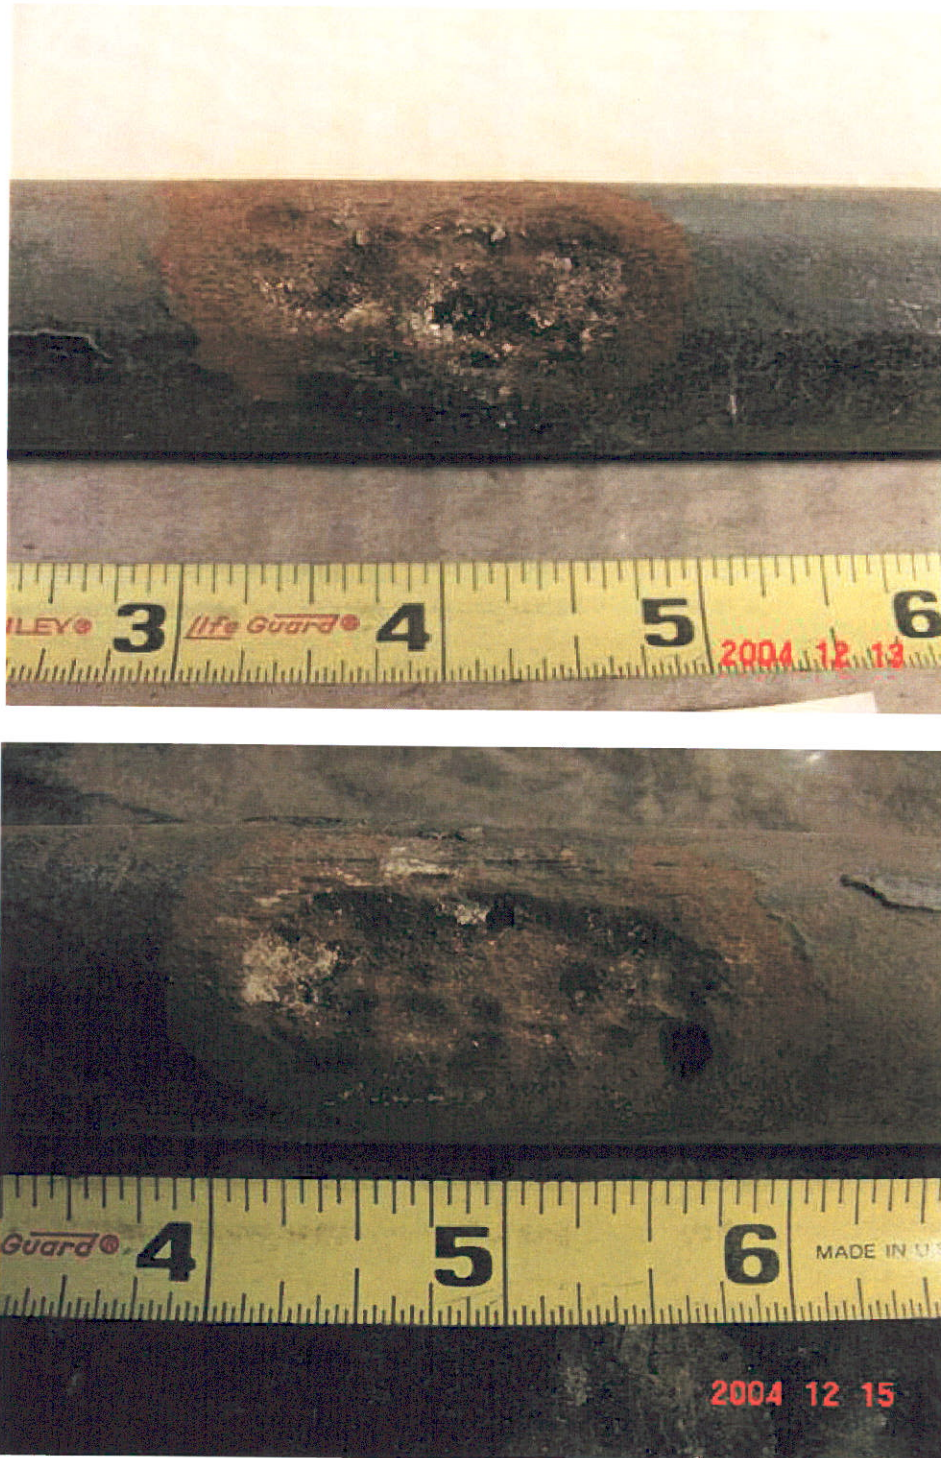
The examination also included Segment 1, which was found to be uncoated. Cleaning of the surface debris on Segment 1 revealed a single deep corrosion anomaly that was within 10 mils (0.010-inch) of full pipe wall penetration. This corrosion anomaly is shown in Figure 10.

Figure 10. Corrosion site in Segment 1. Top photo shows the surface condition prior to the surface cleaning. Bottom photo shows the surface without the debris.

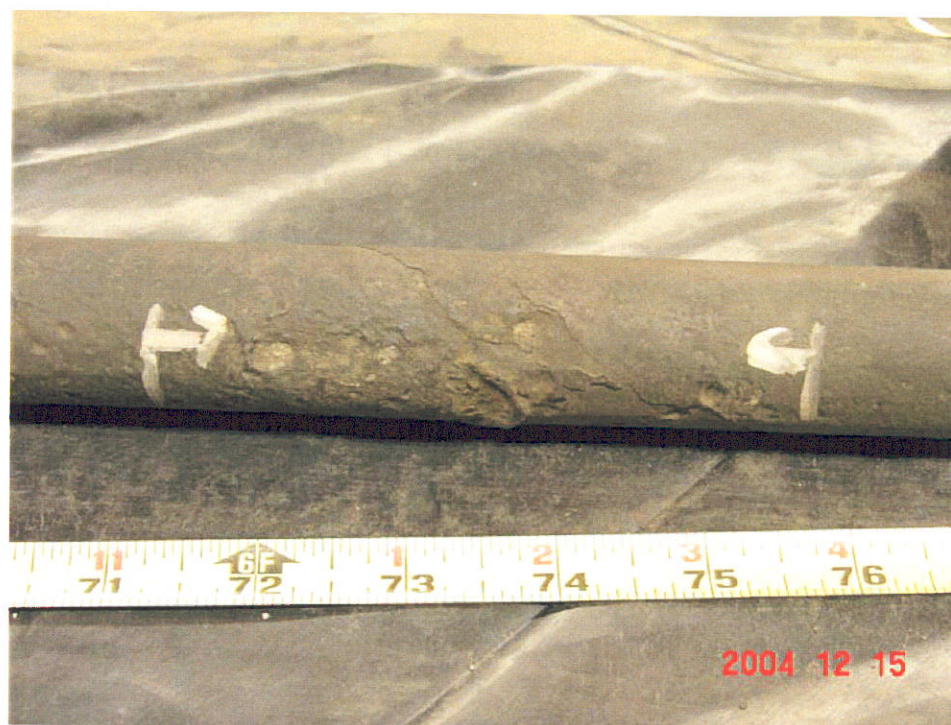
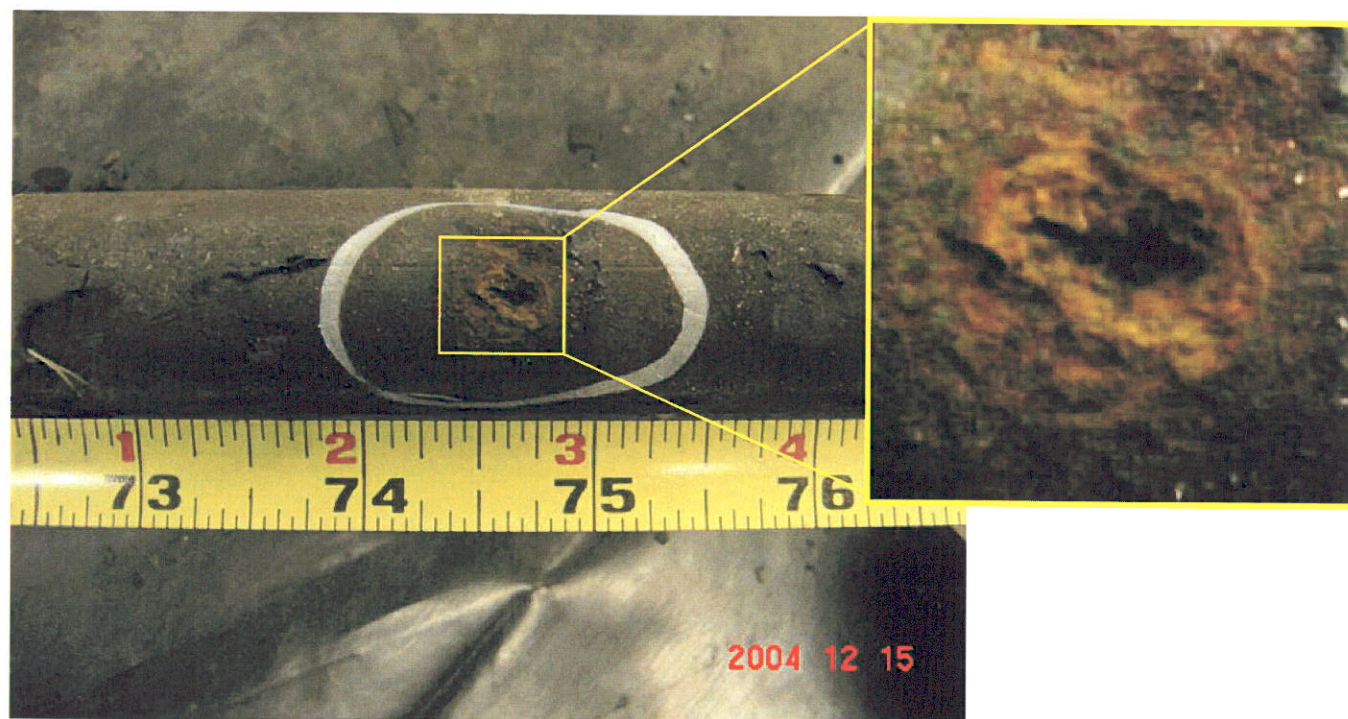
Figure 11. Segment 2 showing damage to the coating between the 71-inch and 75.5-inch locations with a holiday at the 73.5-inch location (top photo). Same location after a portion of the coating was removed showing a 0.25-inch indication at the 74.5-inch location. Inset shows a close-up view of the corroded area.

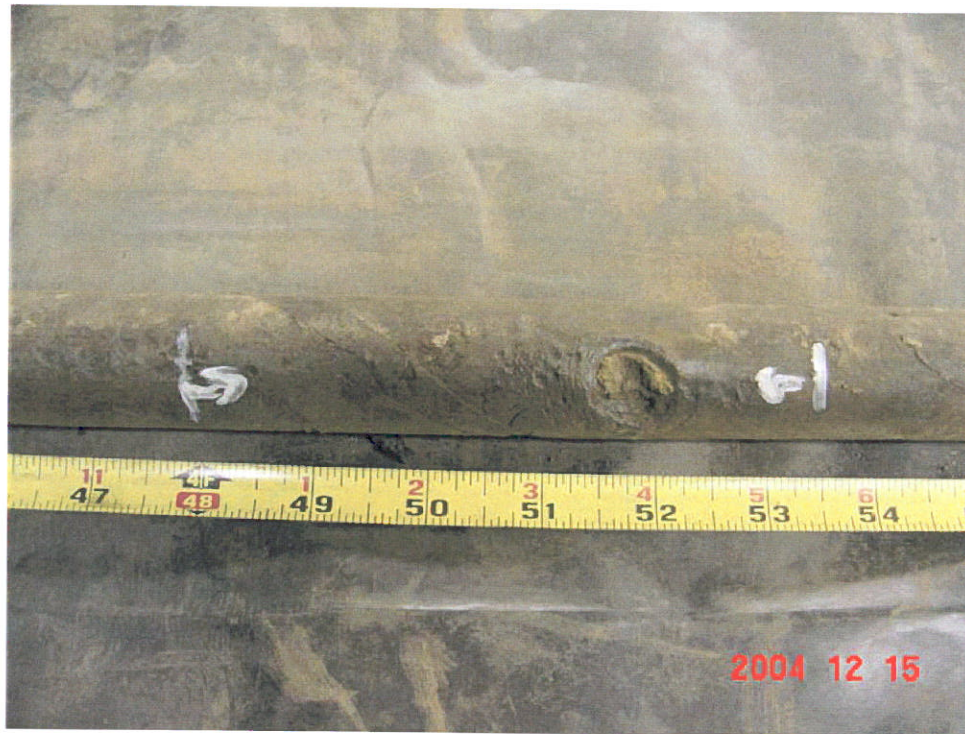
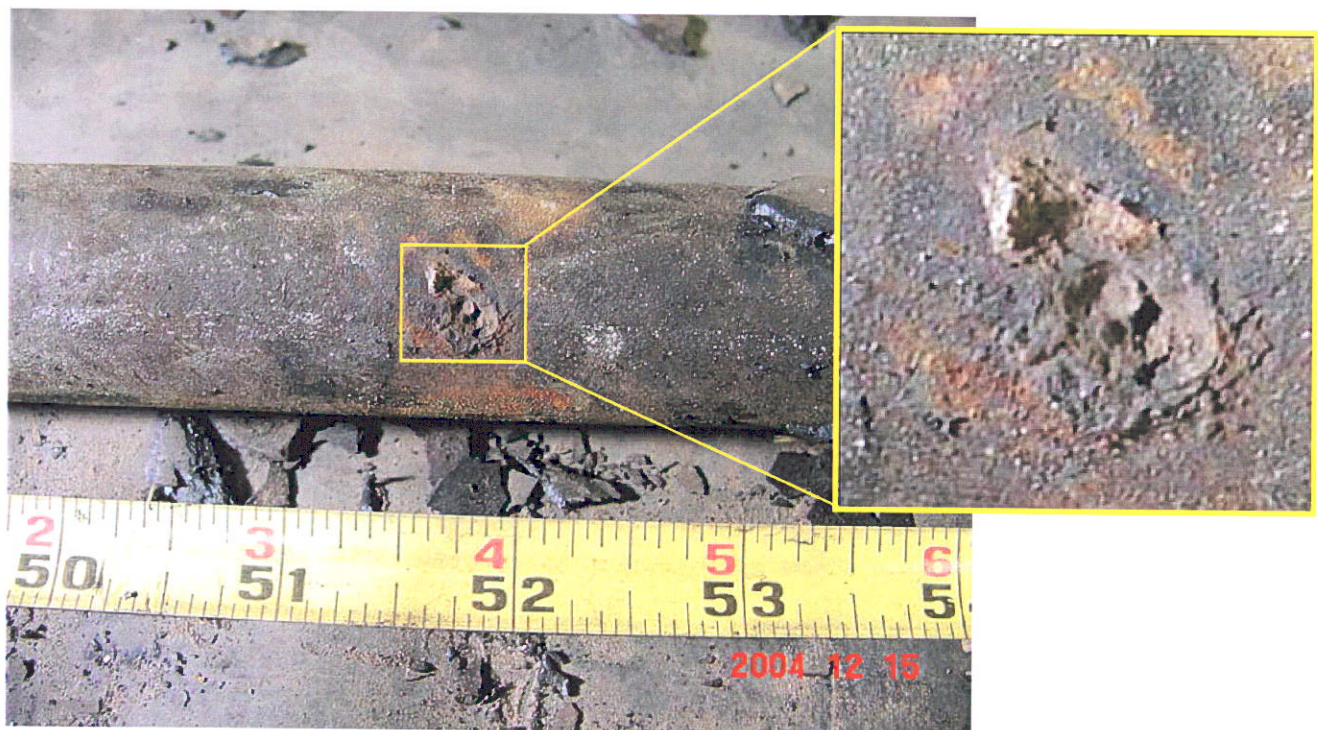
Figure 12. Segment 4 showing a coating holiday at the 52-inch location (left photo). Same location after a portion of the coating was removed showing a 0.25-inch indication at the 51.75-inch location. Inset shows a close-up view of the corroded area.

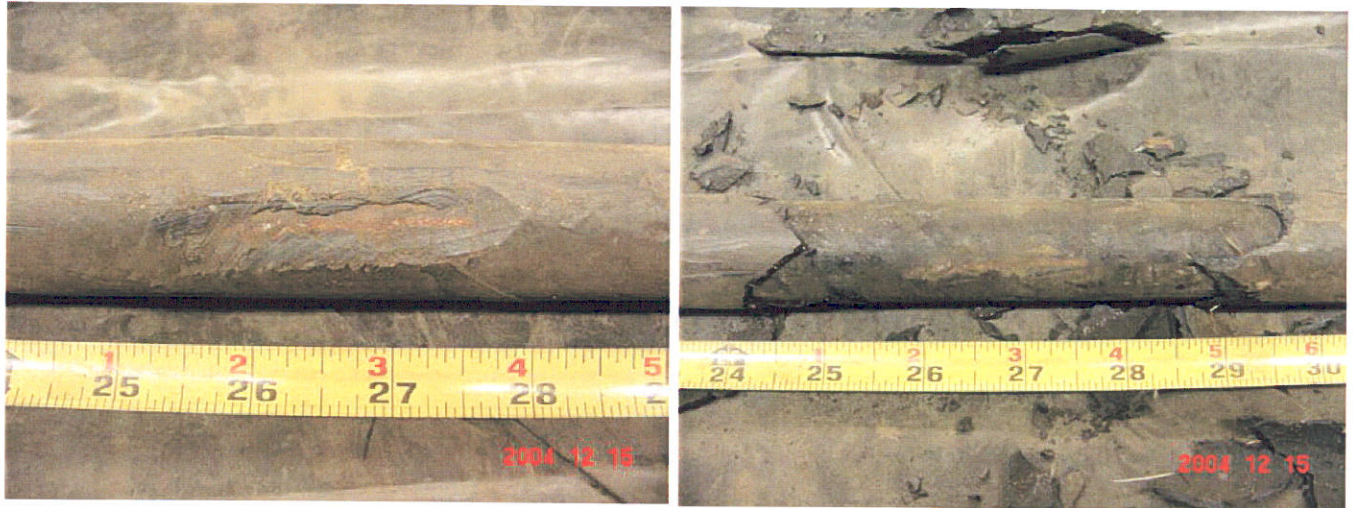
The examination indicated that corrosion pitting was not coincident with all areas of coating damage. An example of such a site (Segment 7) is shown in Figure 13.

Figure 13. Location on Segment 7 showing a gouge in the coating from the 25-inch to 28-inch locations with a 1.75-inch area of bare area (left photo). The same area after removal of a portion of the coating showing no measurable corrosion damage under the gouge in the coating that was located at the 26-inch location (right photo).

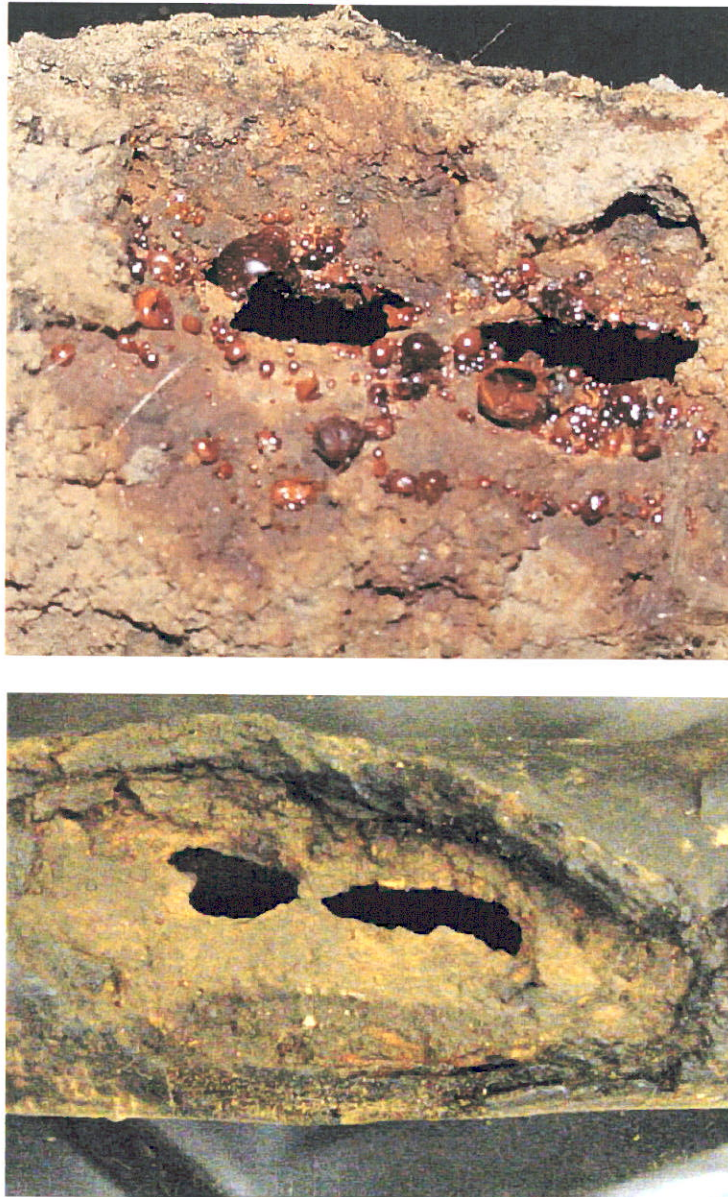
The evaluation has shown that the only through-wall penetration was contained within Segment 10 (the presumed leak site). The appearance of the leak site is documented in Figure 14.

Figure 14. The leak site in Segment 10. Top photo – as received condition with protective plastic enclosure removed; bottom photo – debris and surface deposits removed.

The examination of the morphology at corrosion sites, particularly in Segment 1 and Segment 10, suggests that the corrosion progressed from the external pipe and extended into the pipe wall. In the case of the leak site at Segment 10, the corrosion progress through the pipe wall.

- The leak on the gas service (Segment 10) occurred as a result of external corrosion⁹ that may have initiated at a coating holiday at the outside diameter (OD) surface.
- Internal corrosion¹⁰ at the inside diameter (ID) side at the leak site suggests that the leak may have existed for a period of time prior to the incident.
- There is no evidence to suggest that the ID corrosion contributed to the cause of the leak.
- The wall thickness of the pipe in the areas unaffected by corrosion was measured to be 0.113-inch.
- The external coating was found to be in good overall condition with some isolated holidays.
- Bacteria concentration in the analyzed deposits was low and suggests that microbially influenced corrosion was not a contributing factor.
- The composition and microstructure of the steel is typical for low strength (X52 grade and lower) carbon steel linepipe.

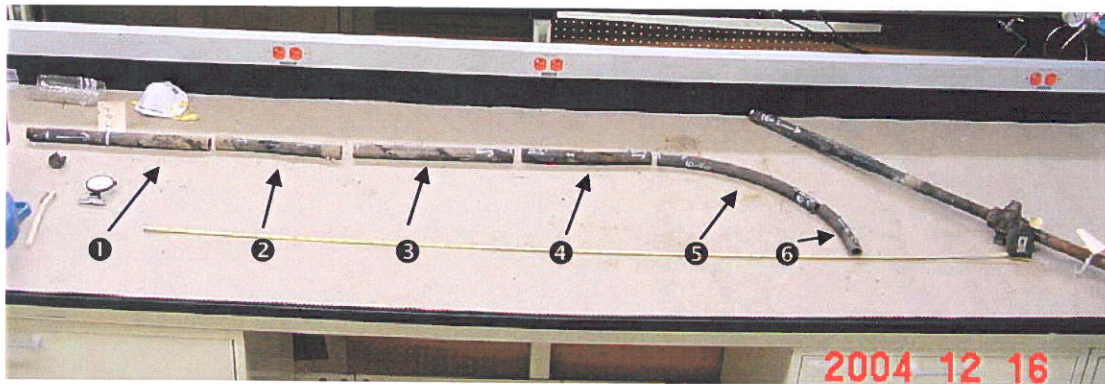
Figure 18. Photograph of Segment 10 showing how the Segment was sectioned; numbers indicate respective Samples. The leak site is in Sample 4.

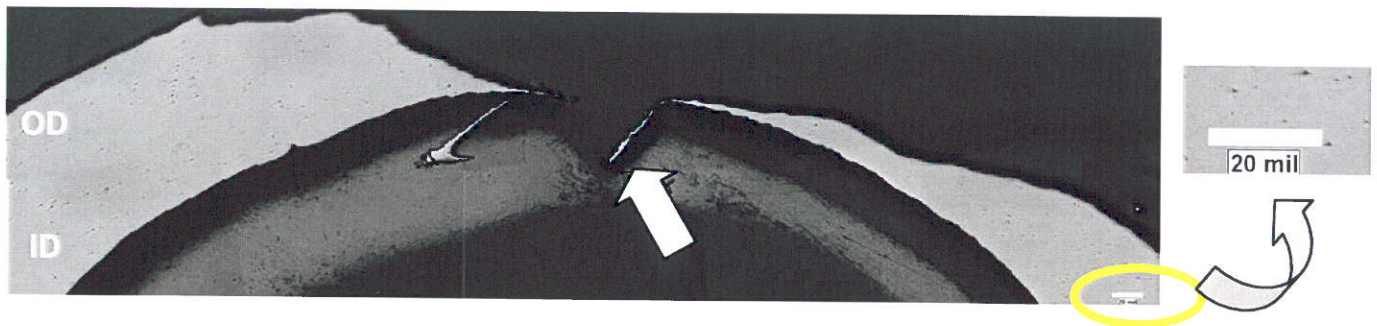
The cross-sectional view of corrosion site in Segment 1 is shown in Figure 21. As seen, there is little remaining wall thickness, and the thin remaining pipe wall ligament separated during the cutting.

Figure 21. Montage of light photomicrographs of the as-polished Mount 1-B in the area of wall loss. Note the small metal pipe wall ligament on the right (arrow).

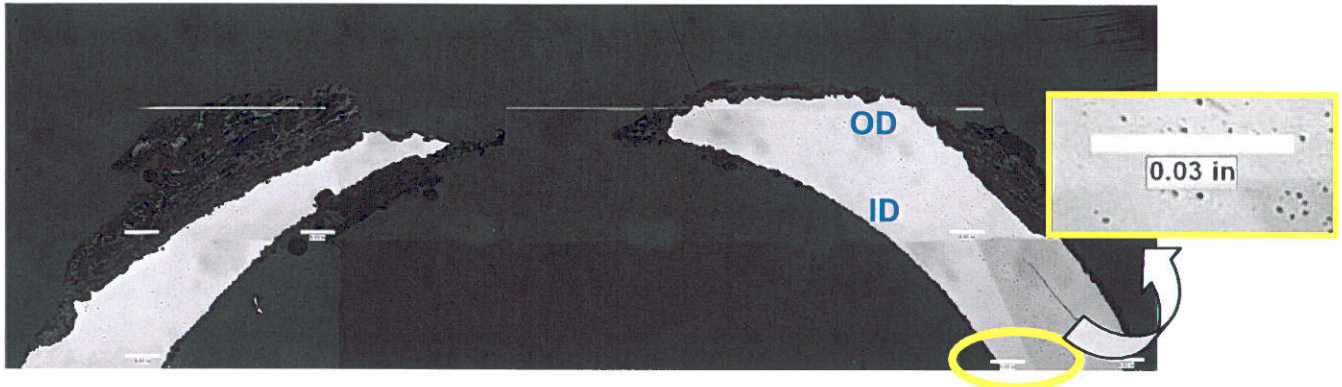
The appearance of the cross-sectional area from leak site (Segment 10), shown in Figure 22, is similar to that observed in Figure 21 (Segment 1). The metallographic observations corroborate the visual examination that the corrosion originated at the OD (outside diameter) pipe surface and progressed through the pipe wall thickness.

Figure 22. Montage of light photomicrographs of the as-polished Mount 10-4B in the area of the leak and wall loss.

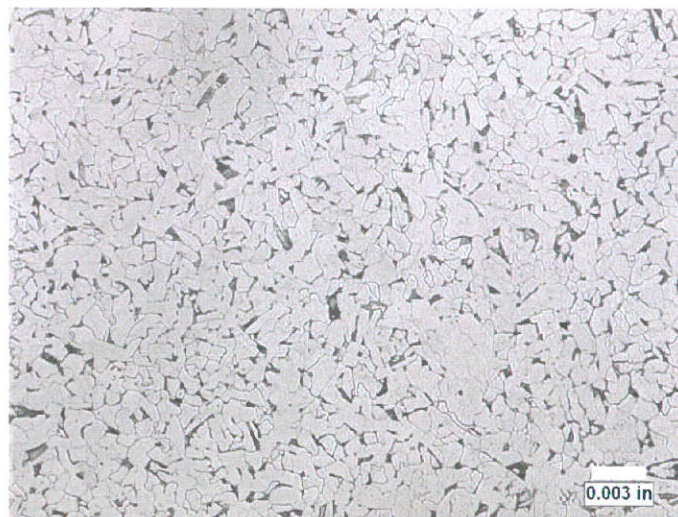
The photomicrographs below (Figure 23 and Figure 24) show examples of the steel microstructure after etching⁷. The microstructure is consistent with that of typical low-strength carbon steel; the primary constituents are mostly ferrite (light areas) and pearlite (dark areas).

Figure 23. Light photomicrograph of etched Mount 1-B of typical base metal microstructure taken at 100X.

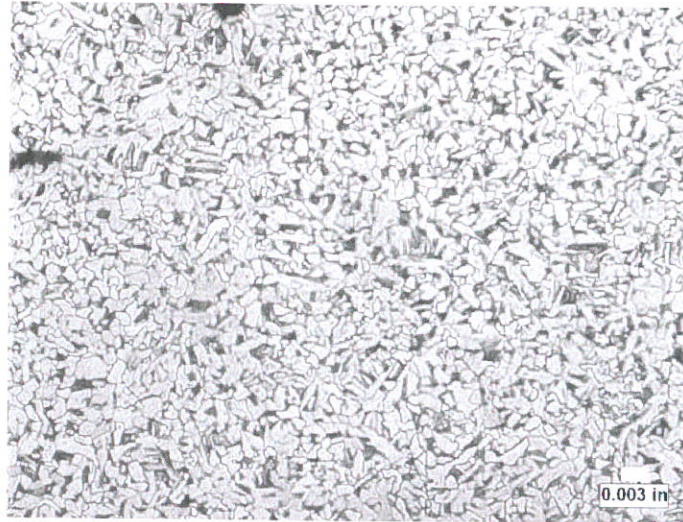
Figure 24. Light photomicrograph of etched Sample 9-B microstructure near maximum wall loss, taken at 100X.

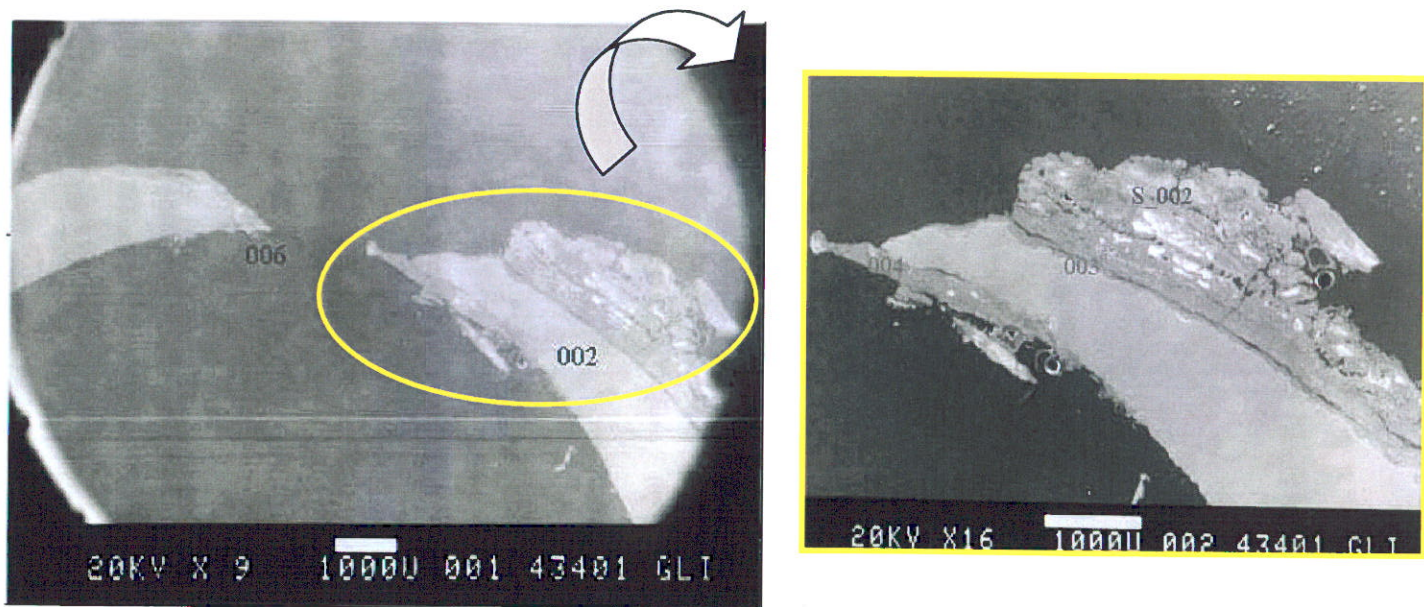
Figure 25. SEM photomicrograph of Mount 10-4B at leak site. Note deposits on OD and ID surfaces. S-002 EDS spectrum is shown in Figure 27.

Examination of Figure 25 and Figure 26 shows the presence of corrosion products on both the OD pipe surface and the ID pipe surface. Corrosion of this nature requires the presence of an electrolyte. The most plausible explanation for the ID corrosion is condensation near the leak location caused by local cooling of the steel wall due to the Joule-Thompson effect.

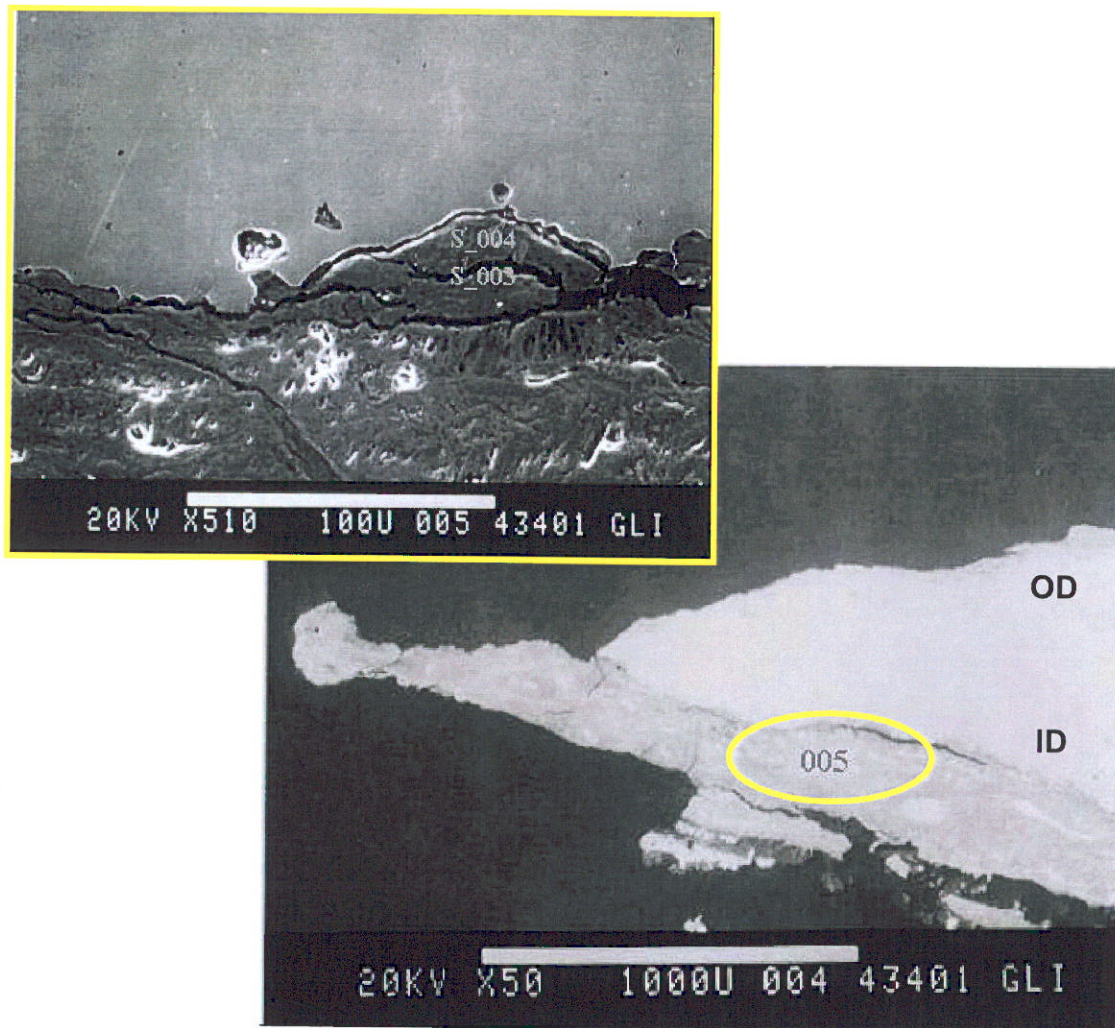
Figure 26. SEM photomicrograph of area marked “004” in inset in Figure 25; the encircled area of deposits at ID surface is shown at higher magnification in inset. S-003 spectrum is shown in Figure 28.

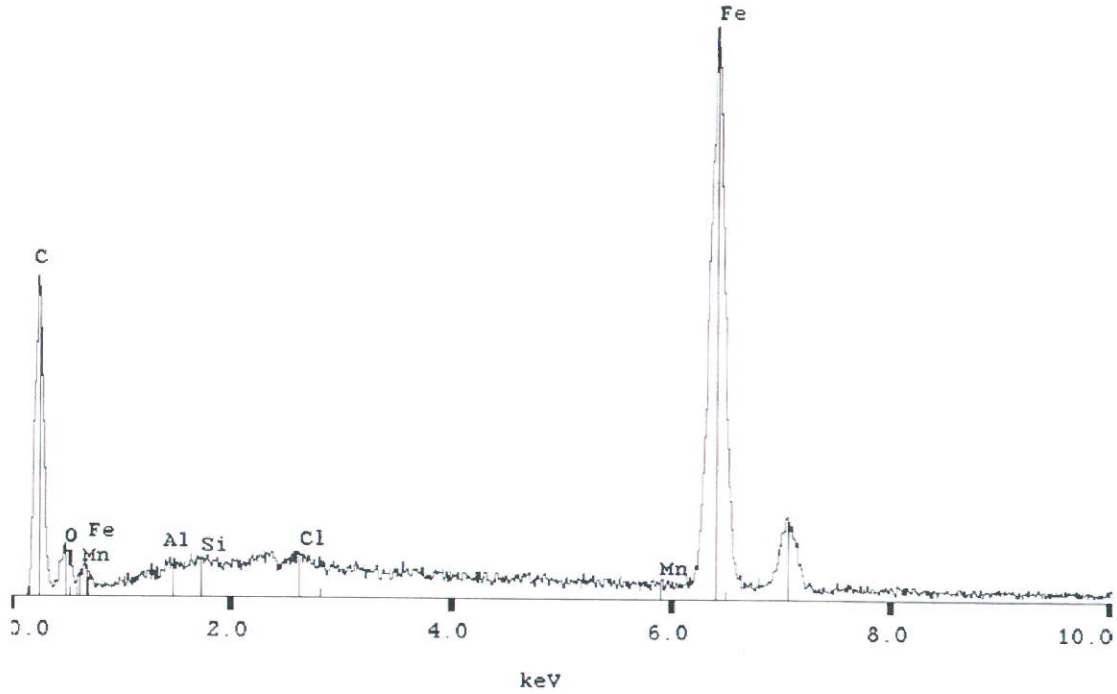
The EDS spectra from selected locations identified in the photomicrographs above are shown in Figure 27 and Figure 28⁸. The heights of the peaks are proportional to the concentration of the elements; however the results should be regarded as qualitative. The spectra are similar; the major element is iron (Fe), which corresponds to the composition of both the steel matrix and corrosion products. Another major peak is associated with carbon (C). The carbon peak may be associated with residual coal tar coating on the pipe surface. Other minor peaks are associated with the elements commonly found in soil (Al, Si, Cl).

Figure 27. EDS scan of Mount 10-4B at spot S-002 (OD surface deposits) in inset in Figure 25.

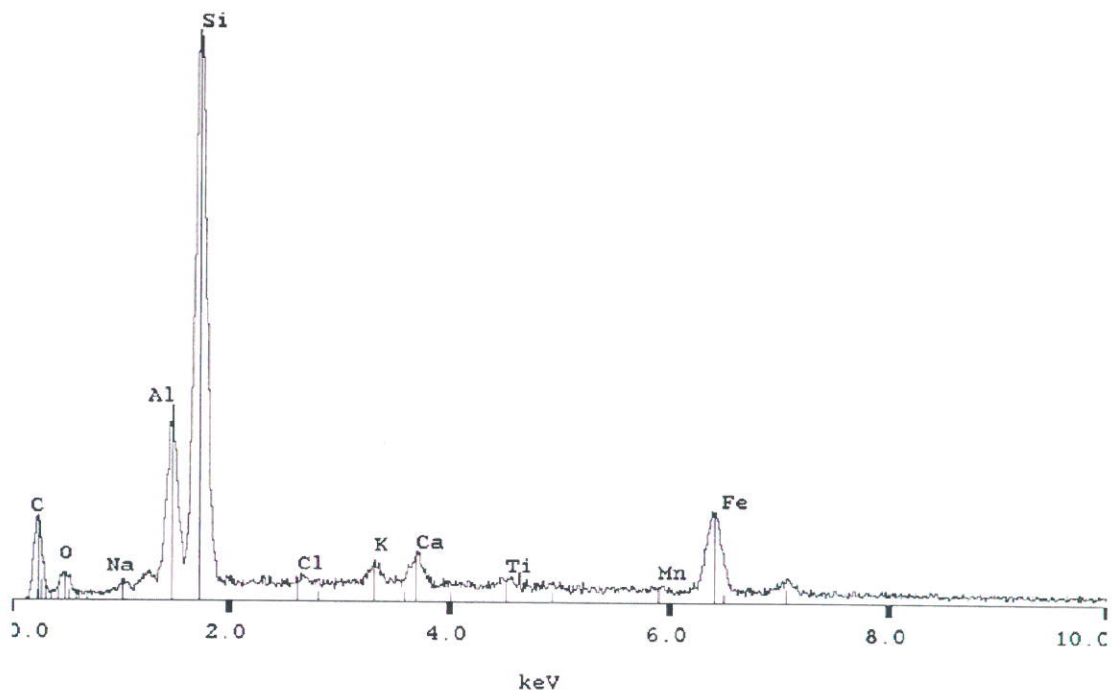
These elements (Al and Si) are present as the major elements identified in the EDS spectra obtained from the loose soil collected from the plastic protector covering the leak site in Segment 10 (see Figure 29).

Figure 29. EDS scan of loose soil collected from the plastic protector covering leak area in Segment 10

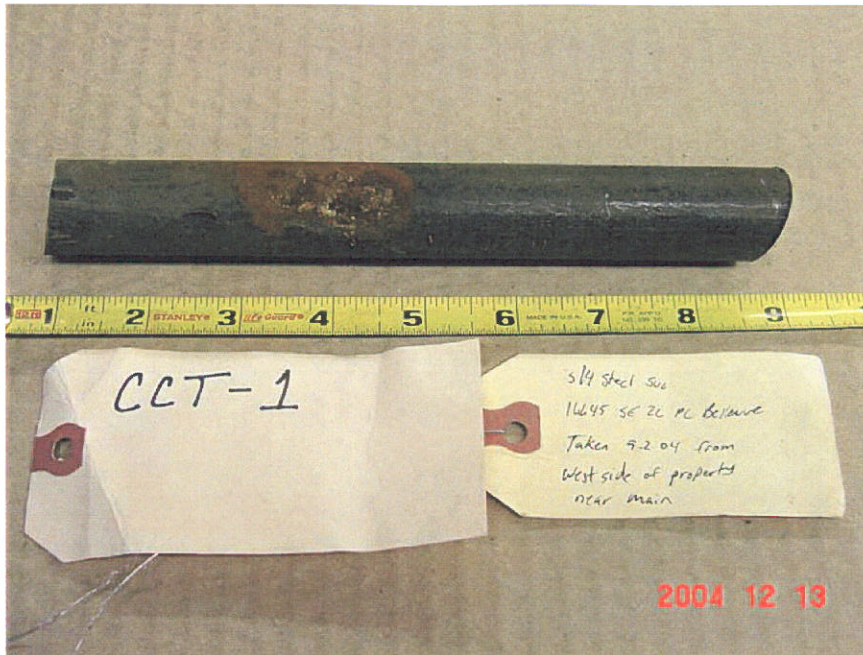
Figure 1. Photograph of Segment 01 showing the pipe as-received had little remaining coating.

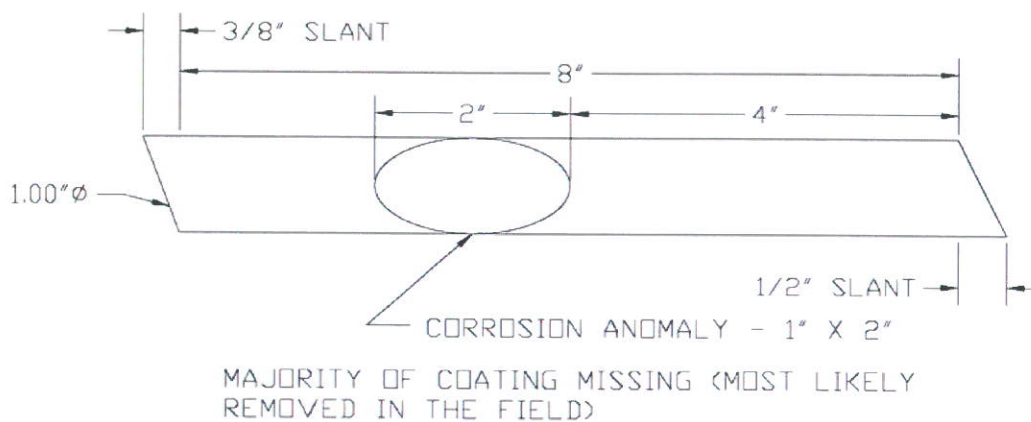
Figure 1. CAD schematic of Segment 1 showing a corrosion anomaly the majority of the coating was missing.

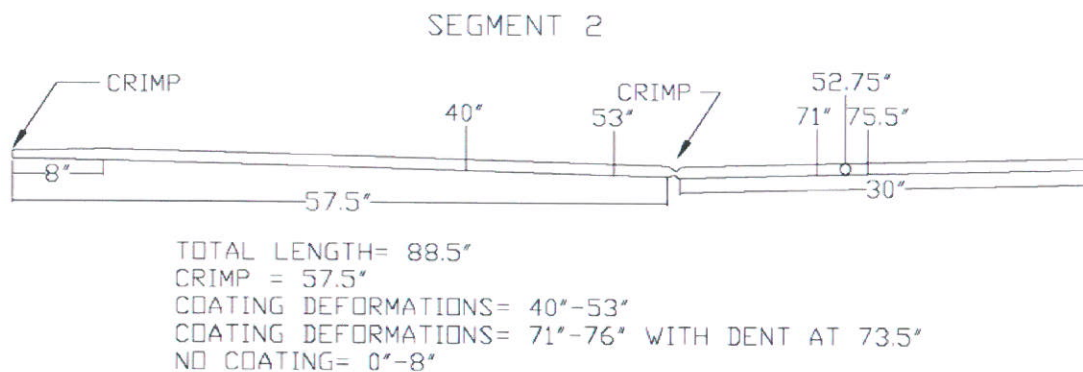
Figure 2. .CAD schematic of Segment 2 showing the locations of coating deformations.

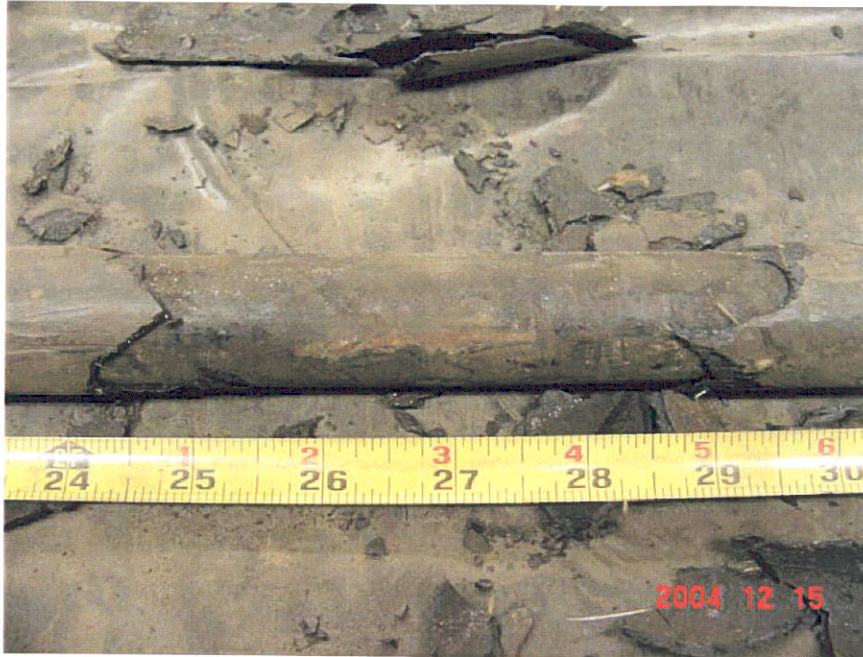
Figure 7. Photograph of Segment 7 after removal of a portion of the coating showing no corrosion under the gouge in the coating to bare pipe that was located at the 26-inch location.

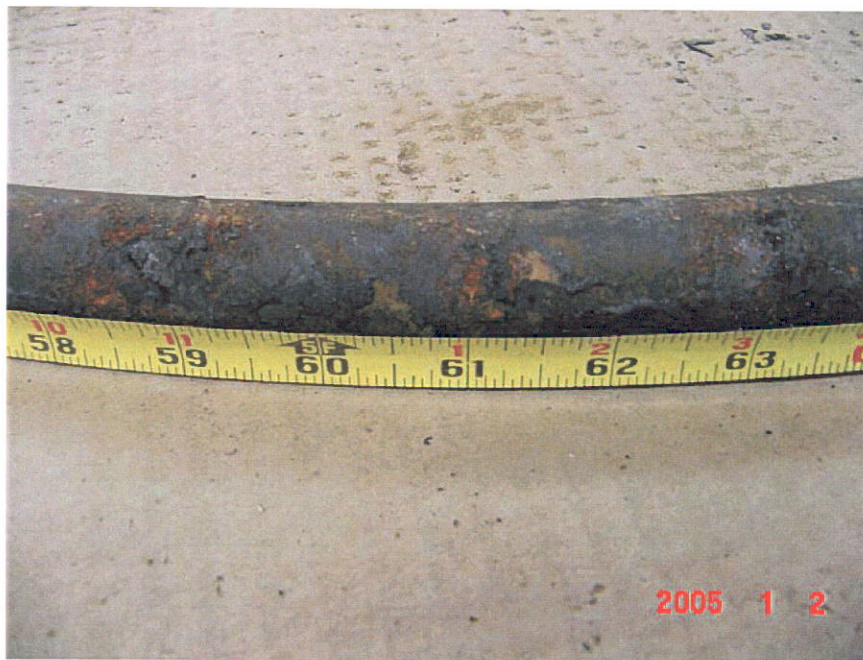
Figure 16. Photograph of Segment 10 after a portion of the coating was removed showing the corrosion colored product that was present on the extrados of the bend in the pipe.

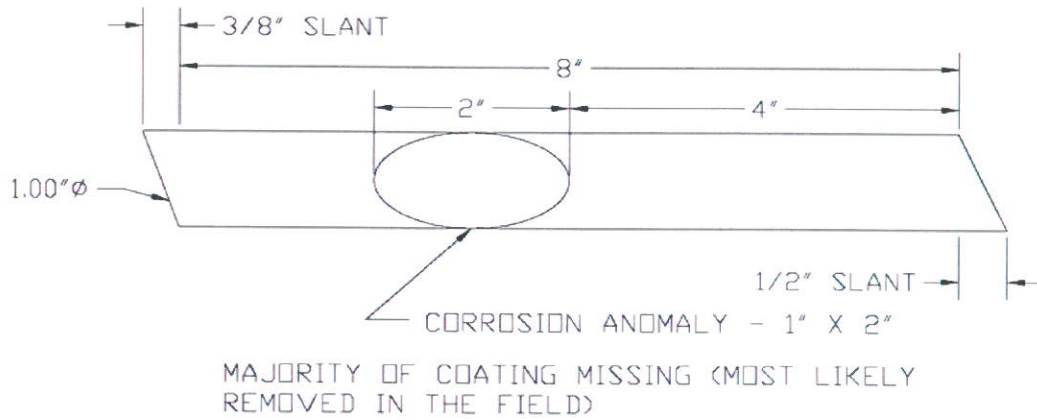
Figure 1. CAD schematic of Segment 1 a 1-inch by 2-inch corrosion anomaly.

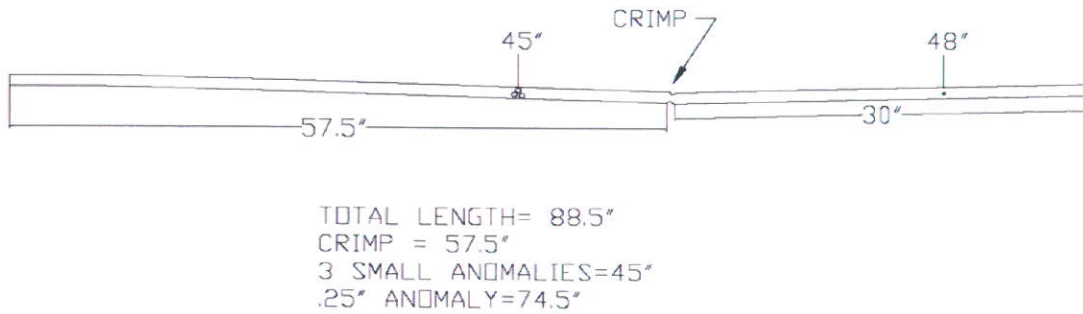
Figure 2. CAD schematic of Segment 2 showing 3 small anomalies after coating removal.

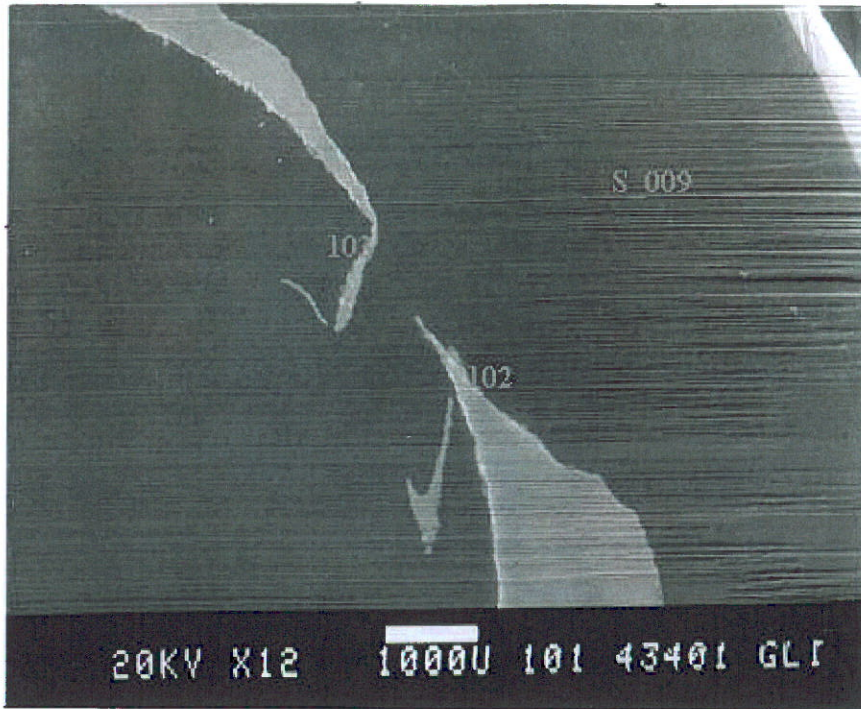
Figure 1. SEM photomicrograph 101 of Mount 1-B showing corrosion attack and the location of additional photomicrographs, 102 and 103, and EDS scan S-009.
