**SECOND EXHIBIT TO THE PREFILED DIRECT TESTIMONY OF
KEVIN C. GARRITY (NONCONFIDENTIAL)
ON BEHALF OF PUGET SOUND ENERGY, INC.**

FINAL REPORT

**LABORATORY-BASED EVALUATION OF FAILED SERVICE LINE
BELLEVUE, WASHINGTON**

PREPARED BY
CC TECHNOLOGIES LABORATORIES, INC.

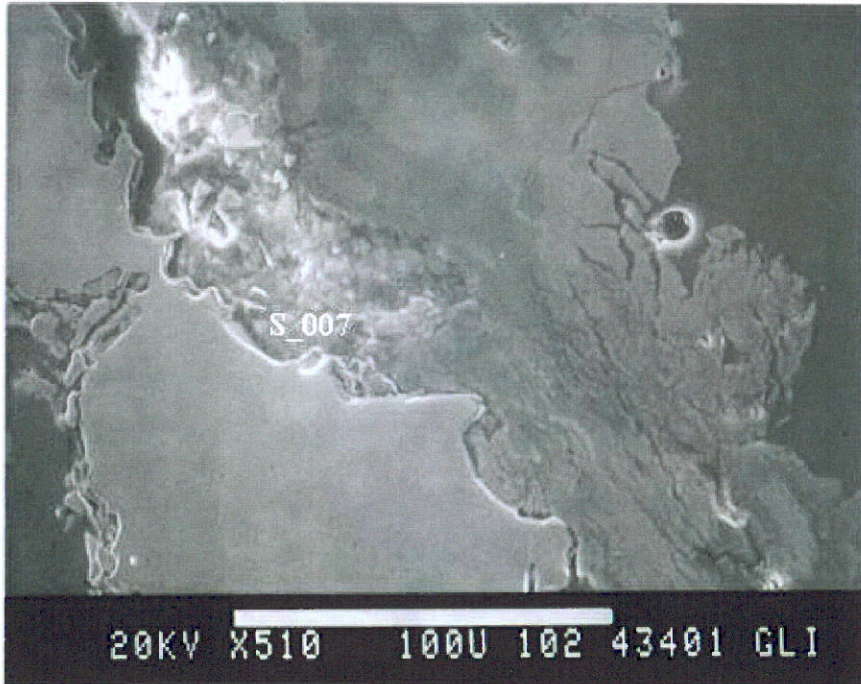
Figure 2. SEM photomicrograph 102 of Mount 1-B near the maximum wall loss showing debris on the OD surface and the location of the EDS scan S-007.
