**FOURTH EXHIBIT TO THE PREFILED DIRECT TESTIMONY OF
KEVIN C. GARRITY (NONCONFIDENTIAL)
ON BEHALF OF PUGET SOUND ENERGY, INC.**

**SUMMARY REPORT - FAILED SERVICE LINE
BELLEVUE, WASHINGTON**

PREPARED BY
CC TECHNOLOGIES SERVICES, INC.
KEVIN C. GARRITY, P.E.
KURT LAWSON

FEBRUARY 28, 2005

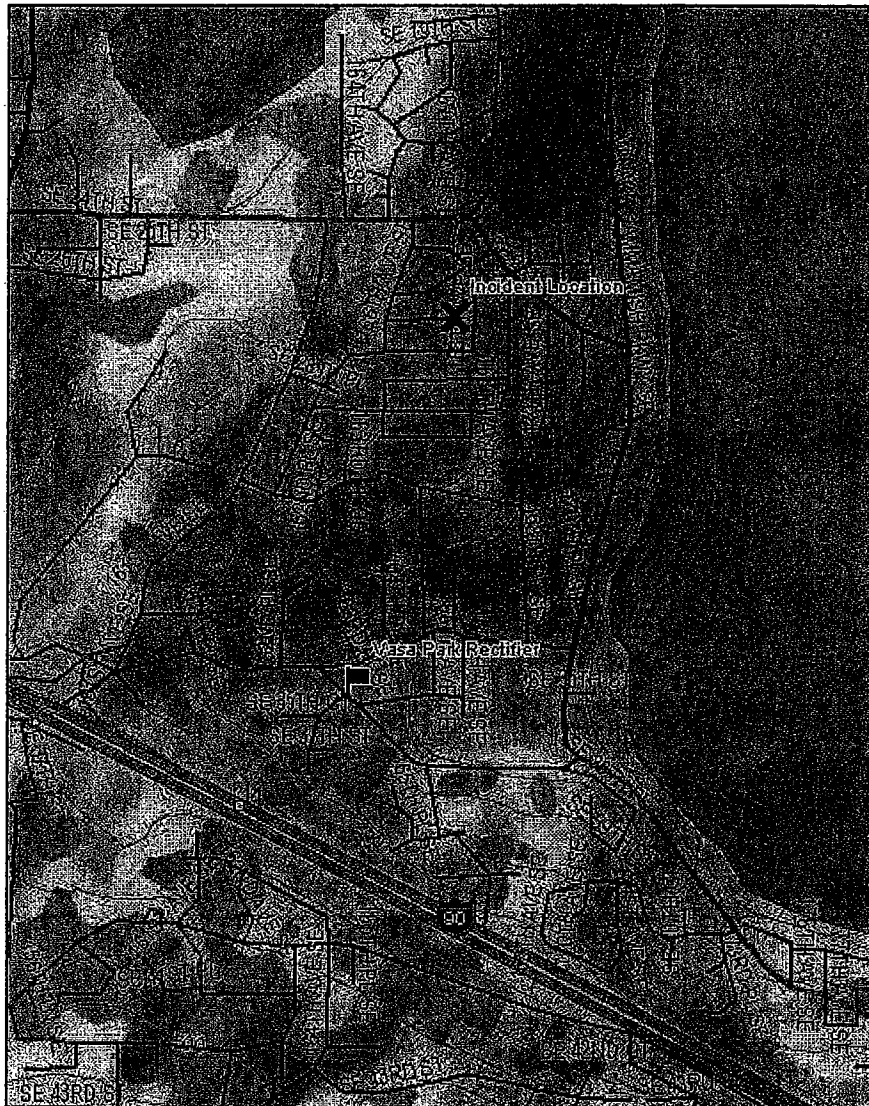
Cathodic protection was applied to the gas mains in the vicinity of the incident during the early 1980's. The coated and wrapped steel service was installed with no dielectric union at the tie-in to the main. The service therefore, was cathodically protected via the CP sources protecting the main. The predominant CP current source in the vicinity of the Spirit Ridge subdivision is located at SE 43rd Street and 164th Place SE and has been referred to as the Vasa Park rectifier. Figure 3 shows the relative location of the incident and the influencing rectifier. The rectifier is situated approximately 3,240 feet from the incident site. Documents reviewed indicate that this

rectifier and ground bed were installed in March 1982. It is reported that supplemental magnesium sacrificial anodes have been installed at various locations during the normal course of pipe excavations and service installations.

Figure 3. Map depicting Incident location and influencing rectifier.

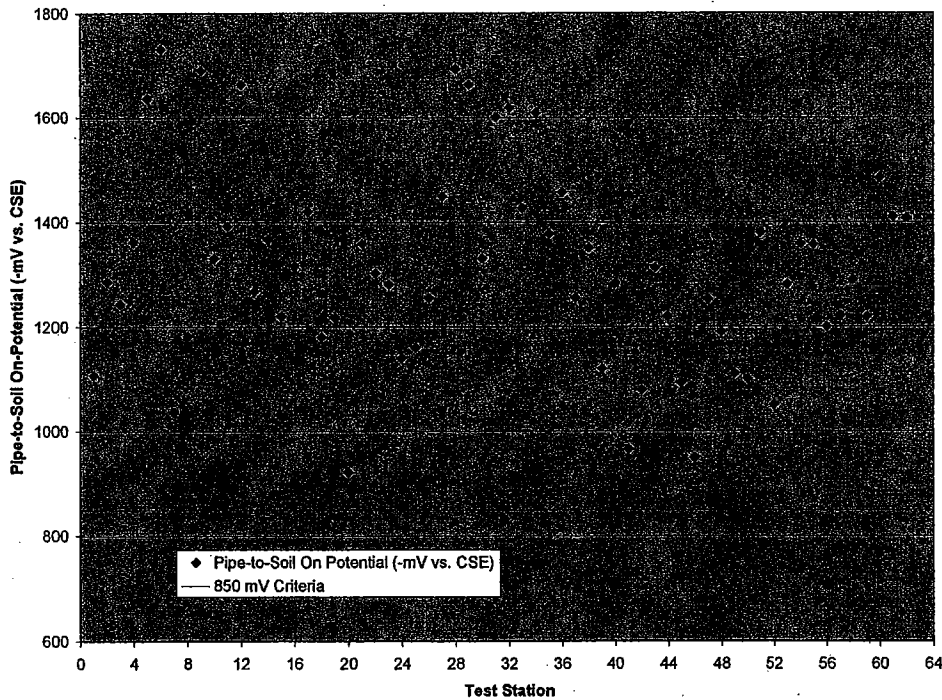
In the summer and fall of 2003 an annual cathodic protection survey was conducted in the Spirit Ridge area. Over sixty test points were investigated in the Spirit Ridge vicinity during the survey. The results of that survey are summarized in Table 1 below and shown graphically in Figure 4. Test stations highlighted in yellow lie directly in the Spirit Ridge area plats. The data indicate that throughout this area of the system at the time of these tests the CP system was operating at a level sufficient to meet the industry recognized criteria for effective CP in the Spirit Ridge area (See Appendix B for CP criteria listed in 49 CFR Part 192).

Figure 4. Pipe-to-soil potentials from the 2003 annual survey of the Spirit Ridge area.

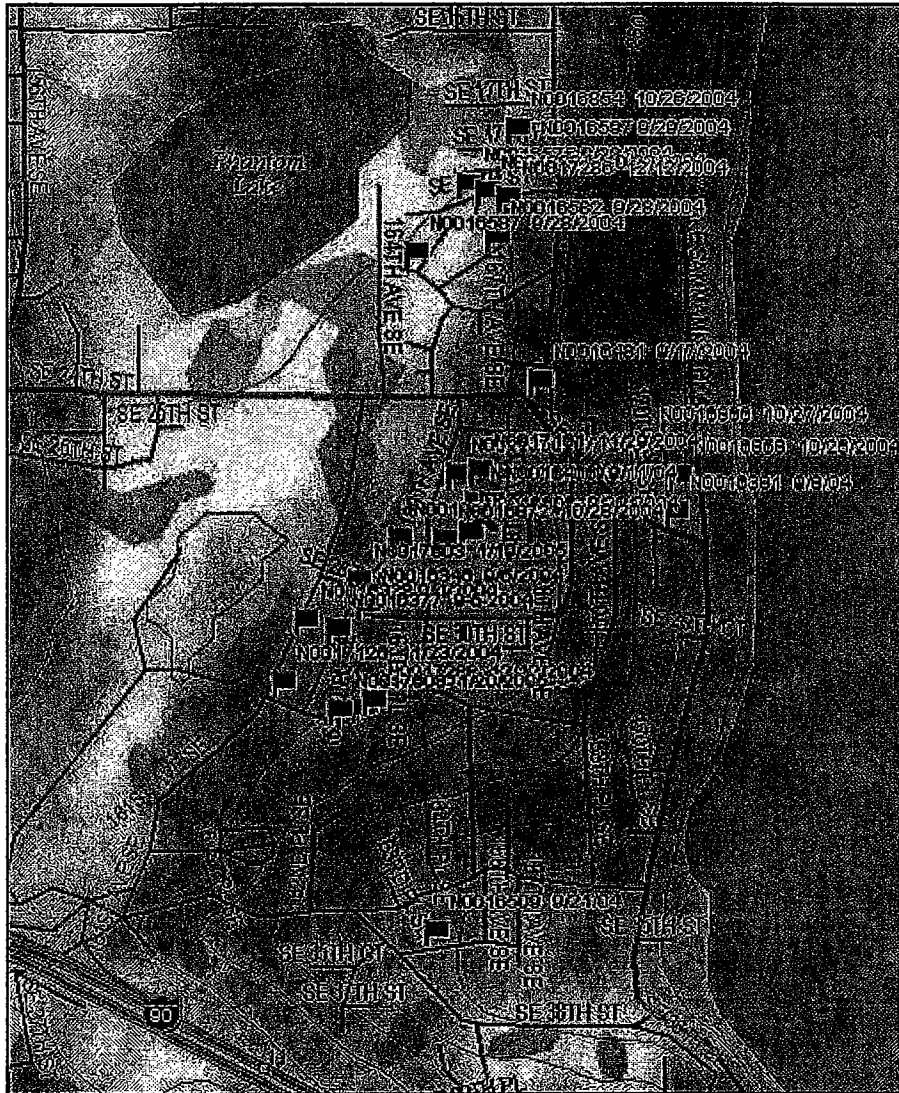
As the leak surveys continued during the months of September and October 2004, an increase in leaks was observed on the portion of the system connected to the Vasa Park rectifier. As of January 25, 2005, a total of 23 additional external corrosion leaks have been detected during this investigative program in the Spirit Ridge neighborhood. Figure 5 below shows the approximate location of these leaks within the Spirit Ridge area. To alleviate the public's concerns over the safety of the system, PSE officials decided in November to replace all of the steel mains and services.

Figure 5. Approximate locations of identified leaks in the Spirit Ridge Vicinity.
