Docket No. PG-041624

**SIXTH EXHIBIT TO THE PREFILED DIRECT TESTIMONY OF
KEVIN C. GARRITY (NONCONFIDENTIAL)
ON BEHALF OF PUGET SOUND ENERGY, INC.**

June 15, 2005

RE: Puget Sound Energy, Spirit Ridge – Summary of Field Inspection of Seventy-five (75) and Metallurgical Analysis of Six (6) Service Risers – Spirit Ridge Subdivision (F4434-01G)

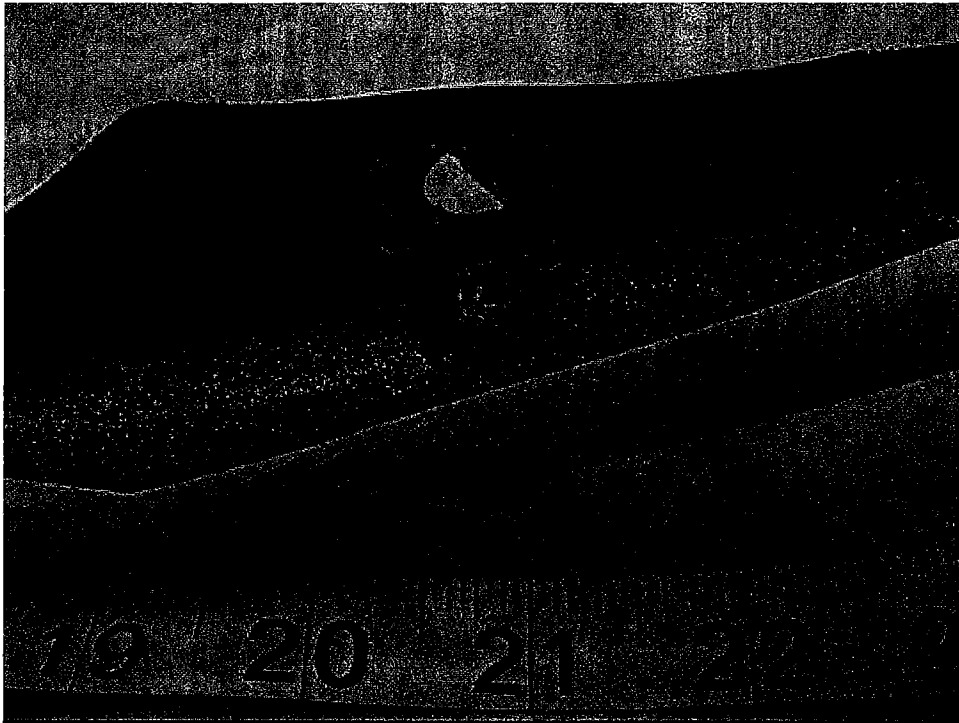
The visual inspection of the as-received pipe revealed two gouges in the extruded polyethylene coating located at 5.5-inches downstream and 21-inches downstream. The gouges were located upstream of the bend and on the downstream portion of the bend, respectively. After removing the coating, a pit approximately 0.4-inches in diameter was visible under the gouge at 21-inches. There was only minor surface corrosion located under the gouge at 5.5-inches and the rest of the pipe appeared to be free of corrosion product. Figure 1 is a photograph showing both the gouge in the coating and the pit in the pipe located at 21-inches.

Figure 1. Photograph showing the pipe after removing the coating around the gouge that was located 21-inches from the upstream end of the pipe.

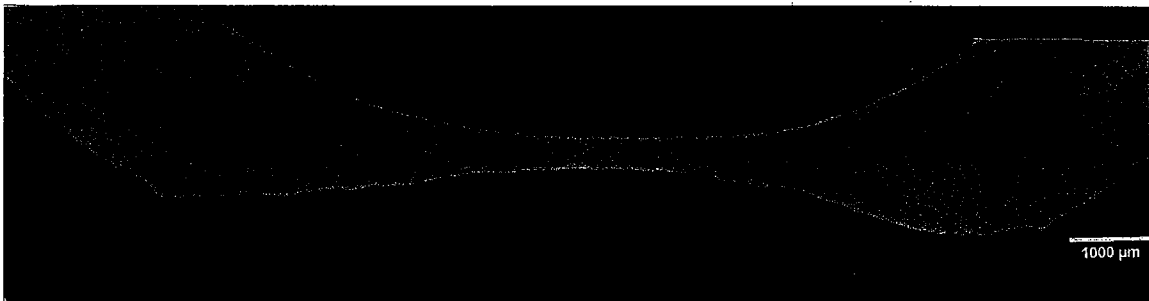
A metallographic cross-section through the deepest portion of the pit was mounted and polished. Figure 2 is a light photomicrograph of the polished sample showing the morphology of the pit. The pit was approximately 83-mils deep, which corresponds to an 81% wall penetration. The pipe was 0.5-inches in diameter and had a wall thickness of approximately 0.105-inches.

Figure 2. Light photomicrograph of the pit located at 21-inches.

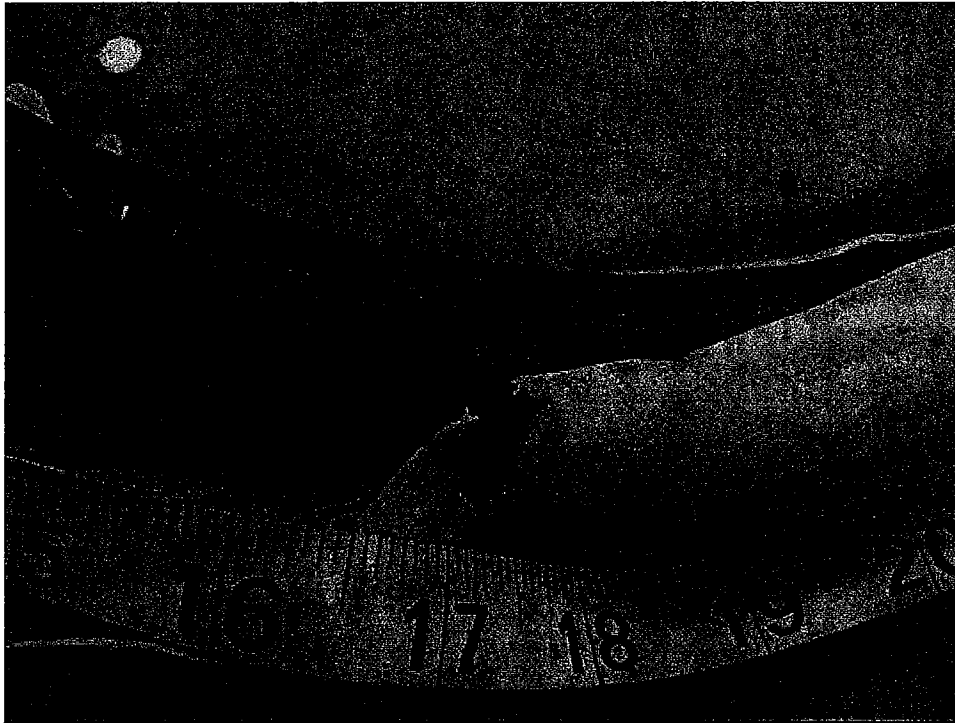
The visual inspection of the as-received pipe revealed four gouges in the extruded polyethylene coating located at 16-inches downstream, 17-inches downstream, 20.5-inches downstream, and 39.5-inches downstream. All four gouges were located either on the upstream or downstream portion of the bend. After removing the coating, a pit approximately 0.4-inches in diameter was visible under the gouge in the coating located at 17-inches. There was only minor surface corrosion located beneath the other three gouges and the rest of the pipe appeared to be free of corrosion product. Figure 3 is a photograph showing both the gouge in the coating and the pit in the pipe located at 17-inches.

Figure 3. Photograph showing the pipe after removing the coating around the gouge located 17-inches from the upstream end of the pipe.

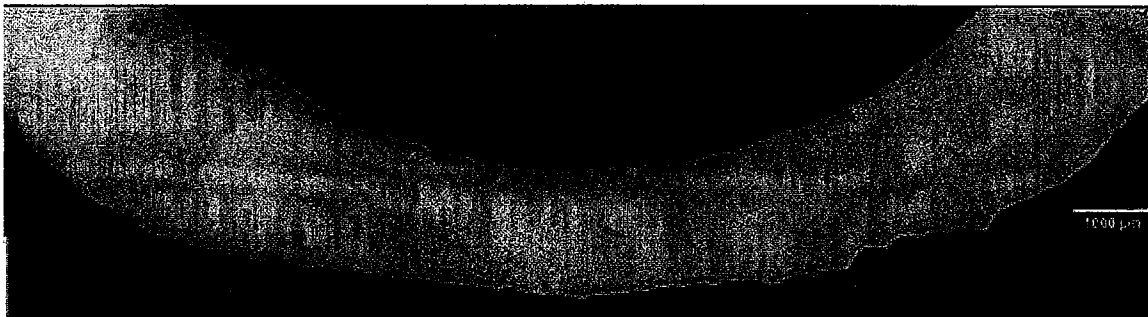
A metallographic cross-section through the deepest portion of the pit was mounted and polished. Figure 4 is a light photomicrograph of the polished sample showing the morphology of the pit. The pit was approximately 41-mils deep, which corresponds to a 39% wall penetration. The pipe was 0.5-inches in diameter and had a wall thickness of approximately 0.105-inches.

Figure 4. Light photomicrograph of the pit located at 16-inches.

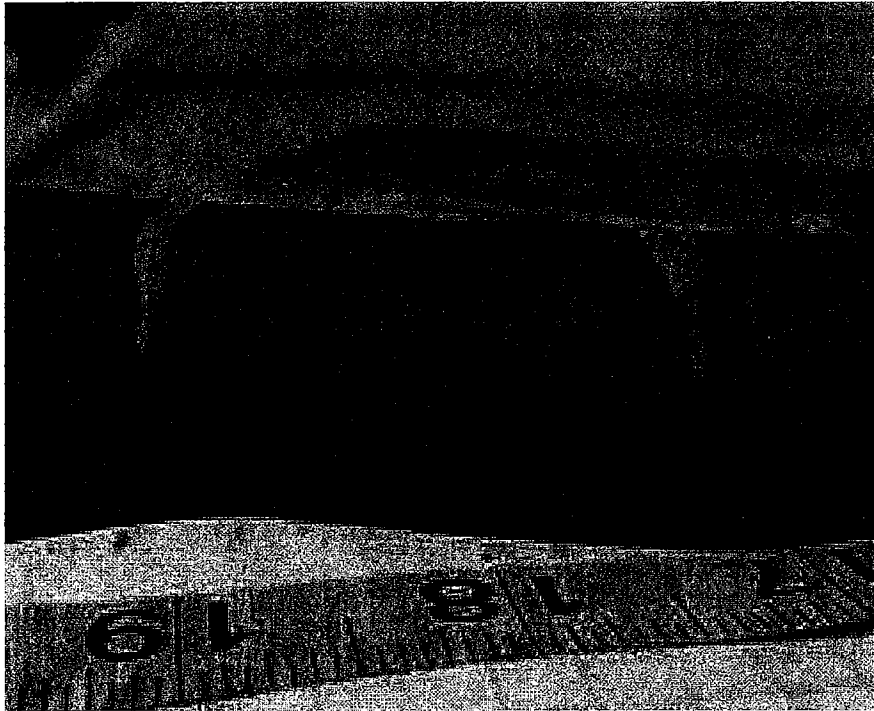
The visual inspection of the as-received pipe revealed 5 anomalies in the coal tar coating. There was a holiday in the coating located at 1.5-inches downstream and cracked/missing coating located at 18.5-inches, 22.5-inches, 24-inches and 26-inches downstream. The holiday was located on the upstream of the bend while the cracked/missing coating was located either on the upstream or downstream portion of the bend. After removing the coating, a pit approximately 0.2-inches in diameter and another small pit were visible under the cracked/missing coating located at 18.5-inches. There was only minor surface corrosion located beneath the other three gouges and the rest of the pipe appeared to be free of corrosion product. Figure 5 is a photograph showing the two small pits at 18.5-inches that were visible after removing the coating.

Figure 5. Photograph of the two pits located at 18.5-inches downstream.

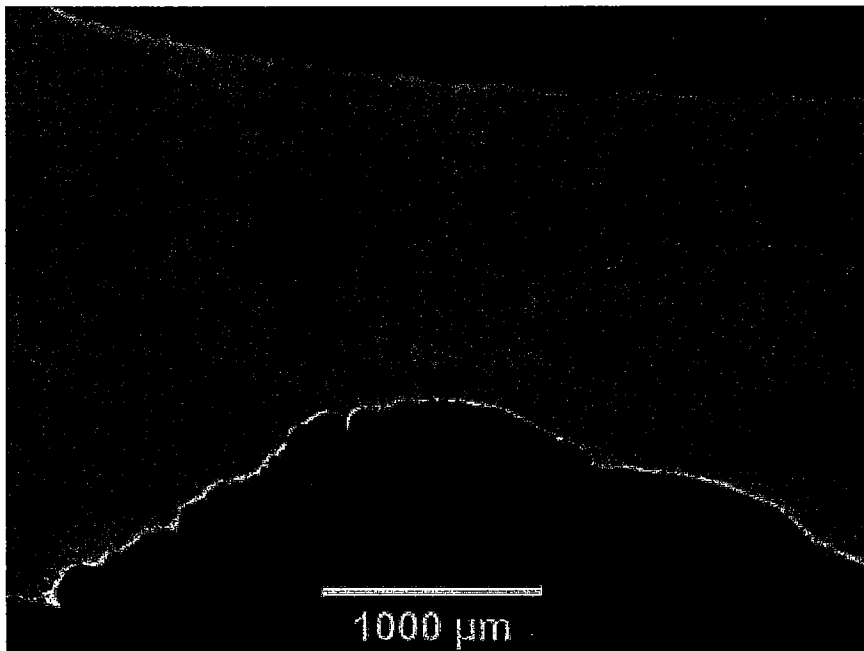
A metallographic cross-section through the deepest portion of the pit located at 22.5-inches and the largest pit at 31.5-inches downstream were mounted and polished. Figure 6 is a light photomicrograph of the pit located at 31.5-inches showing the morphology of the pit. The pit was approximately 51-mils deep, which corresponds to a 46% wall penetration. The pit located at 22.5-inches had a maximum pit depth of 31-mils corresponding to a wall penetration of 27%. The pipe was 0.75-inches in diameter and had a wall thickness of approximately 0.115-inches.

Figure 8. Light photomicrograph of the pit located at 31.5-inches downstream.

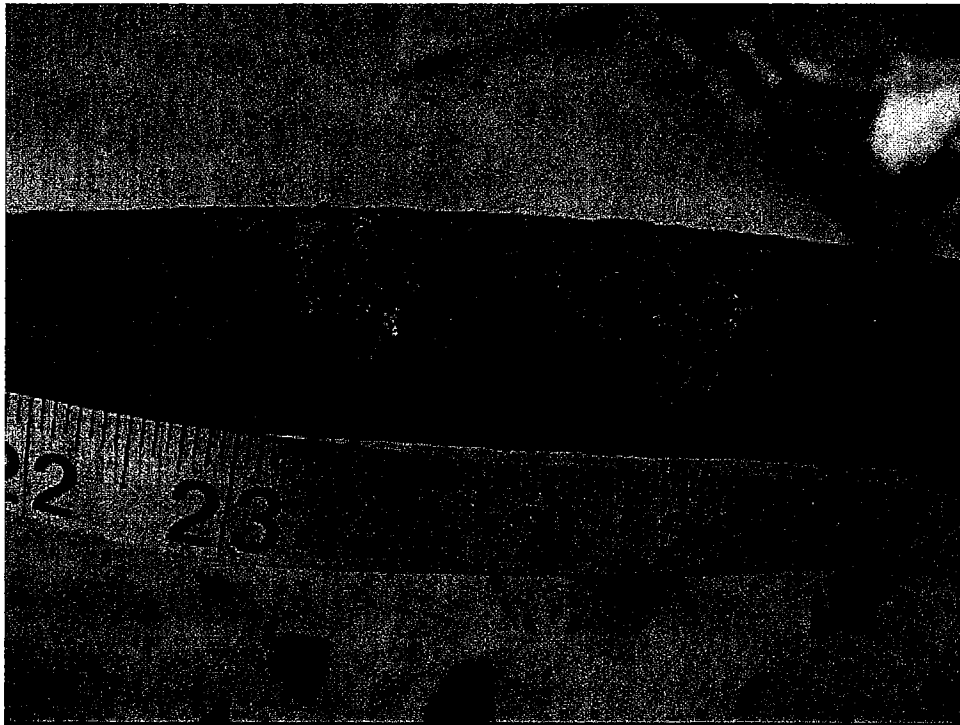
The visual inspection of the as-received pipe revealed three coating faults in the coal tar coating. There were two areas of missing coating located at 7-inches downstream and between 14-inches and 18-inches downstream. There was transverse cracking in the coating located between 21-inches and 27-inches downstream. The missing coating at 7-inches was located upstream of the bend while the other faults were located on the bend. After removing the coating, there were no visible areas of pitting. There were areas of corrosion beneath the cracking and beneath the missing coating. The rest of the pipe appeared to be free of corrosion product. Figure 9 is a photograph showing the corrosion product that was present between 22-inches and 26-inches.

Figure 9. Photograph showing corrosion product after the coating was removed located between 23 and 26" from the upstream end of the pipe.

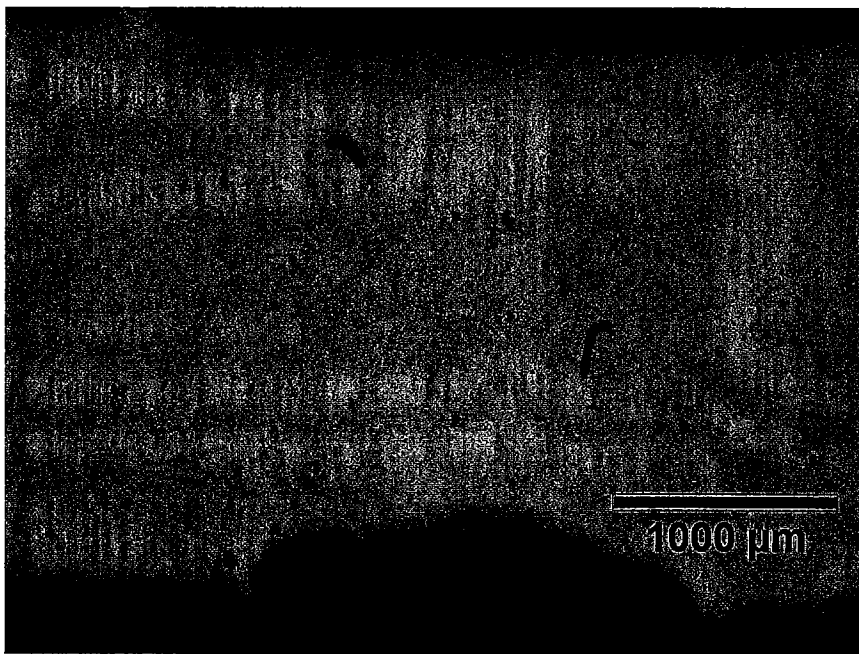
Two metallographic cross-sections through the corrosion product were taken at 16-inches and 25.5-inches downstream. After cutting, a small pit was visible in the mount at 25.5-inches. Figure 10 is a light photomicrograph of the polished sample showing the morphology of the pit. The pit was approximately 29-mils deep, which corresponds to a 26% wall penetration. The pipe was 0.75-inches in diameter and had a wall thickness of approximately 0.115-inches.

Figure 10. Light photomicrograph of the pit located at 25.5-inches downstream.
