Re: June 2020 Monthly Progress Report
Administrative Settlement Agreement and Order on Consent for Removal Action
EPA Region 10 Docket No. CERCLA 10-2009-0255
Gasco Sediments Site within the Portland Harbor Superfund Site

Attachment A Monthly Visual Monitoring Report for Pilot Cap Vicinity

Project: NW Natural – Gasco

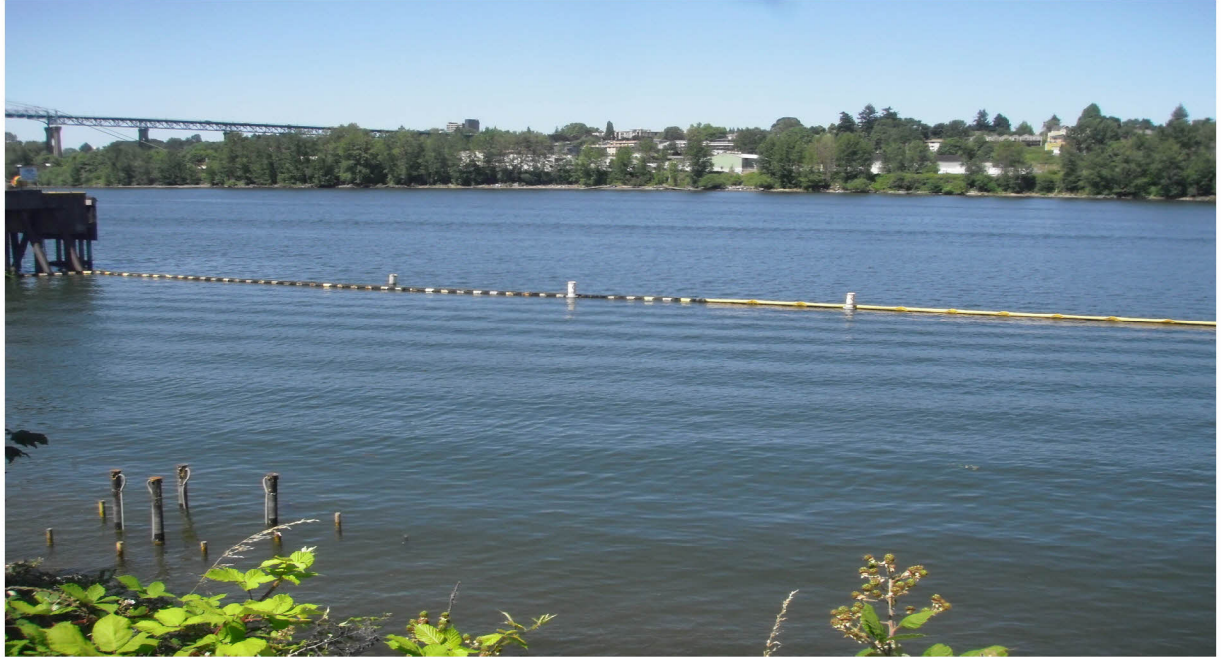
During the observation, the PacTerm containment boom was in place, as normal, from dock to dolphin. The three buoys identifying the cap area to mariners were in place as installed. The positions of the PacTerm oil boom and warning buoys are shown in Photo 1.

Photo 1
PacTerm Oil Boom Placement from Dock to Dolphin with Three Mariner Warning Buoys at Pilot Cap Area (6/26/2020)

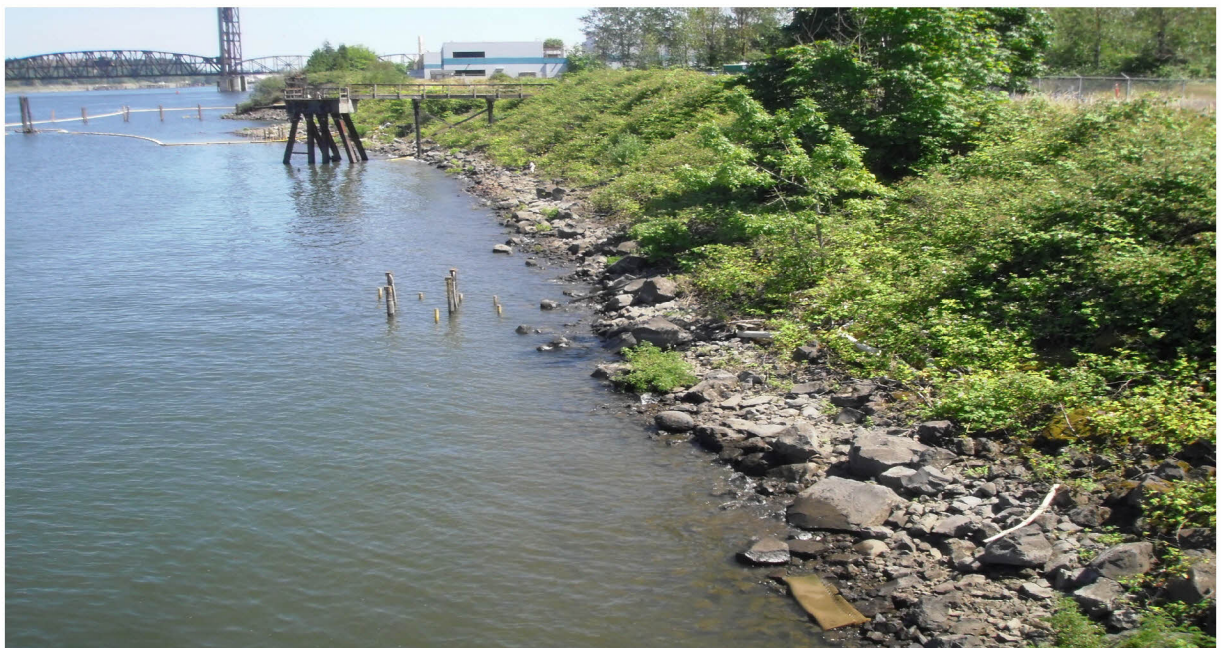
Previously exposed organoclay mat material segments were not visible due to high river water elevations (Photo 2).

Photo 2
Mat Material Not Visible Due to High River Water Elevation (6/26/2020)

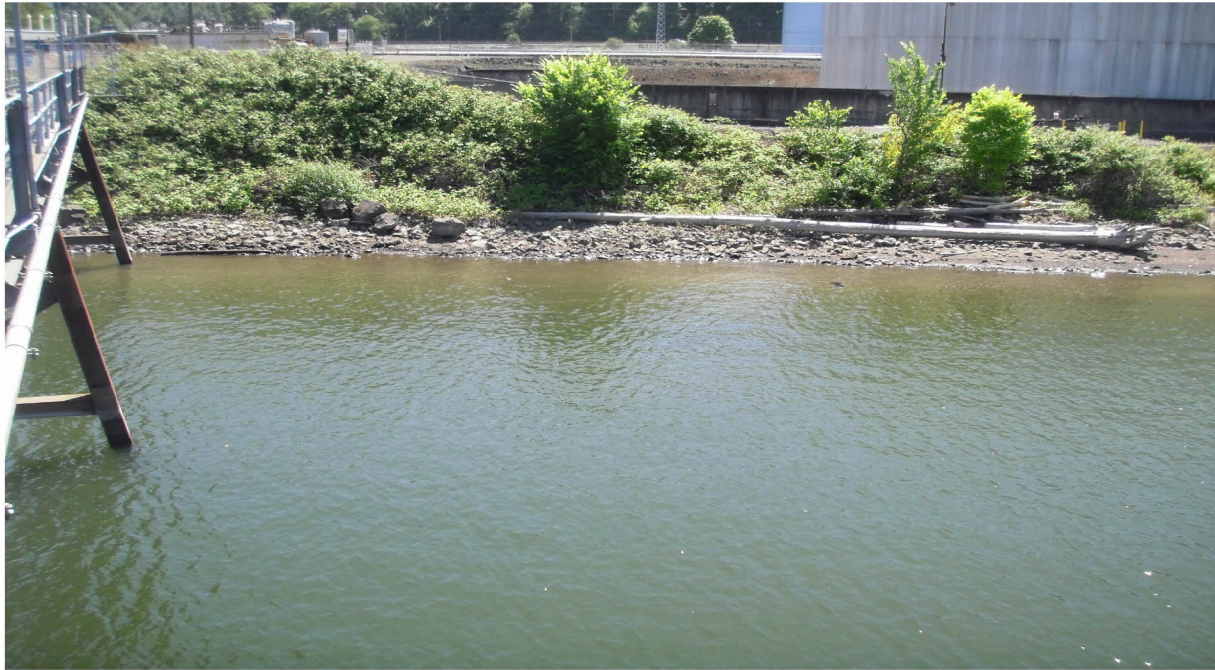
No sheen was observed. Photo 3 shows the water surface and shoreline immediately downriver of the sediment cap.

Photo 3
Conditions Immediately Downriver of Cap Area (6/26/2020)
