EXH. HLR-3

## Protocol for Managing Select Aldyl A Pipe in Avista Utilities' Natural Gas System

May 2013

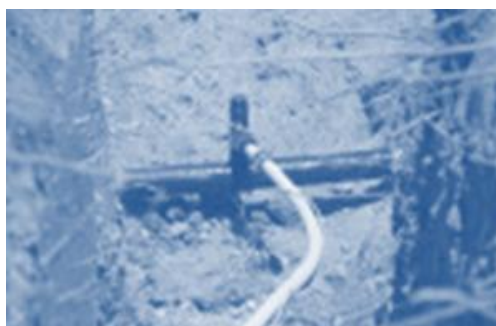
The third most-common failure in Avista's sample occurred where small diameter Aldyl A service pipe is tapped from steel main pipe. In this application, a steel service tee is welded to the steel main pipe and the small-diameter Aldyl A service pipe is then connected to a mechanical transition fitting on the tee, as pictured below in Figure 4.

*Figure 4. Typical polyethylene service tapped from a steel main.*

It is at this transition point, between the rigid steel fitting and the more-flexible Aldyl A service pipe, that brittle-like cracking has been observed. This failure mode in older plastic pipe is well understood, and was one of the three study objectives reported by the

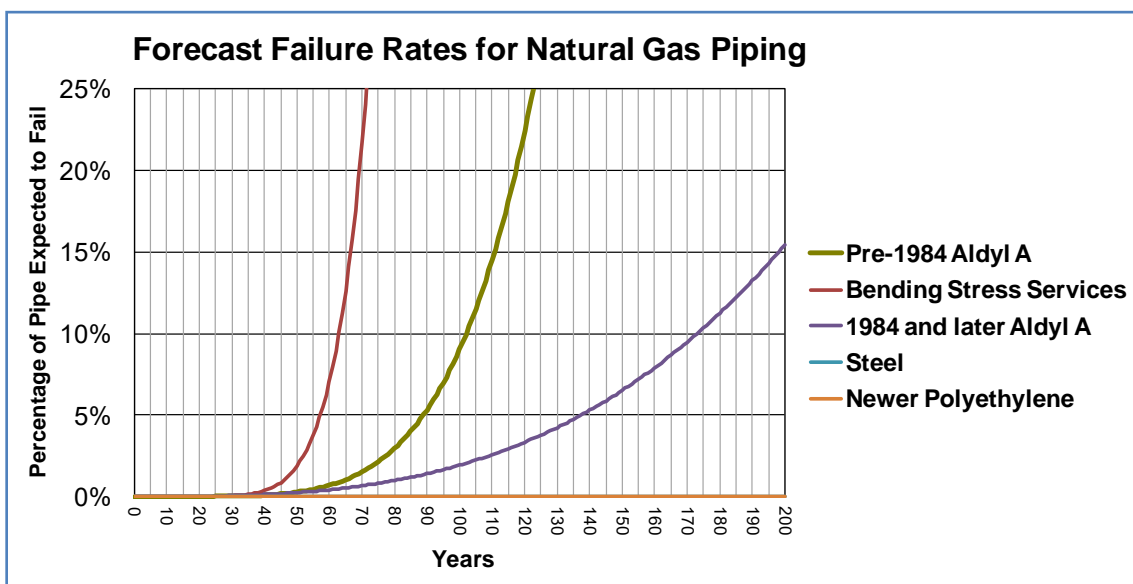
Results of the forecast modeling, for the pipe classes evaluated, are represented as ‘curves’ showing the percentage of the amount of each pipe class that is projected to fail in each year of the forecast time period. The resulting reliability curves are shown in the graph below in Figure 5.

Figure 5. The expected failure rates for several classes of pipe in Avista’s system, as forecast by Availability Workbench Modeling. The “Steel” curve is obscured by the “Newer Polyethylene” curve, both of which are essentially flat lines.

The failure curves show dramatic differences in the expected life for the pipe classes evaluated. The difference in expected life between the Aldyl A products as a group, compared with that of steel and newer-generation plastic pipe, is particularly evident. Striking also, are the expected performance differences among the classes of Aldyl A pipe evaluated, providing some clear trends useful in designing remediation strategies.

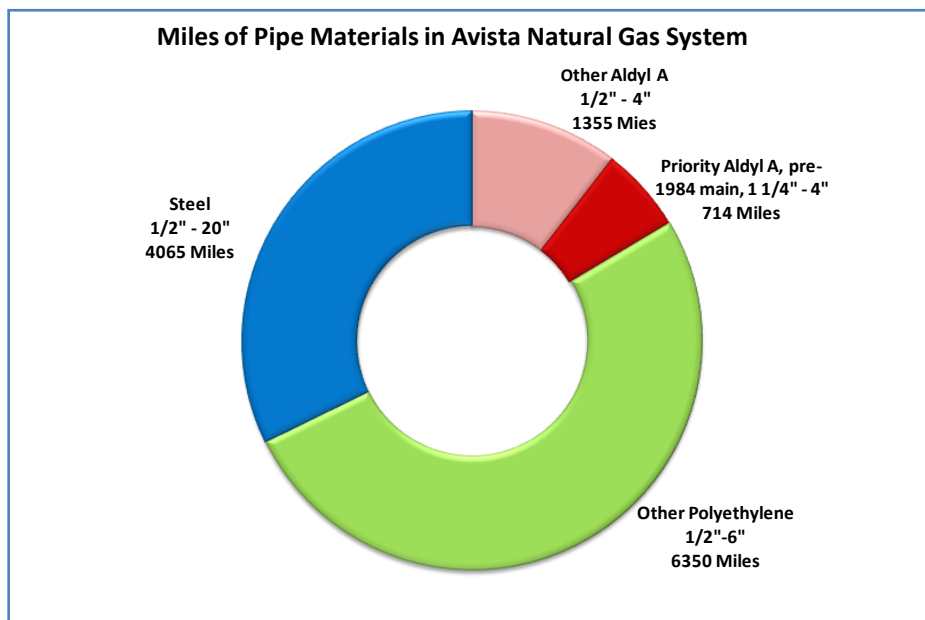
**Main Pipe** - Avista has approximately 12,500 miles of natural gas main pipe in its service territories in the States of Washington, Oregon and Idaho. Approximately seventeen percent of this total, or 2,000 miles, is Aldyl A pipe of all classes and sizes. Proportions of various classes of piping in Avista’s system, including priority Aldyl A pipe (pre-1973 and pre-1984 mains) is shown below in Figure 6.

*Figure 6. Avista’s priority Aldyl A pipe, shown as a proportion of the different pipe classes in Avista’s natural gas system (items 2 and 3 from the list above).*
