UW-240151

CASCADIA WATER, LLC

UNDERWATER INSPECTION REPORT OF PROCEDURES AND FINDINGS

Underwater Inspection of Estates 2

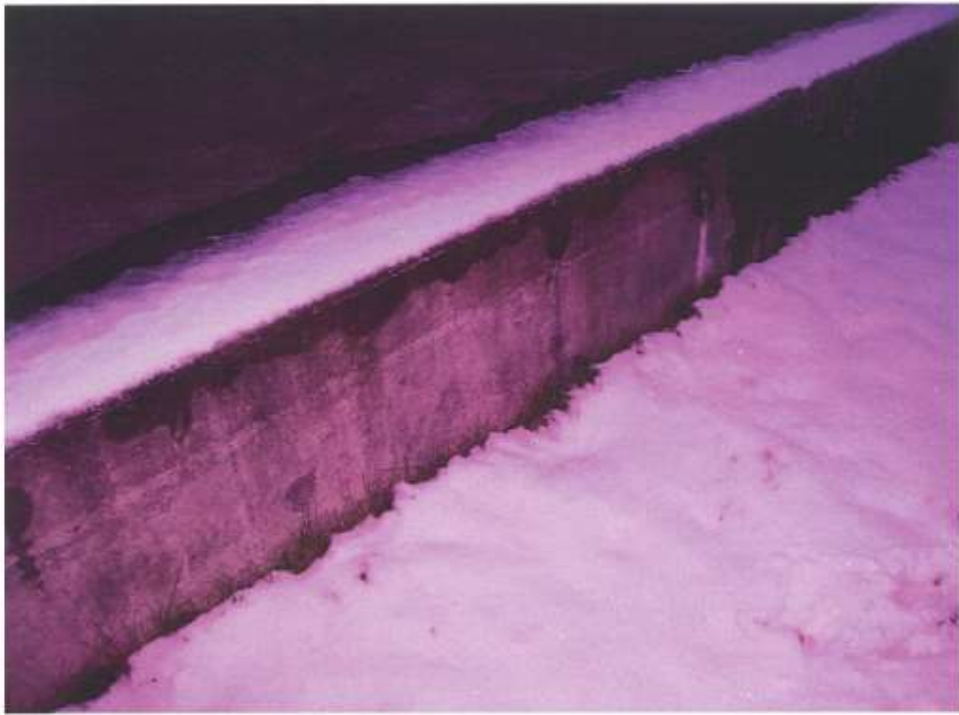
Image #
1

Component	Condition				Pic. #s	Comments
	NA	Ex.	Good	Fair Poor		
Site Security			X			Tank is in residential area with entrance to hatch in locked building.
Reservoir Exterior						Appeared to be in good condition.
<i>1st Ring Wall</i>			X		1	Concrete Deform. ⁴ <u>GC.</u>
<i>Top Ring Wall</i>			X			Concrete Deform. ⁴ <u>GC.</u>
Exterior Roof						Appeared to be in good condition with minor surface cracking.
<i>Roof North</i>			X			Concrete Deform. ⁴ <u>GC.</u>
<i>Roof East</i>			X		4	Concrete Deform. ⁴ <u>GC.</u>
<i>Roof South</i>			X			Concrete Deform. ⁴ <u>GC.</u>
<i>Roof West</i>			X		2	Concrete Deform. ⁴ <u>GC.</u>
<i>Roof Center</i>			X			Concrete Deform. ⁴ <u>GC.</u>
Roof Vents			X		3	Rust Grade ² <u>7.</u>
Exterior Telemetry			X		7	Appeared to be in good condition.
Exterior Inlet			X		10	Rust Grade ² <u>9.</u>
Exterior Outlet			X		8,9	Rust Grade ² <u>9.</u>
Exterior Overflow			X		6	Rust Grade ² <u>10.</u>

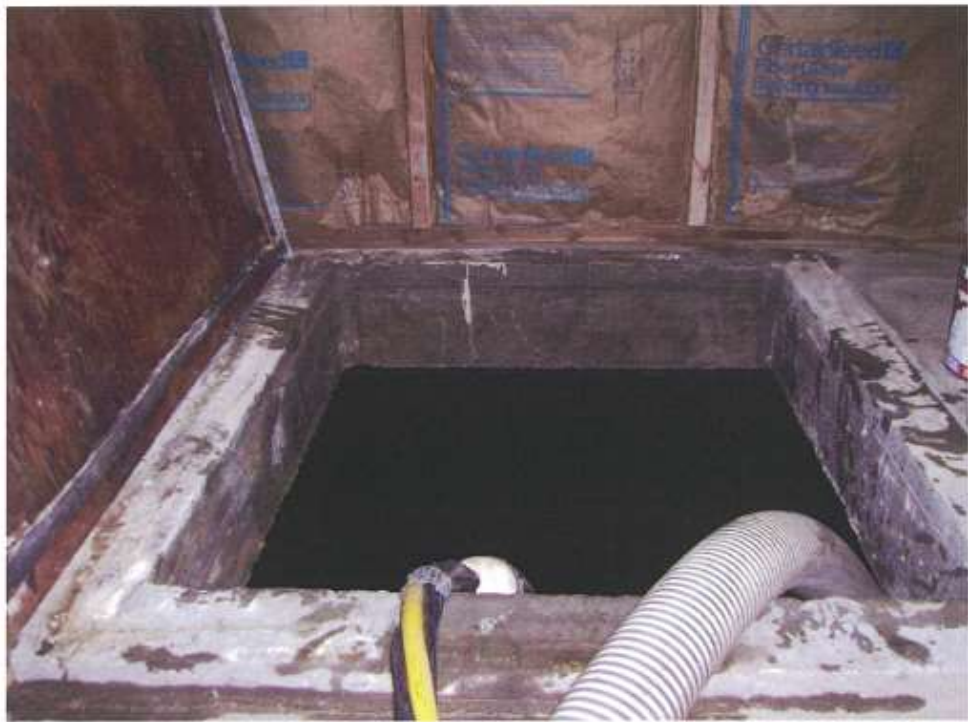
Image #
5

Component	Condition				Pic. # ^s	Comments
	NA	Ex.	Good	Fair		
Entry Hatch			X		5	Rust Grade ² <u>10.</u>
Telemetry Sensor			X		12	Appeared to be in good condition.
Interior Walls						Appeared to be in good condition with heavy staining that could not be removed with LiquiVac.
<i>1st Ring Wall</i>			X		19,25	Concrete Deform. ⁴ <u>GC.</u>
Interior Floor						Appeared to be in good condition.
<i>Floor North</i>			X			Concrete Deform. ⁴ <u>GC.</u>
<i>Floor East</i>			X		18	Concrete Deform. ⁴ <u>GC.</u>
<i>Floor South</i>			X			Concrete Deform. ⁴ <u>GC.</u>
<i>Floor West</i>			X		24	Concrete Deform. ⁴ <u>GC.</u>
<i>Floor Center</i>			X		20	Concrete Deform. ⁴ <u>GC.</u>
Support Columns						Appeared to be in good condition with minor cracking.
<i>Center Baffle Wall</i>				X	21	Concrete Deform. ⁴ <u>GC CK.</u>
Interior Overflow Pipe			X		27	Rust Grade ² <u>10.</u>
Interior Inlet			X		15,22	Rust Grade ² <u>10.</u>

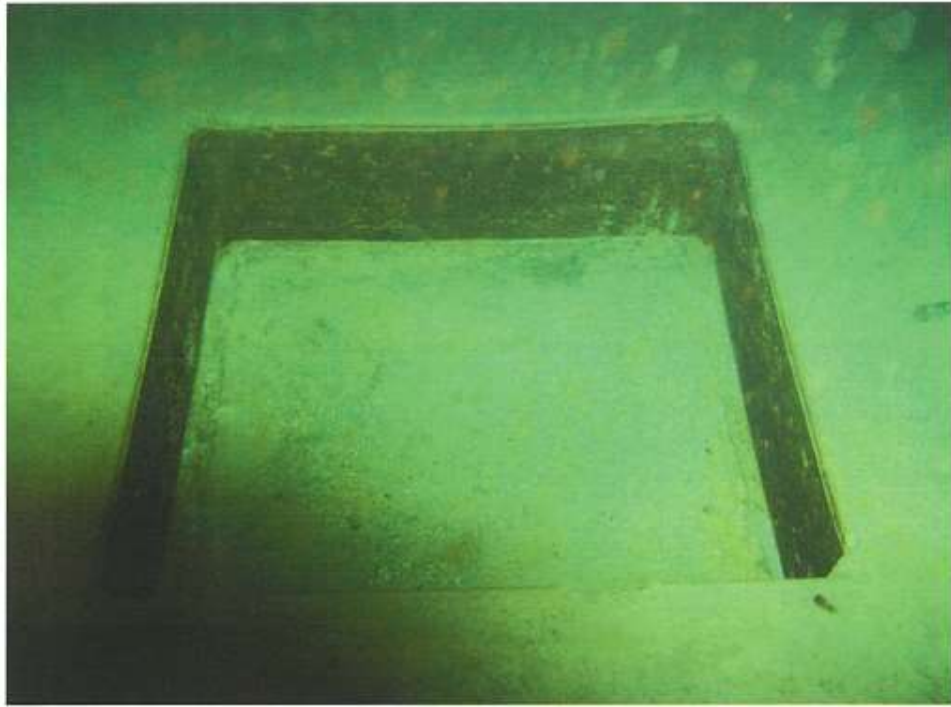
Image #
11

Interior Crossover			X		17,26	Rust Grade ² <u>10.</u>
Interior Outlet			X		13,14	Rust Grade ² <u>9.</u>
Interior Slump			X		11	Rust Grade ² <u>9.</u>
Interior Ceiling						Appeared to be in good condition with minor cracking
<i>Ceiling North</i>			X		23	Concrete Deform. ⁴ <u>GC CK.</u>
<i>Ceiling East</i>			X			Concrete Deform. ⁴ <u>GC.</u>
<i>Ceiling South</i>			X		16	Concrete Deform. ⁴ <u>GC.</u>
<i>Ceiling West</i>			X			Concrete Deform. ⁴ <u>GC.</u>
<i>Ceiling Center</i>			X			Concrete Deform. ⁴ <u>GC.</u>
Other/Repair						
Other/Repair						
Other/Repair
