EXH. HLR-4

Protocol for Managing Select Aldyl A Pipe in Avista Utilities' Natural Gas System

May 2013

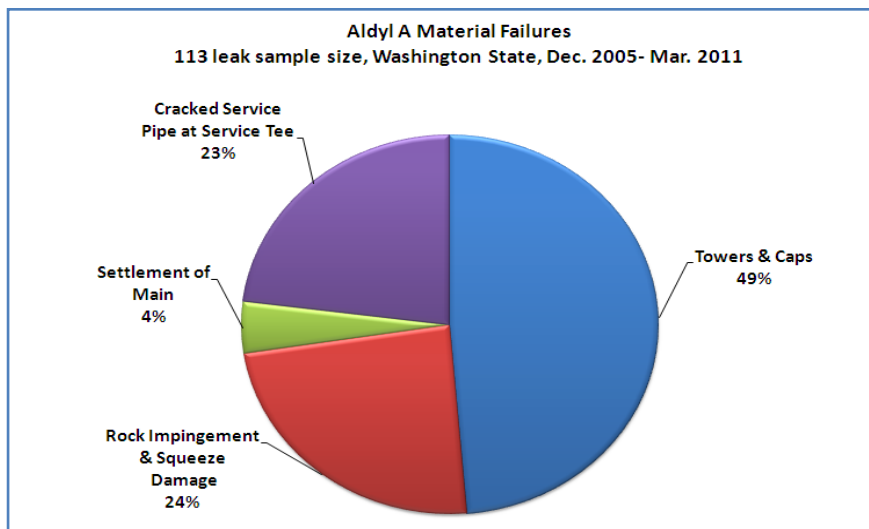
In tackling the first objective of the assessment of its Aldyl A piping, Avista aggregated the gas leaks resulting from Aldyl A material failures found in its gas system in Washington State from late 2005 through March 2011. The sample included 113 material failures that were evaluated and summarized by component to offer an understanding of the specific failure modes for Aldyl A pipe. The 'modes' or types of material failures categorized are shown below in Figure 1.

Figure 1. Modes or types of material failures documented in a sample of 113 leaks in Avista’s Aldyl A piping in Washington State, December 2005 through March 2011.

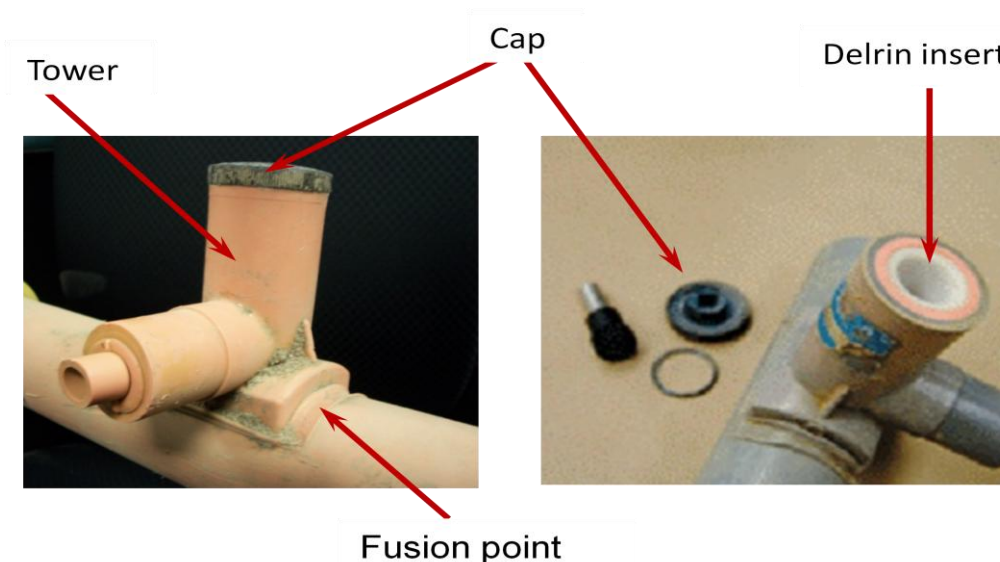
The largest percentage of material failures in the sample occurred in Towers and Caps, referring to failure of the service tapping tee itself, shown below in Figure 2. In these cases, the pressure applied to the tee as the cap was tightened onto the body during initial installation has resulted in slow crack growth and failure of the tower body, the cap, or the Delrin[®] insert many years later. Additionally, the saddle fusion point of the tower to the main pipe is another frequent point of failure in this assembly. The unavoidable stresses created during standard installation (using factory recommended procedures) have led to brittle cracking in these components many years later. This phenomenon clearly demonstrates the susceptibility of certain resins of Aldyl A piping to tend to fail by brittle cracking due to the slow crack growth initiated during installation.

Figure 2. External features and internal components of a typical Aldyl A service tee, as fused to Aldyl A main pipe.

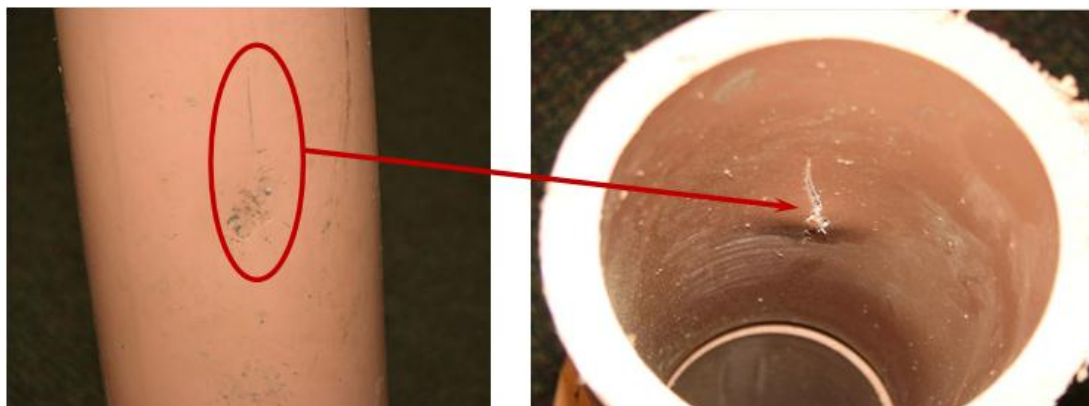
The second-most common material failure observed in Avista's Aldyl A pipe was due to localized, brittle cracking in Aldyl A mains that resulted from rock impingement – rock pressure directly on the pipe, or places where ‘squeeze-off’ was applied over the pipe's service life. These failures are very typical for certain resins of Aldyl A main pipe, having been consistently reported by other utilities since before the time of DuPont's 1986 letter. As described earlier, when these external stresses (rock impingement or squeeze-off) cause the pipe to fail, it always begins with crack initiation on the inside surface of the pipe wall, eventually resulting in slow crack growth that propagates toward the outer wall of the pipe, and finally, through-wall failure. These failures generally appear as short, tight cracks in the outer wall of the pipe that run either parallel, or slightly off-parallel with the length of the pipe. A typical failure in Aldyl A main pipe, showing a crack through the pipe wall as it appears on both the inner and outer surfaces, is shown below in Figure 3.

Figure 3. Typical brittle-like crack through the wall of Aldyl A pipe, resulting from rock contact directly on the pipe.

Although the duration of the stress caused by rock contact with the pipe is very different from that associated with squeeze-off, they both result the same pattern of crack initiation and slow crack growth leading to failure of the pipe. Other sources of external stress that can result in brittle failure of Aldyl A pipe, as mentioned earlier in the report, include bending of the pipe, soil settlement, dents or gouges to the pipe, and improper installation of fittings.

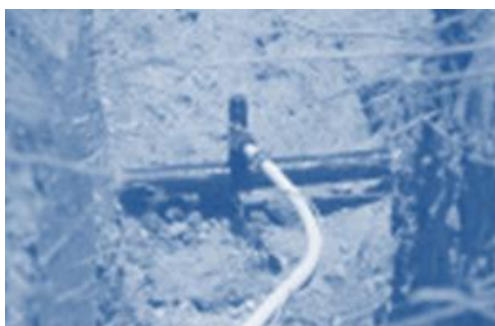
The third most-common failure in Avista's sample occurred where small diameter Aldyl A service pipe is tapped from steel main pipe. In this application, a steel service tee is welded to the steel main pipe and the small-diameter Aldyl A service pipe is then connected to a mechanical transition fitting on the tee, as pictured below in Figure 4.

Figure 4. Typical polyethylene service tapped from a steel main.

It is at this transition point, between the rigid steel fitting and the more-flexible Aldyl A service pipe, that brittle-like cracking has been observed. This failure mode in older plastic pipe is well understood, and was one of the three study objectives reported by the

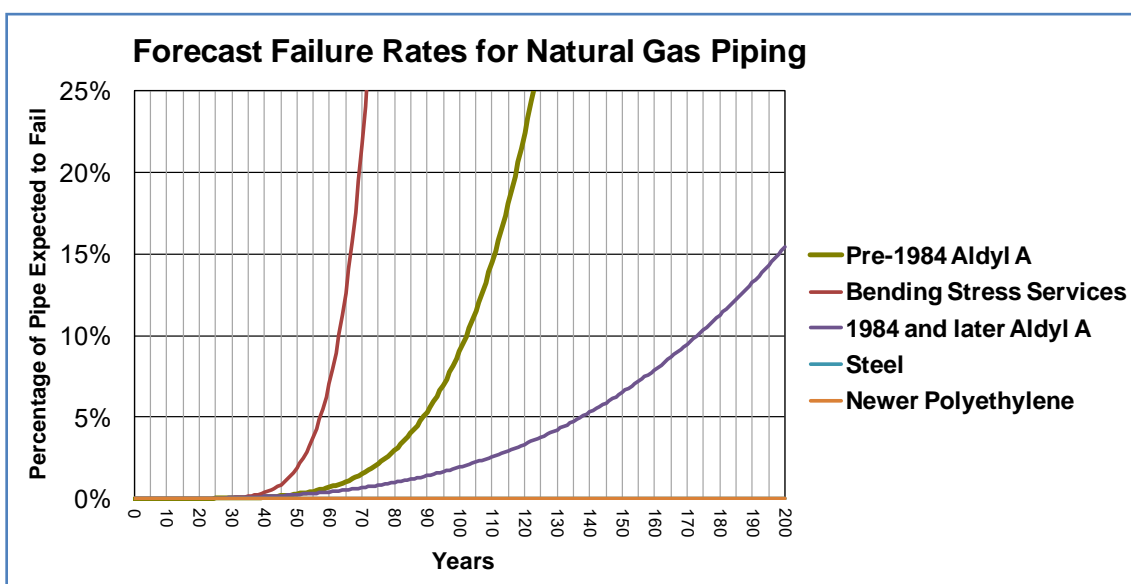
Results of the forecast modeling, for the pipe classes evaluated, are represented as ‘curves’ showing the percentage of the amount of each pipe class that is projected to fail in each year of the forecast time period. The resulting reliability curves are shown in the graph below in Figure 5.

Figure 5. The expected failure rates for several classes of pipe in Avista’s system, as forecast by Availability Workbench Modeling. The “Steel” curve is obscured by the “Newer Polyethylene” curve, both of which are essentially flat lines.

The failure curves show dramatic differences in the expected life for the pipe classes evaluated. The difference in expected life between the Aldyl A products as a group, compared with that of steel and newer-generation plastic pipe, is particularly evident. Striking also, are the expected performance differences among the classes of Aldyl A pipe evaluated, providing some clear trends useful in designing remediation strategies.

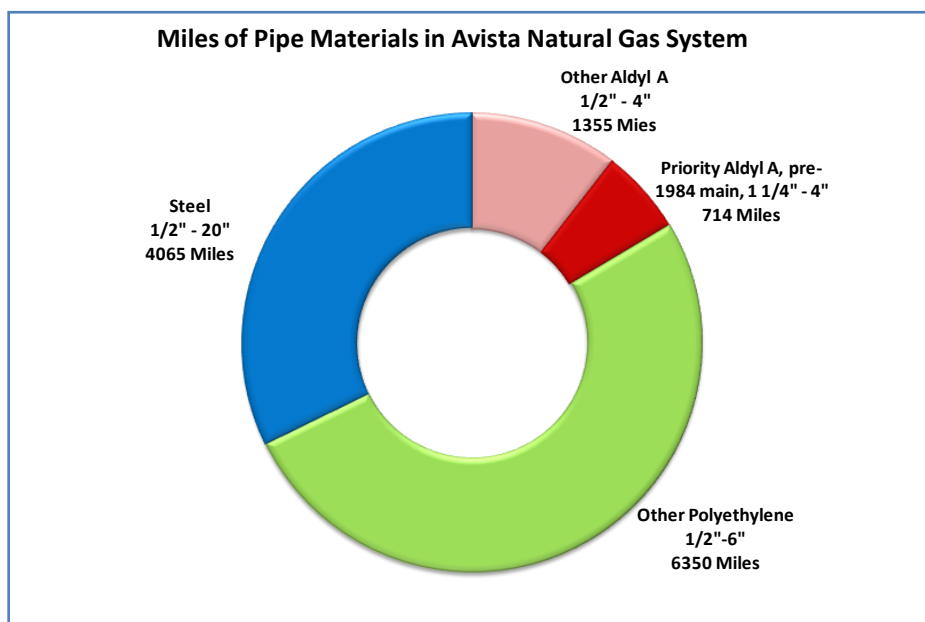
Main Pipe - Avista has approximately 12,500 miles of natural gas main pipe in its service territories in the States of Washington, Oregon and Idaho. Approximately seventeen percent of this total, or 2,000 miles, is Aldyl A pipe of all classes and sizes. Proportions of various classes of piping in Avista’s system, including priority Aldyl A pipe (pre-1973 and pre-1984 mains) is shown below in Figure 6.

Figure 6. Avista’s priority Aldyl A pipe, shown as a proportion of the different pipe classes in Avista’s natural gas system (items 2 and 3 from the list above).

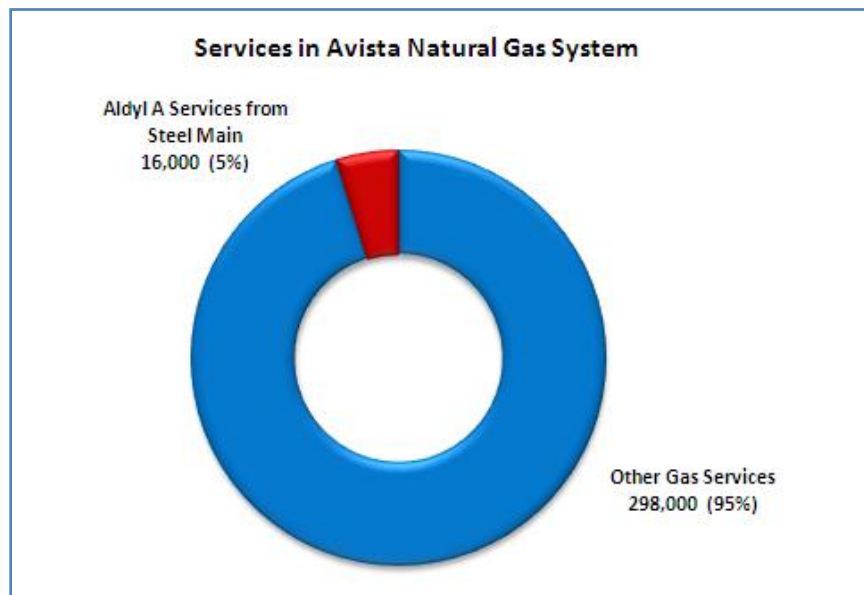
Gas Services - Avista has approximately 314,000 natural gas services, of which approximately 16,000, or five percent, are Aldyl service pipe tapped to steel main pipe, shown below in Figure 7 as priority Aldyl A services.

Figure 7. Avista's priority Aldyl A gas services (tapped from steel mains), shown as a proportion of Avista's total gas services.

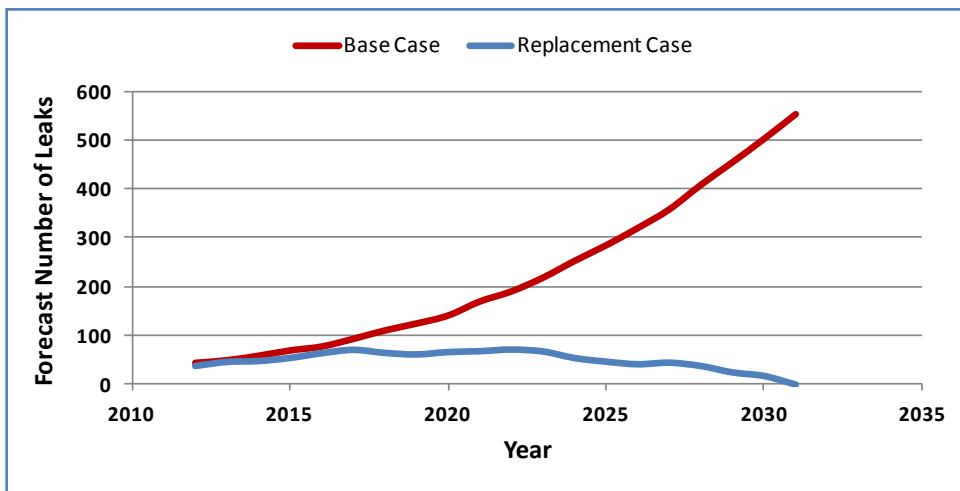
failures each year is expected to increase slightly until 2017, at which time the cumulative effect of priority piping replaced since 2012 begins to check the failure count and then drive it toward zero over the remaining course of the program (Figure 8).

Figure 8. Expected numbers of material failures in Avista’s priority Aldyl A piping in two cases: Replacement Case - piping replaced over a twenty year horizon in the manner proposed by Avista in this report, and Base Case – assumed that priority piping was not remediated under any program.
