UW-240151

SANITARY SURVEY REPORT

January 12, 2022 Dale Metzger Estates Inc. Post Office Box 92 Sequim, Washington 98382	Estates Inc. Water System ID #081669	
	County:	Clallam
	System Type:	Community
	Operating Permit Color:	Green
	Surveyor:	Jocelyne Gray
	Water System Attendees:	Dale Metzger Culley Lehman
	County Health Attendees:	Sue Waldrip Ben Majors
	Inspection Date:	December 8, 2021

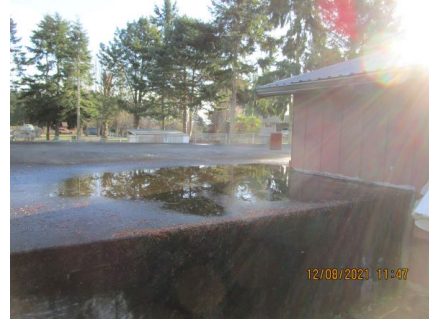
Large Storage Tank - Ponding

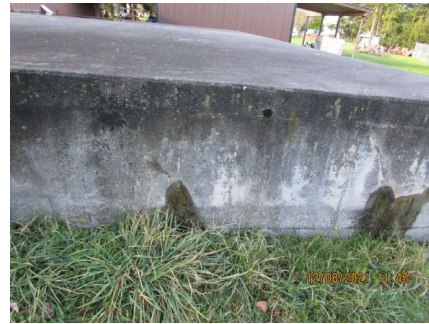
Tank 2, the larger tank, has several locations on the north side and one on the east side that are leaking. ODW is aware Cascadia Water plans to replace both buried reservoirs with an above ground storage tank. Submit a corrective action plan for engineering design and construction of the proposed tank. If a new tank is not proposed, hire a qualified structural inspector to evaluate the reservoir. Submit a copy of the inspection results and a corrective action plan describing how you will address the inspector’s findings.

East Side Large Storage Tank

If a new tank is not proposed, hire a qualified structural inspector to evaluate the reservoir. Submit a copy of the inspection results and a corrective action plan describing how you will address the inspector's findings.

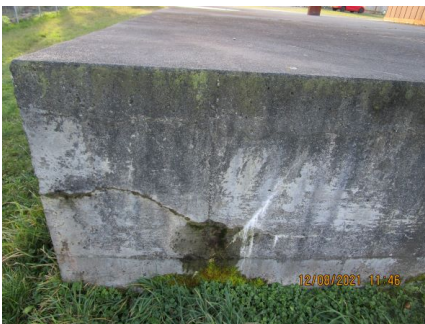
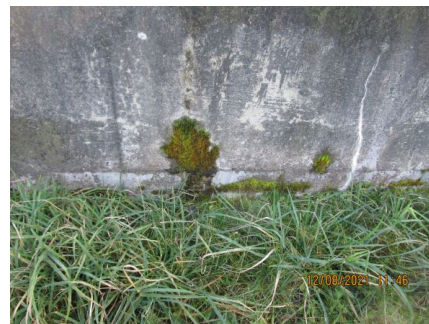
North Side Large Storage Tank

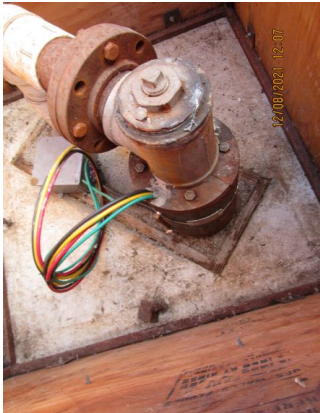
Electrical wires entering Well 1 need to be sealed. Wires were sealed during inspection.

Well 1 With Sealed Wires

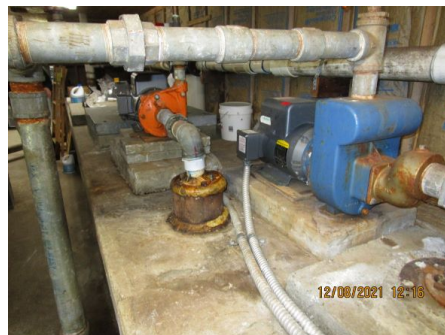
The existing generator only runs the booster pumps for Tank 1.

Booster Pumps for Small Storage Tank
