## **Bellingham to Mount Constitution**

ANTENNA AND TOWER ROUTINE INSPECTION		
	SITE NAMEBellingham	
	SITE LOCATIONBellingham, WA_	
	SITE CLLIBHLMWA01	
	DATE01/12/2016	
	INSPECTED BYFord - Hogue

ANTENNA AND TOWER ROUTINE INSPECTION		
SITE NAMEMt. Constitution North		
SITE LOCATIONOrcas Island		
SITE CLLIMTCSWAQA		
DATE01/13/2016		
INSPECTED BYFord - Hogue

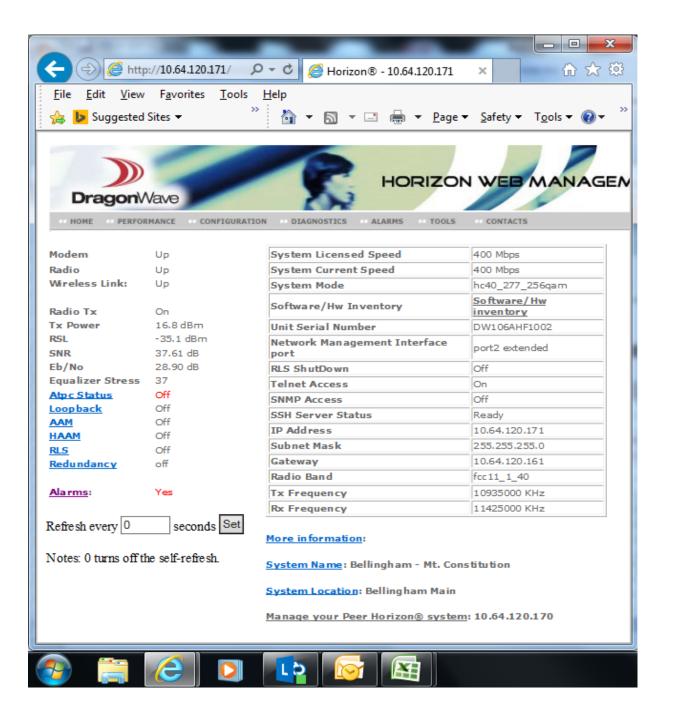
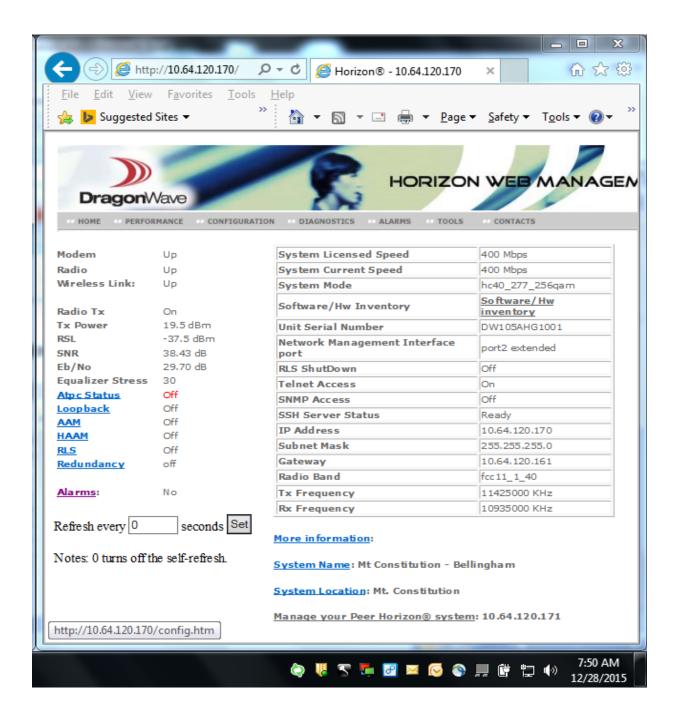
Each radio indicates a properly operating link, despite the ATPC Alarm indication. That alarm indicates that the Automatic Transmit Power Control circuit is off, which is the normal operating condition for microwave radio systems operating within CTL.

There is also an Alarm indication on the .171 radio, which is located in Bellingham. This alarm is a Port 2 Open alarm, which indicates that the Management cable is disconnected. This is due to the Bellingham radio not being connected to the local CO-LAN. Management is done via the Mt. Constitution LAN, with data transmitted via the radio link.
