POST INSPECTION MEMORANDUM

Operator Inspected:
Kelso-Beaver Pipeline Company
c/o Cascade Natural Gas Company
222 Fairview Ave N
Seattle, WA 98109

Facilities Inspected: This field inspection was to inspect the installation of finger drains (French drains) at the Flow Slide Area. This project is phase II of the overall project by PGE to stabilize the hillside (approximately 60-degrees slope) and protect the existing pipeline. During Phase I project, a geotextile fabric, drainage collection pipe, and 3" to 8" size rocks were installed in the area where the Flow Slide occurred. The purpose of Phase I project was to provide stability to the adjacent soil by placing approximately 9 foot thick rock mass at the head of the scarf and decreasing the depth of the rock mass to the toe of the hillside. Phase I was completed in early April of 2009. The Phase II project includes excavating 5 narrow and deep parallel trenches next to the Phase I project and fill the trenches with polystyrene aggregate. The separation between two adjacent trenches is approximately 10 feet. Two 4" diameter perforated corrugated plastic pipes surrounded by 4 inches of polystyrene aggregate are placed at the bottom

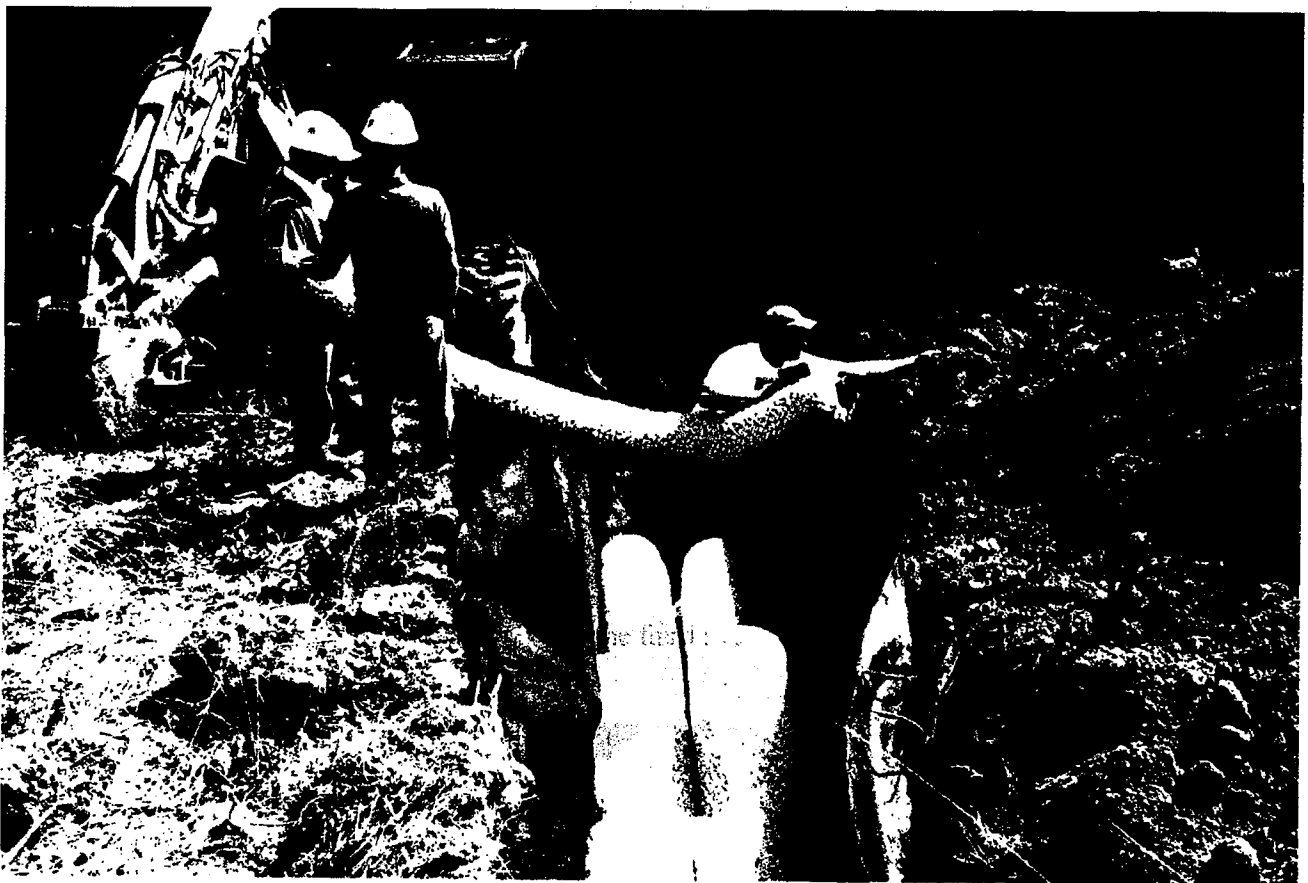
View: looking down slope (approximately 60-degrees). The contractor's crew was installing black geotextile fabric in open finger drain, EZ flow pipe, and backfill with expanded polystyrene aggregate, cover with geotextile fabric and native soil.

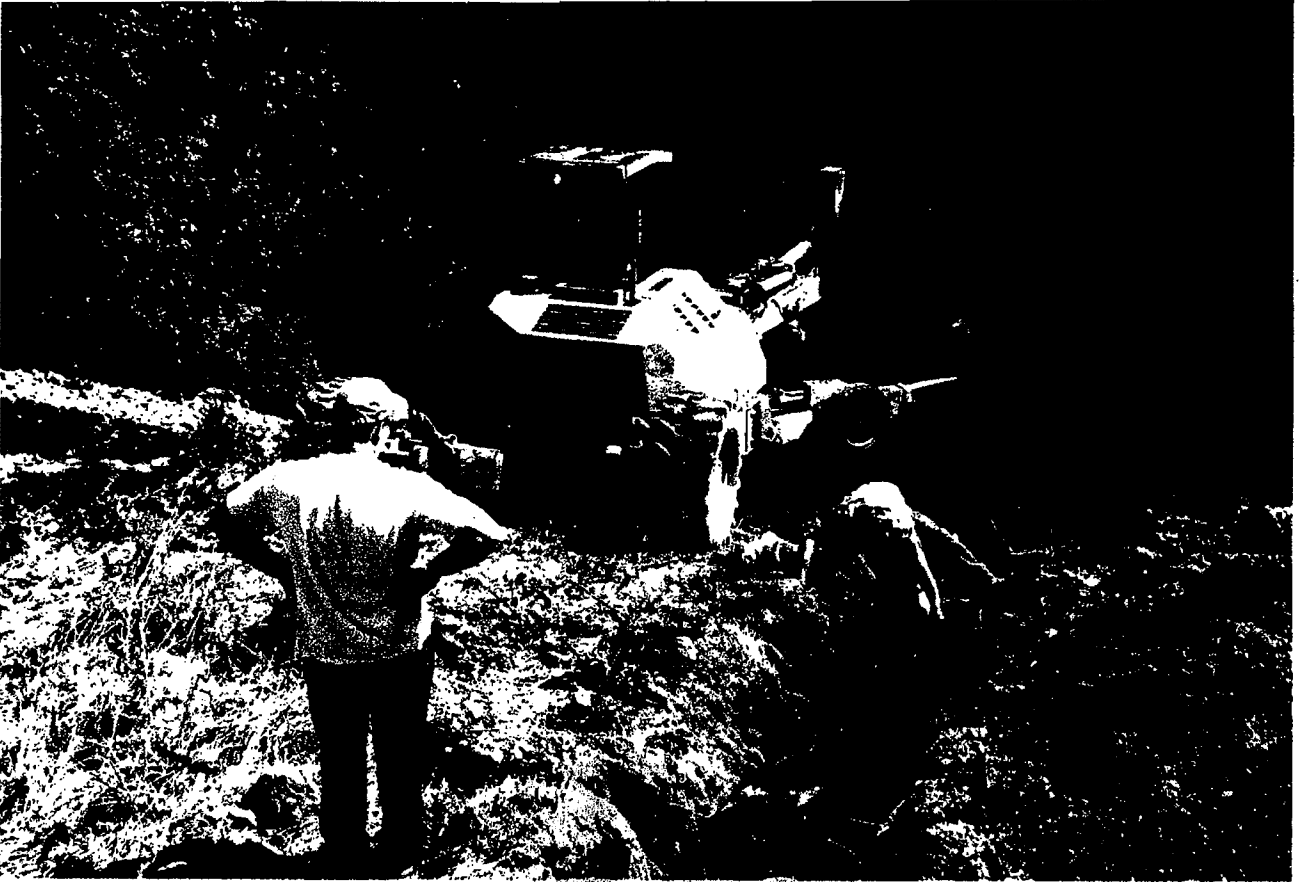
View: Looking down slope. The contractor's crew was working on the geotextile fabric before the trench is covered with approximately 1 foot of soil backfill material.
