## **APPENDIX B**

**COMPANY RESPONSE TO STAFF REPORT  
(NOVEMBER 3, 2006)**

Subject: Natural Gas Pipeline Safety Inspection, Clark County  
Ref. No. Docket PG-060208

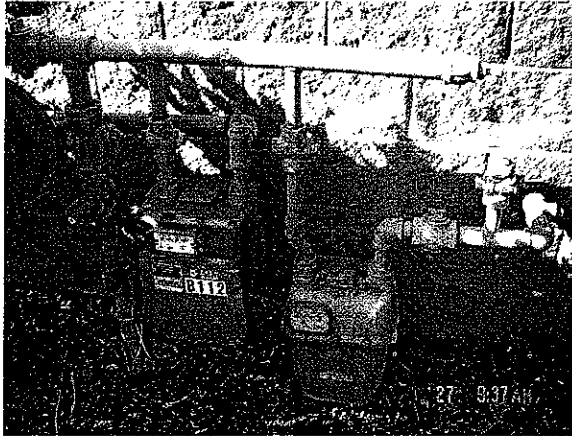
*At the time of this inspection, the following service regulators had relief vents which were installed in a manner that could have potentially allowed rain and moisture accumulation inside the regulator which may affect the proper operation of the device.*

Figure 1. Meter #743434: Corrected regulator vent.

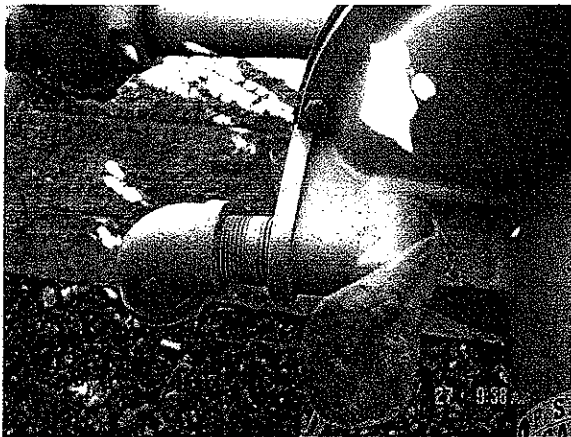
Figure 2. Meter #743434: Corrected regulator vent.

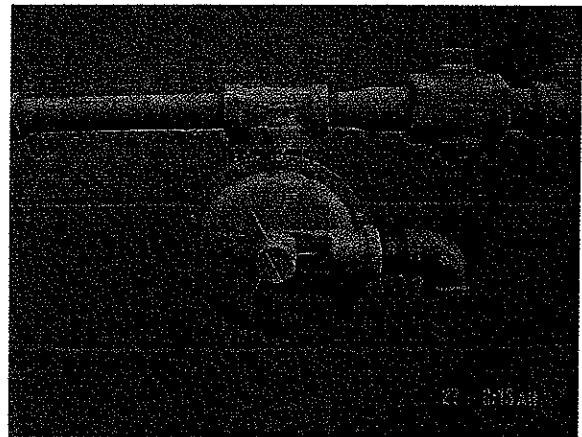
Figure 5. Meter #316080: Corrected regulator vent.

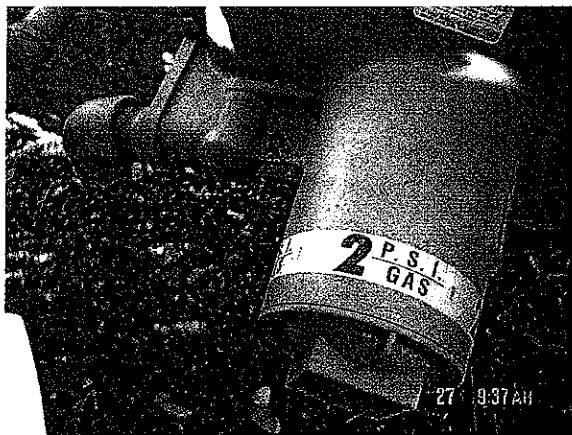
Figure 3. Meter #743434: Corrected regulator vent.

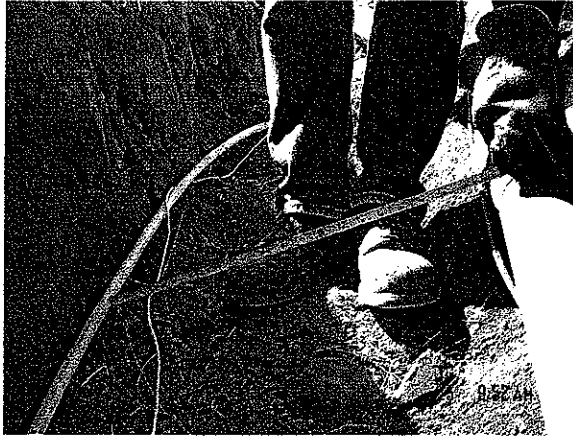
*On August 24, 2006, we observed the following ½-inch plastic new construction residential services in open ditches which did not have 12-inches of separation from other underground utilities. The services were direct buried without protection from hazards which could result from the close proximity of other utilities.*

Figure 6. 5911 NE 62<sup>nd</sup> Street, Vancouver: Depicts approximately 20-inch separation between gas line and other utilities.

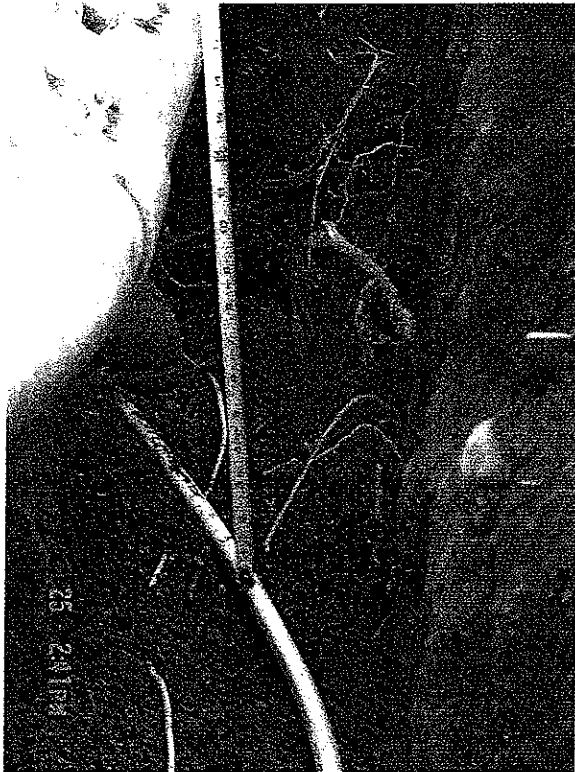
Figure 7. 9117 NE 77th Street, Vancouver: Depicts approximately 15-inch separation between gas line and other utilities.

**9117 NE 77 Street, Vancouver.** In order to ensure adequate separation, NW Natural replaced the entire length of the service to another alignment (Figure 7).

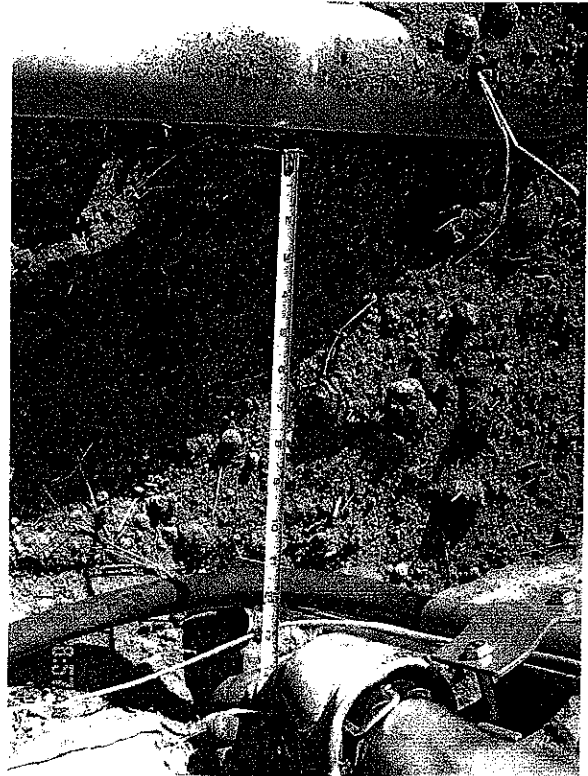
Figure 8. 5923 NE 62<sup>nd</sup> Street, Vancouver: Depicts approximately 12-inch separation between gas line and other utilities.

Upon becoming aware of Staff's concerns, NW Natural took prompt corrective action as described in the company's response to Probable Violation 11 which addresses the same locations as items a. and c. above. In addition, at 5923 NE 62<sup>nd</sup> Street, Vancouver, the company took the following corrective action:

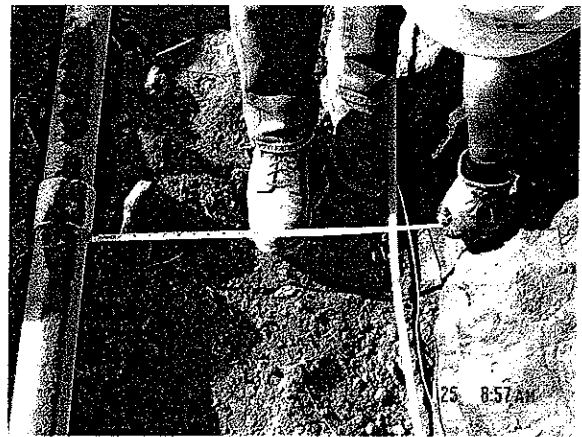
Figure 9. 5923 NE 62<sup>nd</sup> Street, Vancouver: Depicts approximately 19-inch separation between gas line and other utilities.
