THE WASHINGTON STATE UTILITIES AND TRANSPORTATION

DOCKET PG-082253

Commission Staff Investigation Report on Explosion and Fire

206 North Birch Street; Odessa, Lincoln County

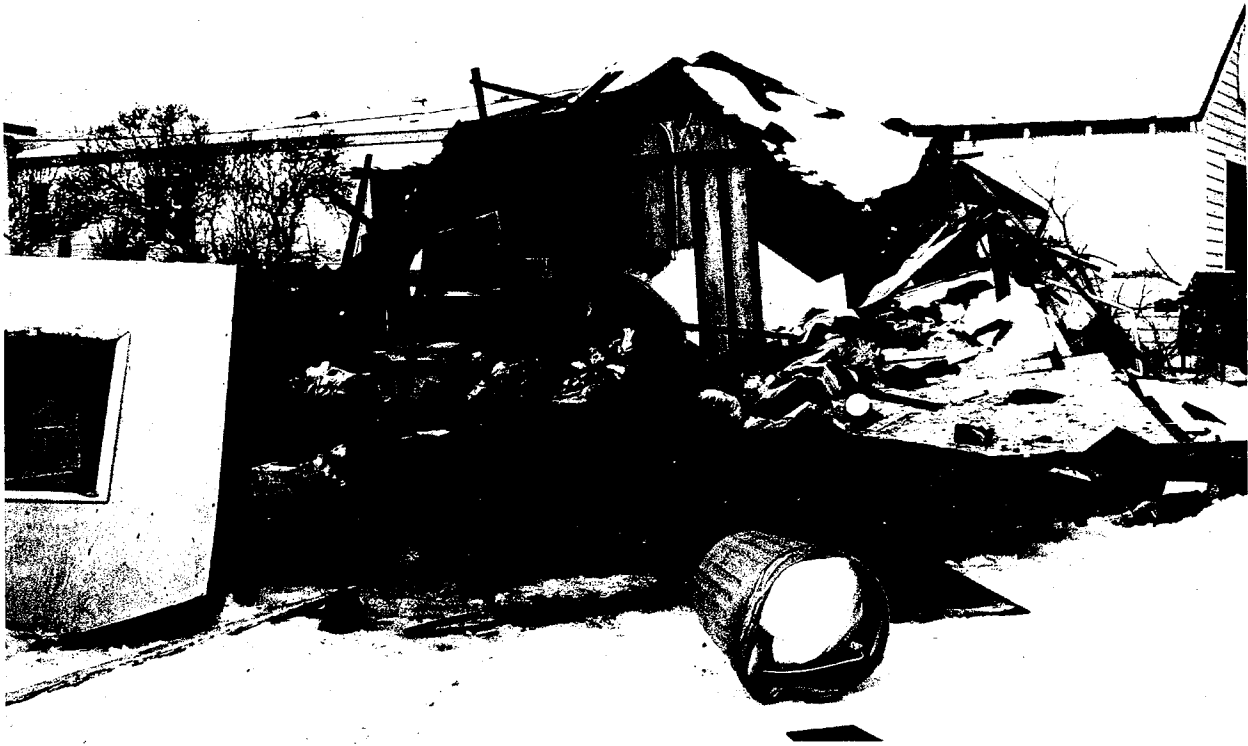
Exhibit B

View: Looking to the northwest at the destroyed secondary living quarters and damaged attached garage (white structure in background). The gas most likely entered through cracks in the concrete basement foundation walls and entered the garage through an internal door connecting the two structures. The fire was confined mostly to the secondary living quarters.

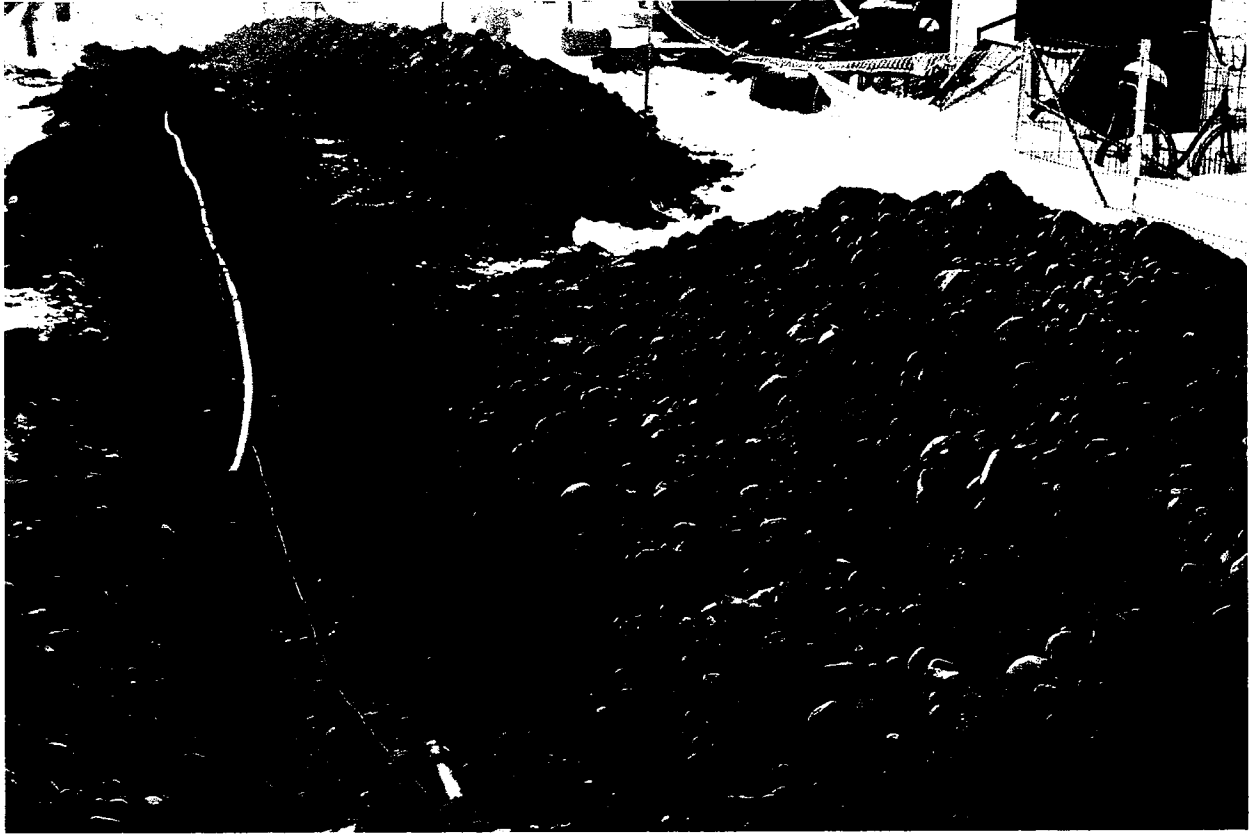
consistent with volcanic ash-like soil. At each end of the open trench, where the soil was not disturbed, there was no evidence that Avista placed any sand or other non-native material under or around the main when Avista installed it in August 1981. Exhibit C also shows the typical material found on-site.

View: Looking south down the alley. The two inch diameter PE gas main is in-situ. The section of failed pipe has been removed. Avista removed that section of main and transported it to Spokane. Typical bedding and backfill material in the trench is mostly round, smooth rock and some fractured rock less than 6-inch in diameter. Dirt consists mostly of fine volcanic ash-type soil.
