**BEFORE THE WASHINGTON
UTILITIES & TRANSPORTATION COMMISSION**

DOCKET NOS. UE-200900 and UG-200901 (*Consolidated*)

EXHIBIT PADS-16

Avista Response to Public Counsel Data Request No. 110, Attachments A–N

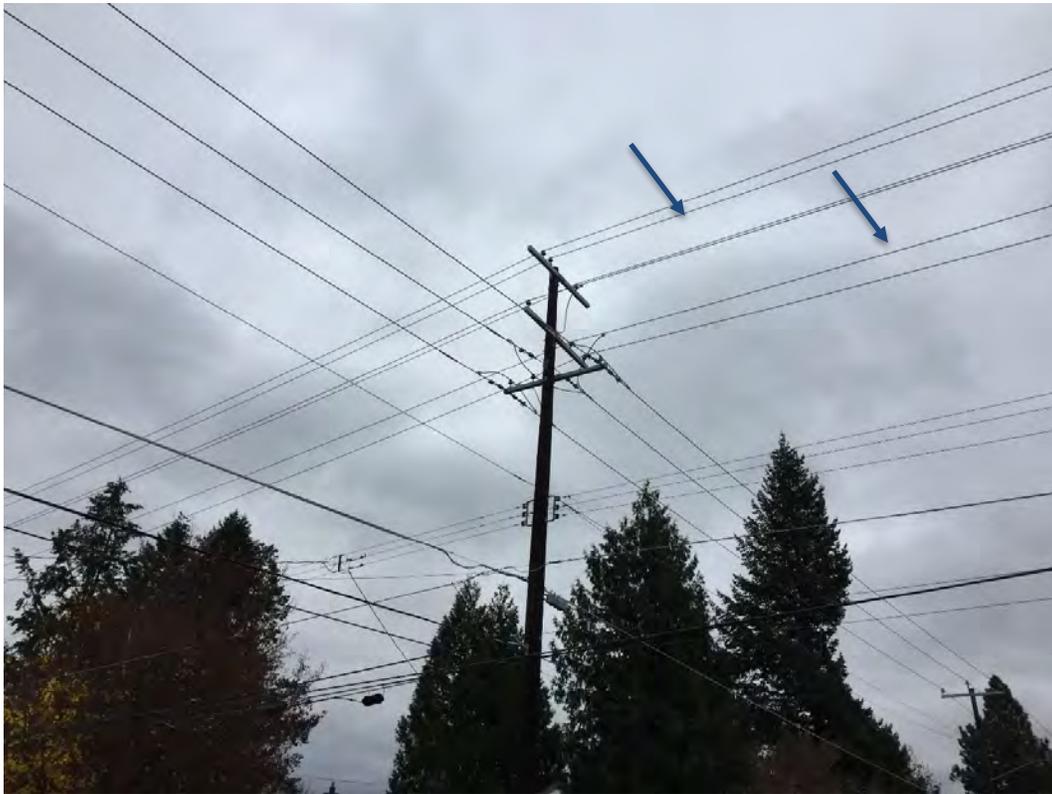
Figure 4. Paralleled 336 ACSR trunk at Cedar-Walnut & Wabash

Figures 4 and 5 illustrate the paralleled 336 ACSR trunk on F&C 12F1 as observed in the field.

Any designs to reconductor shall adhere to the Avista Distribution Construction and Material Standards, Distribution Feeder Management Plan, and the Existing Facility Replacement/Modification Guidelines to ensure that all construction criteria are satisfied to bring these sections up to new installation requirements.

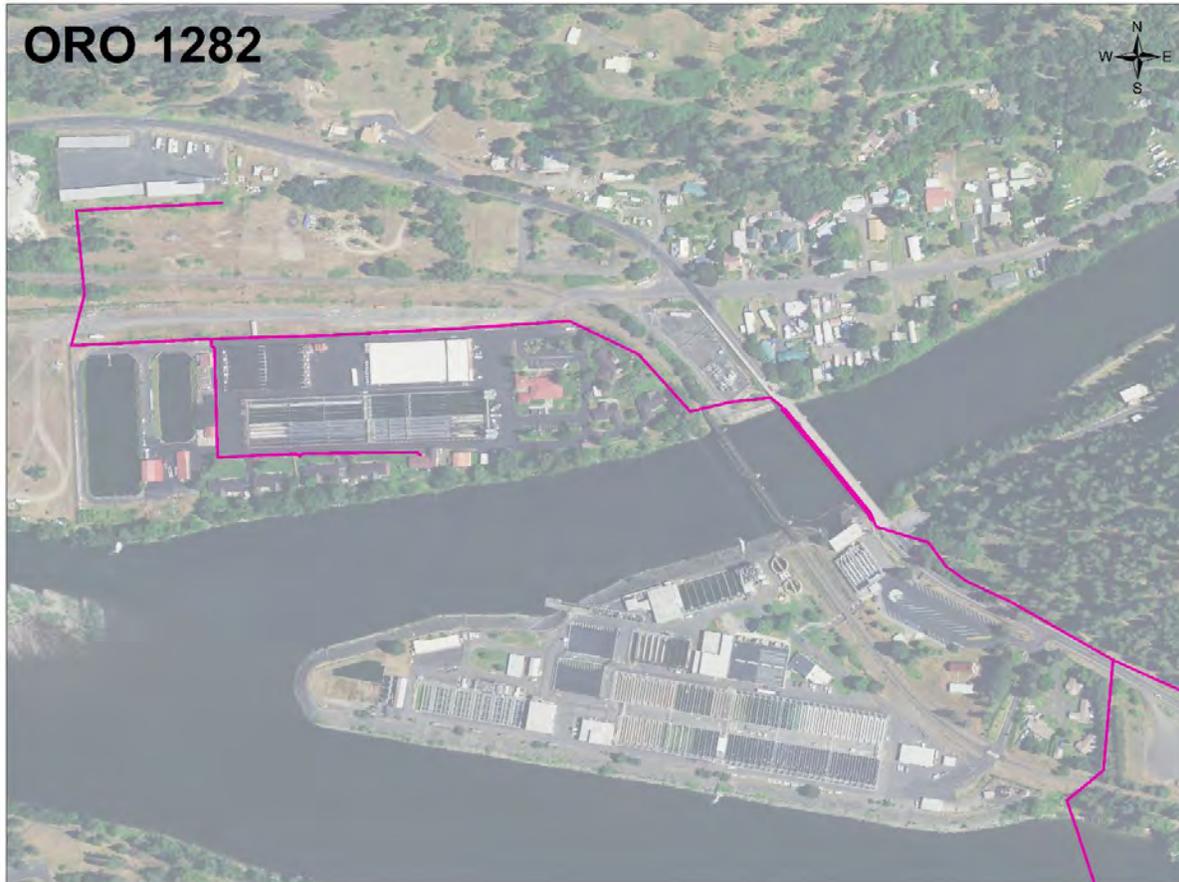
Figure 15. River Crossing Opportunity at Clearwater River near Ahsahka

Clearwater River Crossing near Clearwater Power's Ahsahka Substation
