Docket No. PG-080292

SEA, Ltd. PROJECT NO. 148643

ISSUE DATE: July 7, 2008

CAP SCREWS FAILURE ANALYSIS

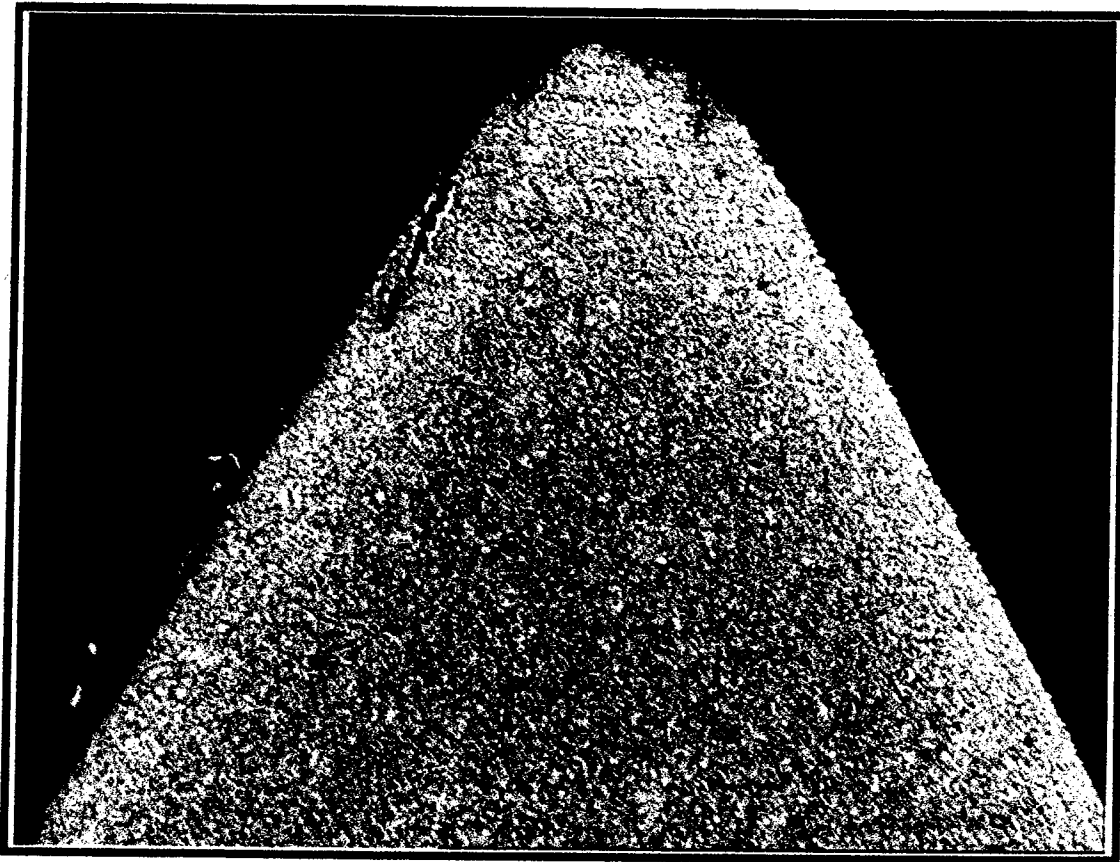
The metallographic results show the failed cap screws Nos. 1 and 5 from PBV Valve 0297306 had a carburized layer at the outside surfaces (see **Figures 1 and 2**), whereas the unfailed cap screw No. 1 from PBV Valve 1095426 showed no carburization or decarburization (see **Figure 3**). It should also be noted that the μ HRD values taken in the near surface area of the failed cap screws Nos. 1 and 5 from PBV Valve 0297306 were higher than the μ HRD values in the unfailed cap screw No. 1 from PBV Valve 1095426.

FIGURE 3: Optical image of cross section of Sample 1 from PBV valve 1095426. Note the absence of the carburized layer of the outer surface of the cap screw thread.
