DOCKET NOS. UE-200900 and UG-200901 (*Consolidated*)

EXHIBIT PADS-20

Avista Response to Public Counsel Data Request No. 215, Attachment A

**AVISTA CORP.
RESPONSE TO REQUEST FOR INFORMATION**

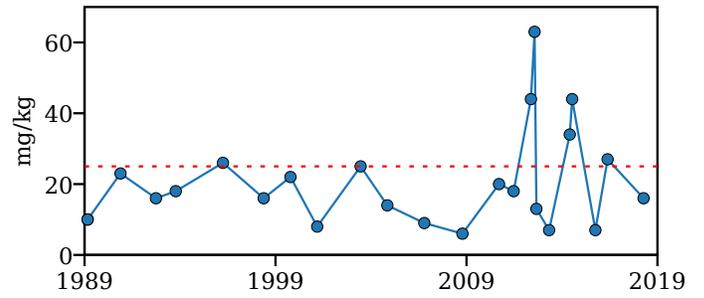
Moisture

The water content of the oil is acceptable.
