**Subject: Groundwater Treatment System Outfall Structural Inspection, Cleaning and Corrosion Protection**

**NW Natural Source Control Groundwater Treatment Facility,  
7900 NW St. Helens Road, Portland, OR  
NPDES Permit Number 103061 (permit renewal pending with DEQ)**

## DIVE INSPECTION REPORT

NW Natural - Gasco Willamette River Outfall Diffuser  
Inspection

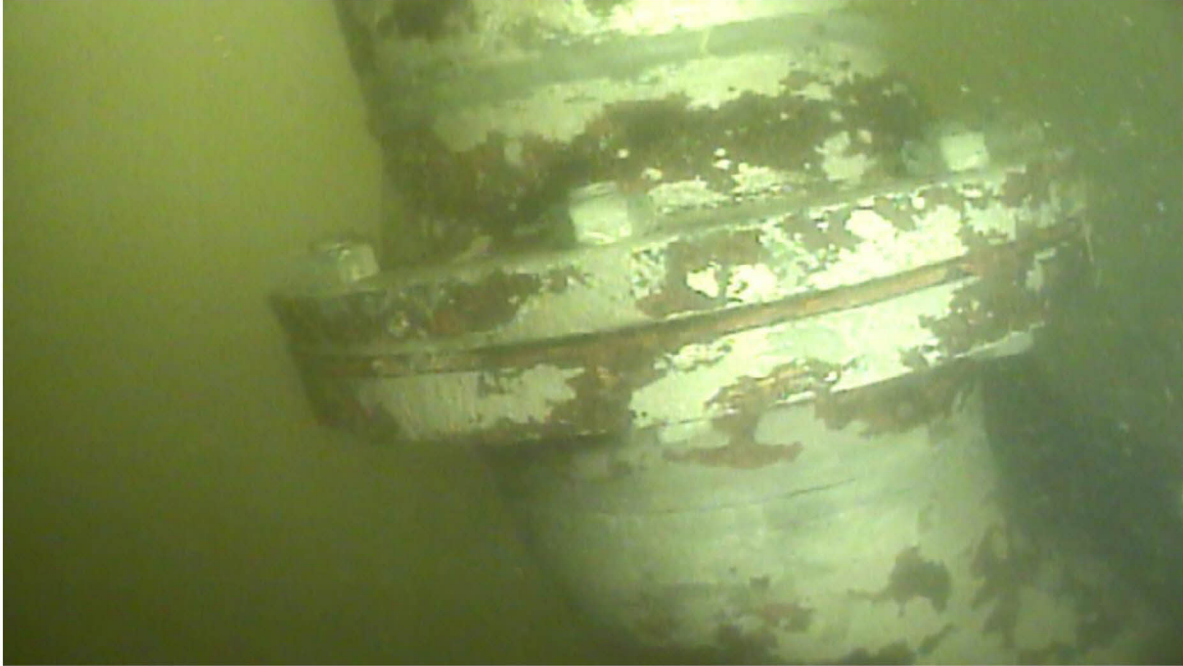
- Both the vertical flange that was installed prior to the 8" main pipe turns horizontal in water and the blind flange had all hardware present and tight. Hardware and flange highly corroded and marine growth build-up present.

**Figure 2 – 8” Outfall pipe flange connection, clean and in good condition**

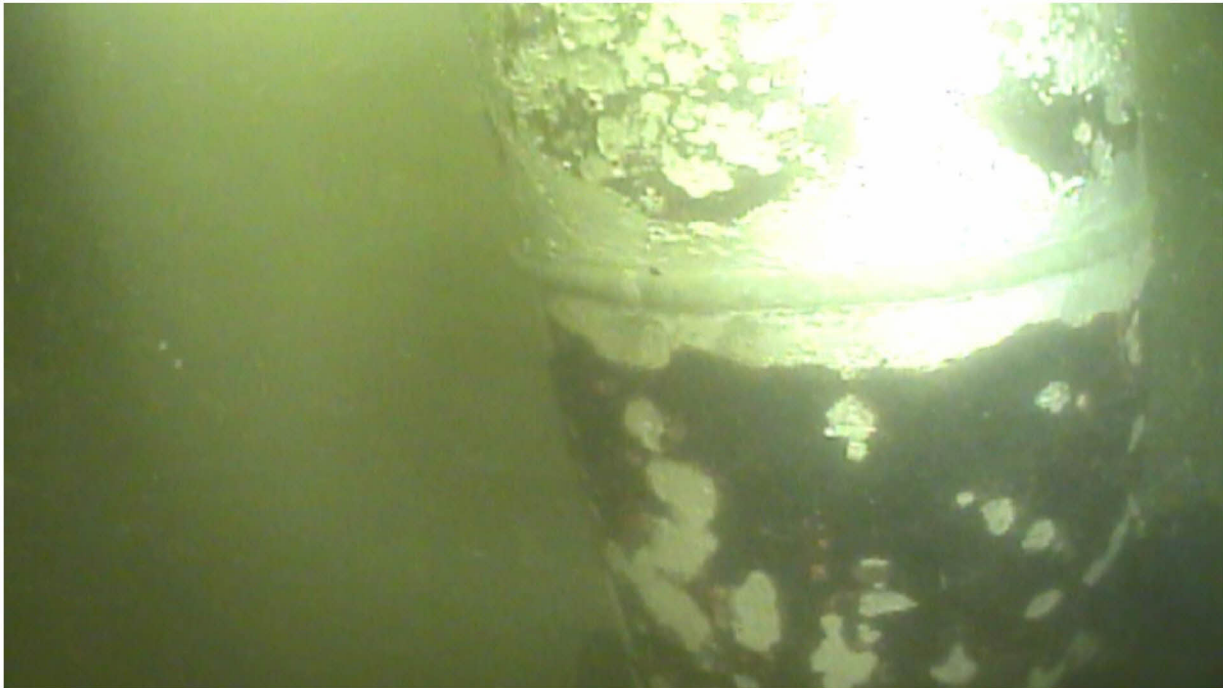
**Figure 3- 8” Outfall weld connection in good condition**

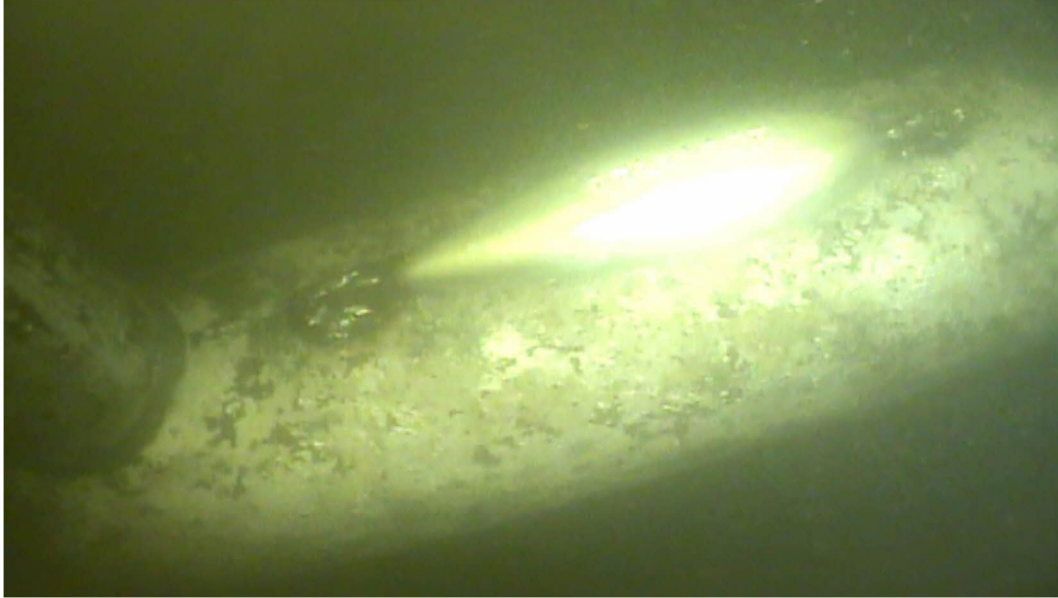
**Figure 4- Sacrificial Zinc Anode Welded Between Diffusers #2 and #3**

- An 8 pound sacrificial zinc anode was welded to the 8" mainline between diffusers #2 and #3.

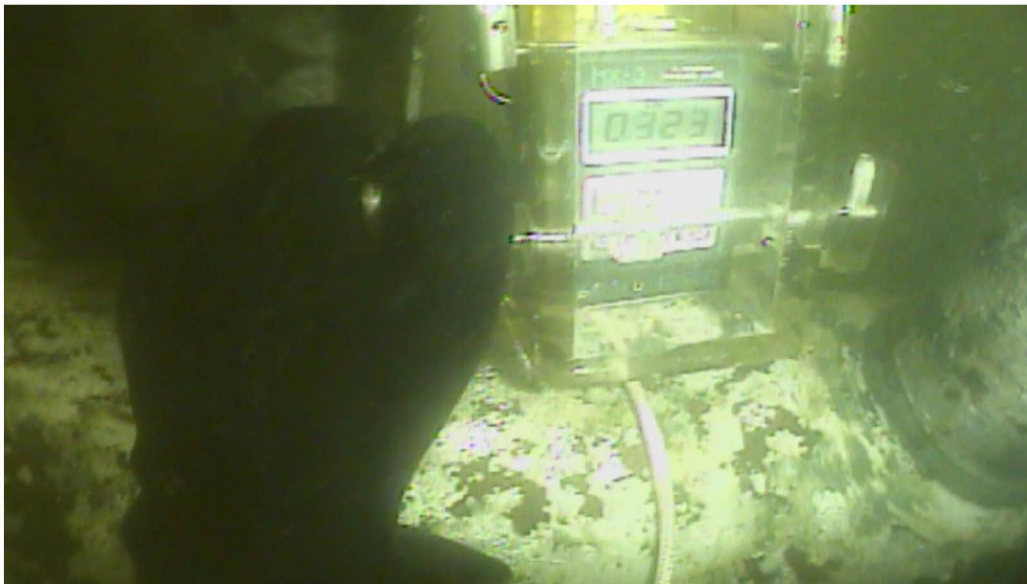
**Figure 5- UT Thickness Measuring Tool**

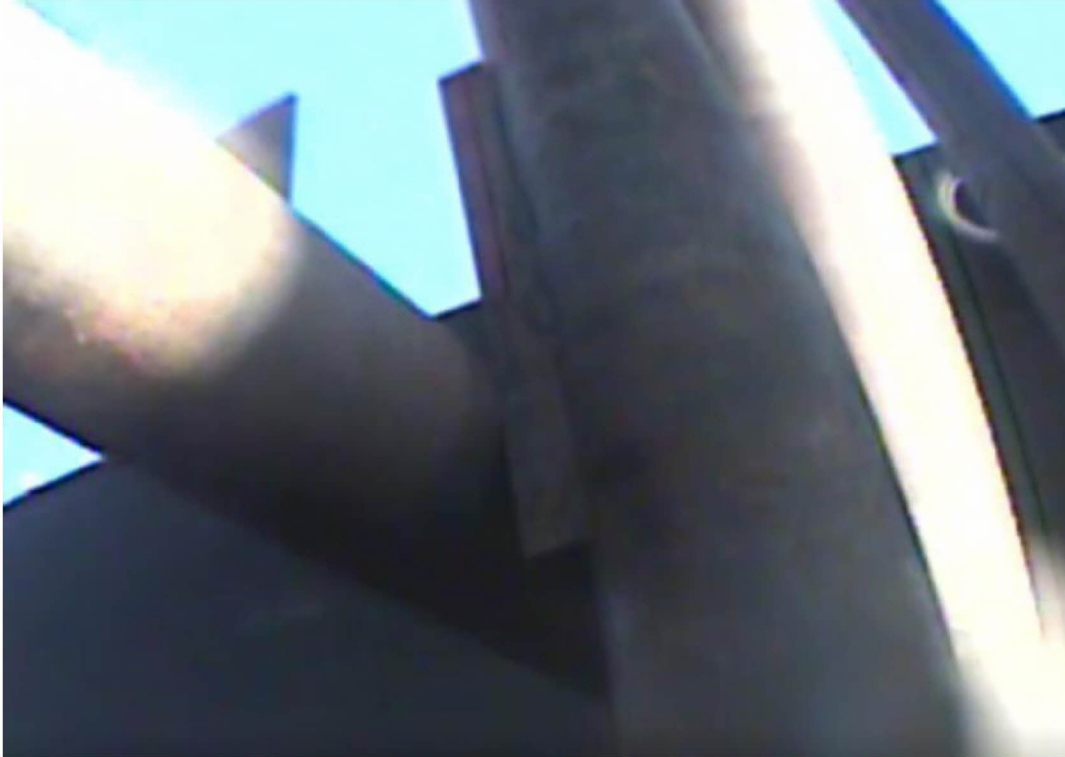
**Figure 6 - Above water of 8" pipe welded to horizontal support**

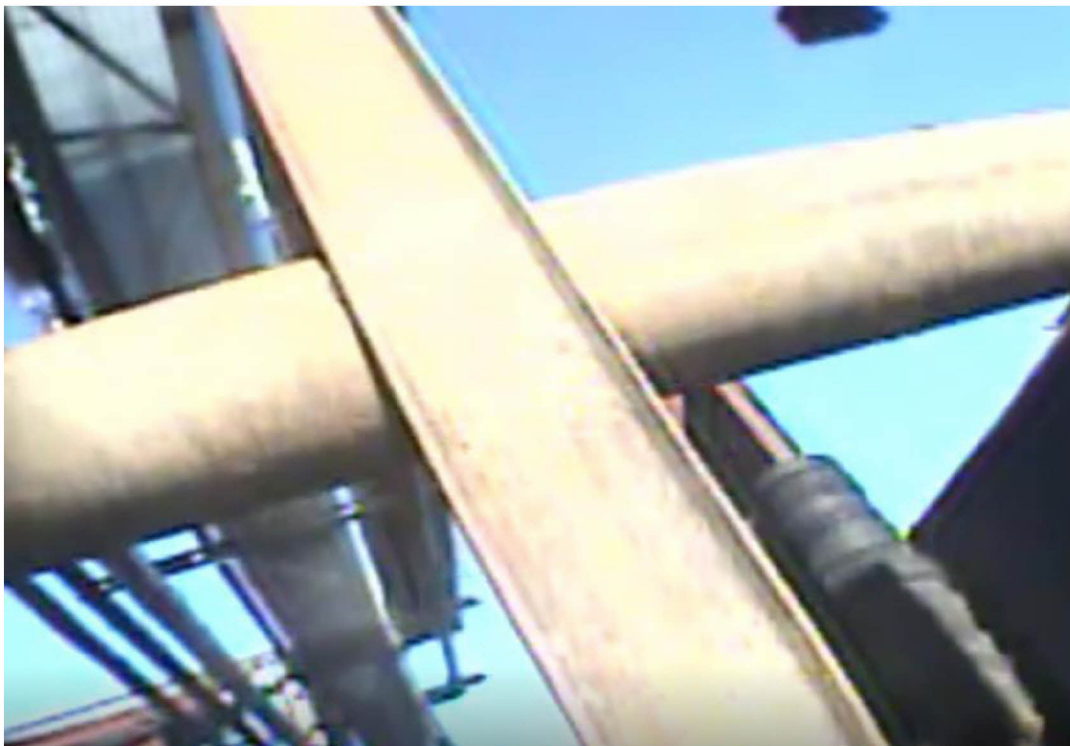
**Figure 7 - Above water view of vertical channel support welded into horizontal support**

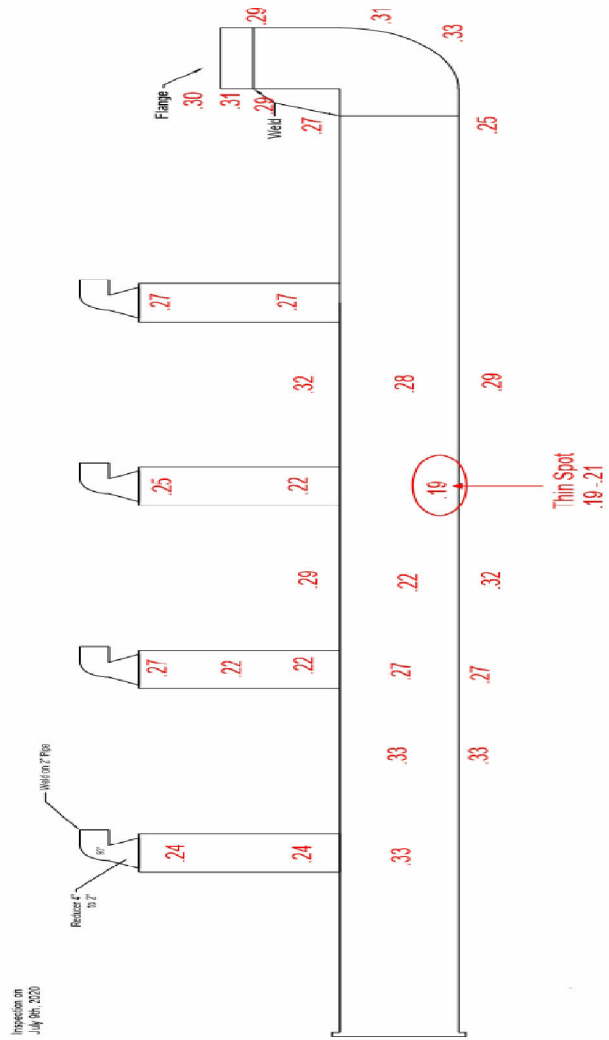
Figure 9 – Diffuser Section UT Thickness Measurements

- After cleaning the diffuser section with a pressure washer, periodic wall thickness measurements were taken. Results varied between .19" and .33". (See attached drawing for detail)
