STATE OF WASHINGTON
BOARD OF PILOTAGE COMMISSIONERS

➤➤ **Preliminary Investigation Report
M/V LEVANT**

19 March 2020

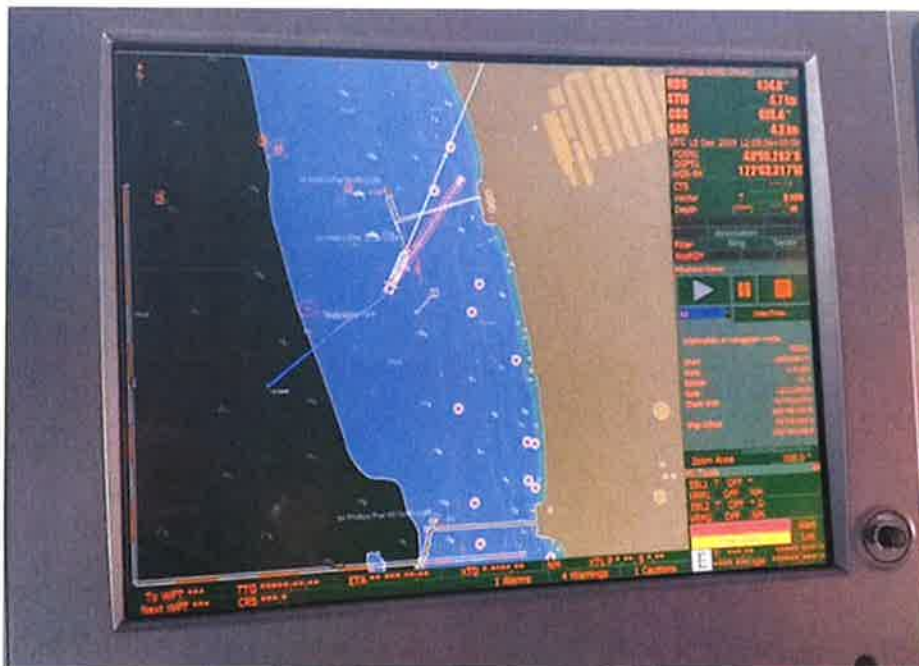
Time 0406
Contact with dock
Heading 025° Speed 4.3Kts

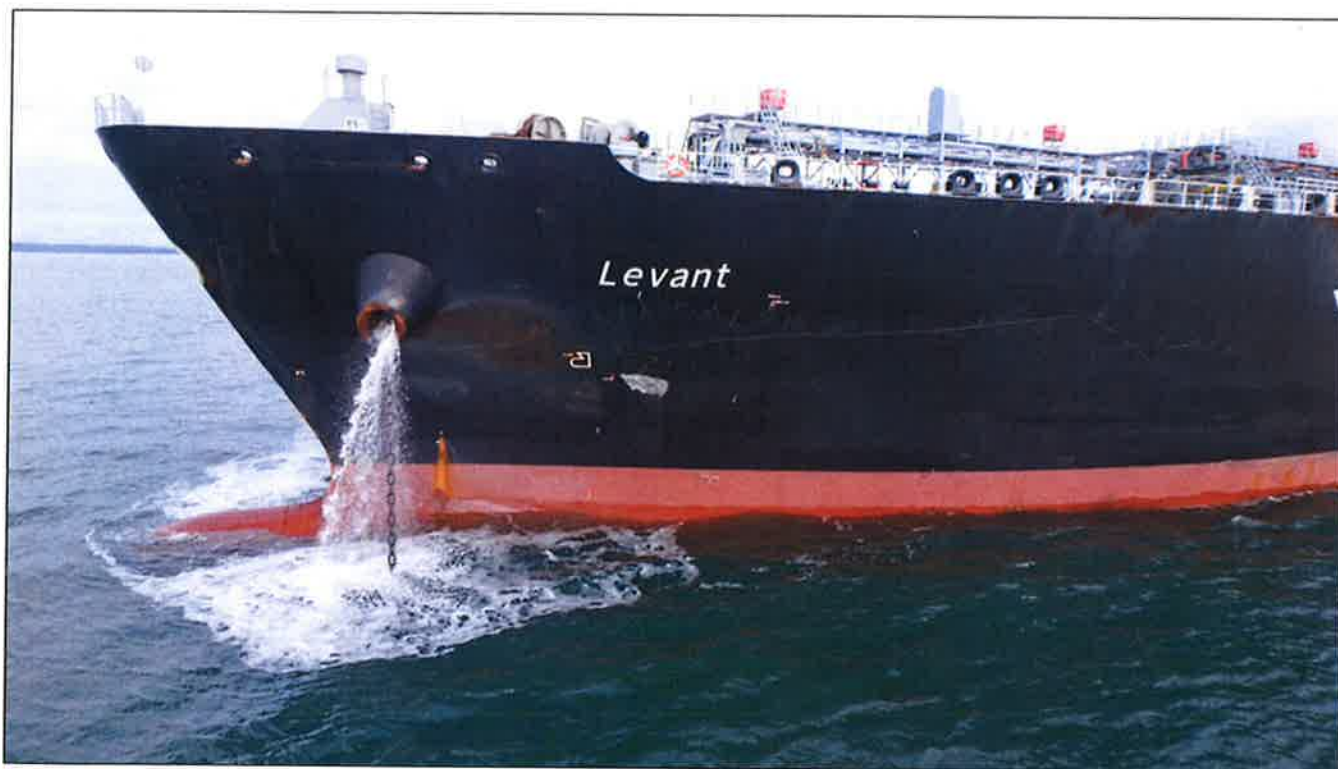
- a crease approx. 40'-60' long on the port bow without any breach of the hull.
- 4 breached holes under the water line in the ships #1 ballast tank reported by surveyor diver measuring:

#1	10MM long	1MM wide
#2	333MM long	50MM wide
#3	90MM long	5MM wide
#4	Numerous Fractures	70MM X 20MM

Temporary repairs have been accomplished (doubler plates welded on) but actual costs are unknown.

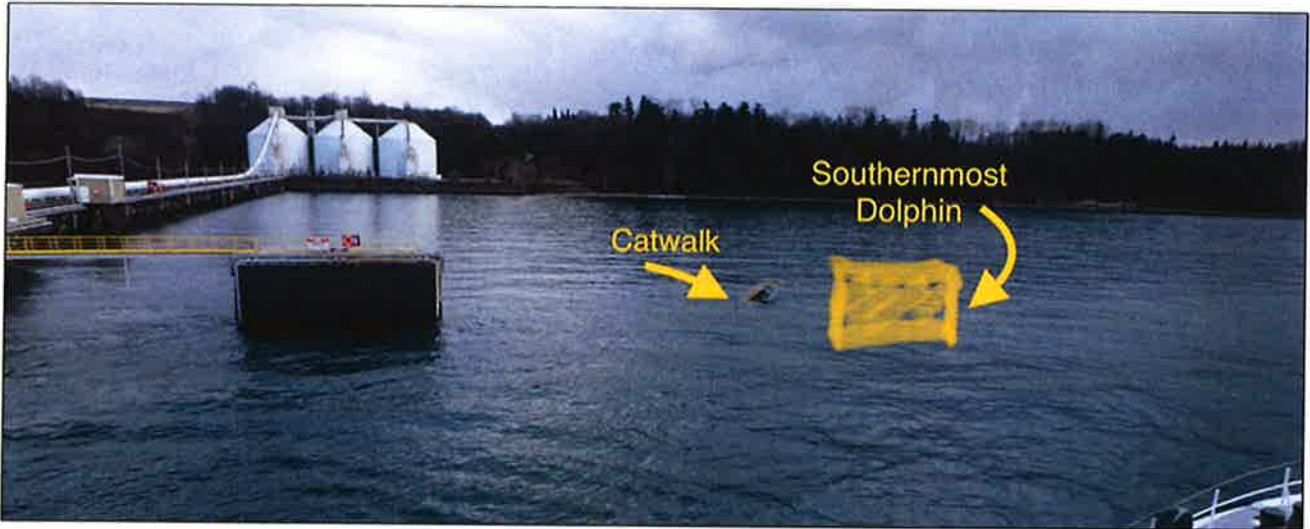
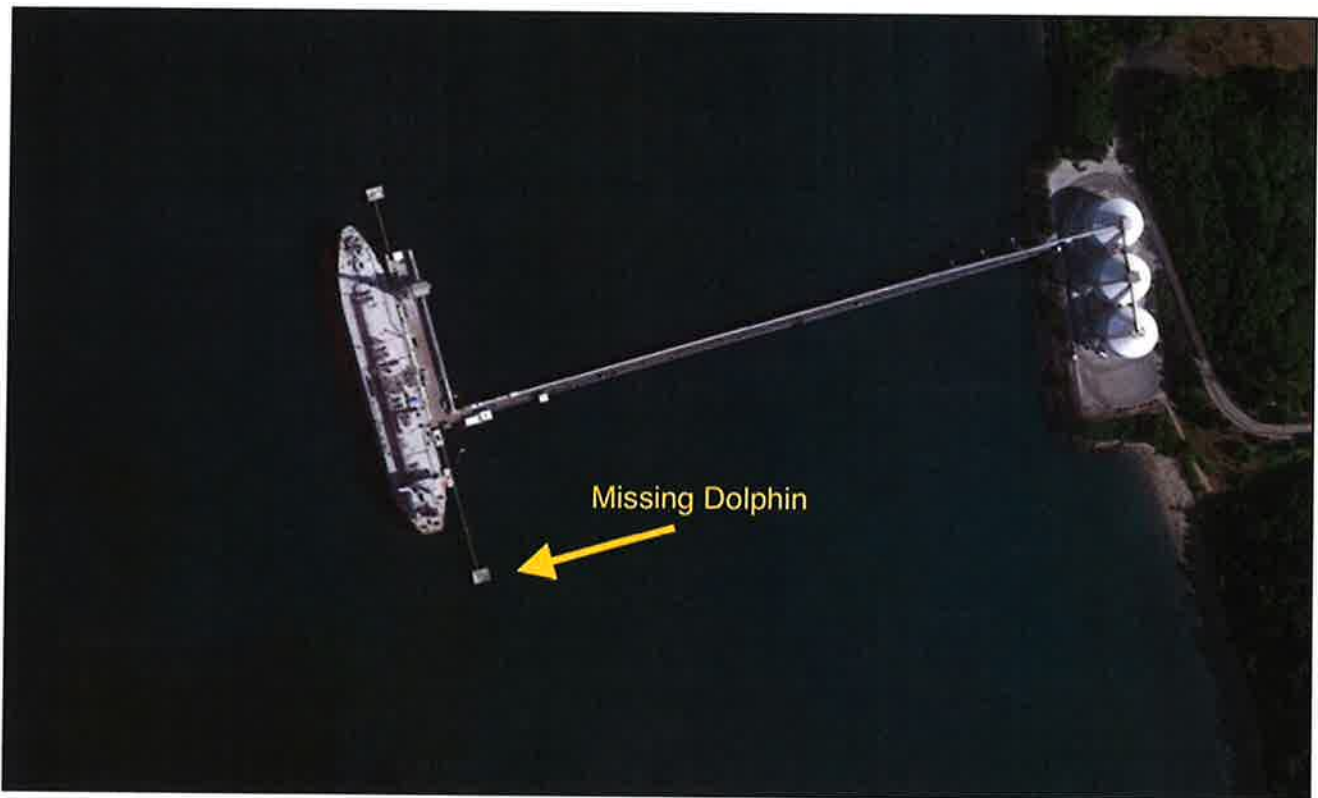
Damage to the dock was total destruction of the dock's southernmost mooring dolphin and total loss of the catwalk to the dolphin.

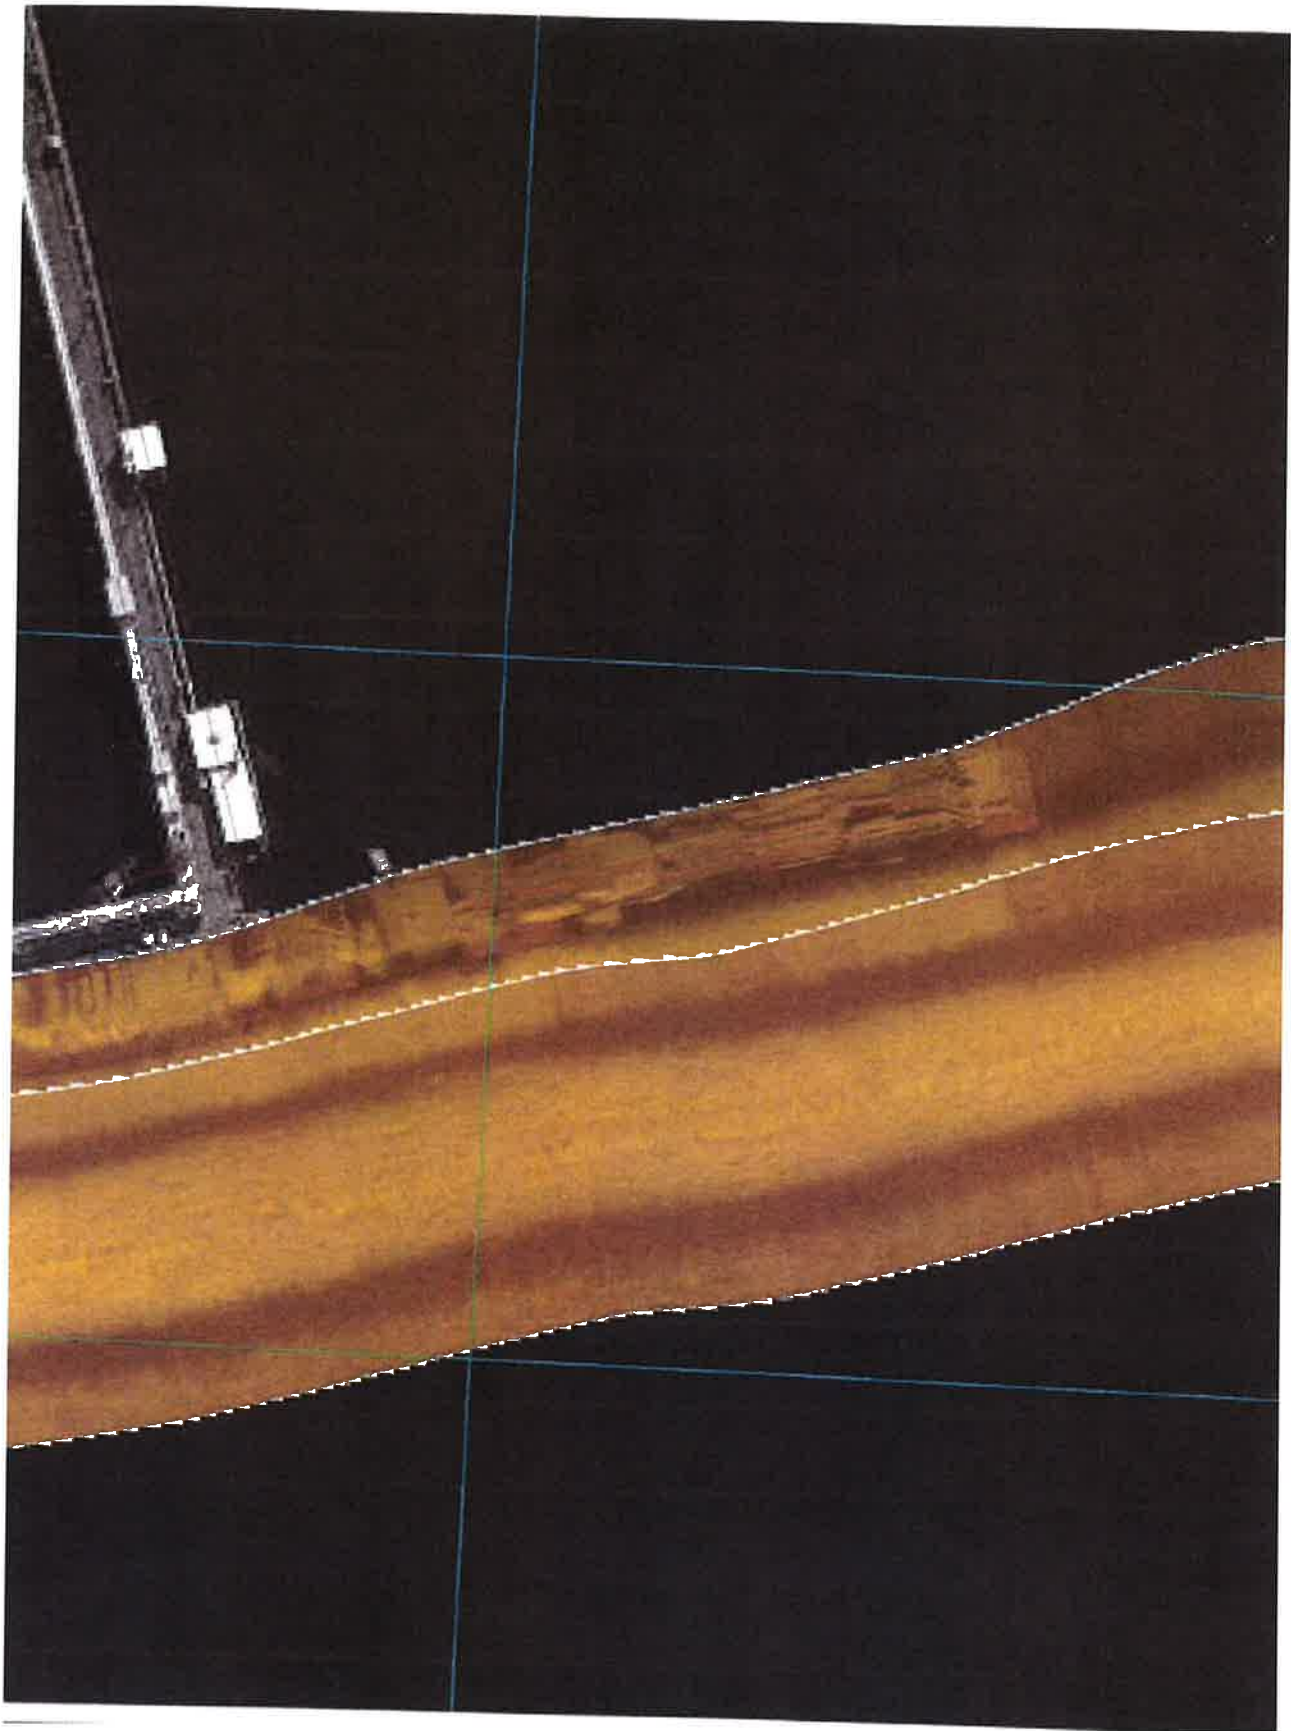
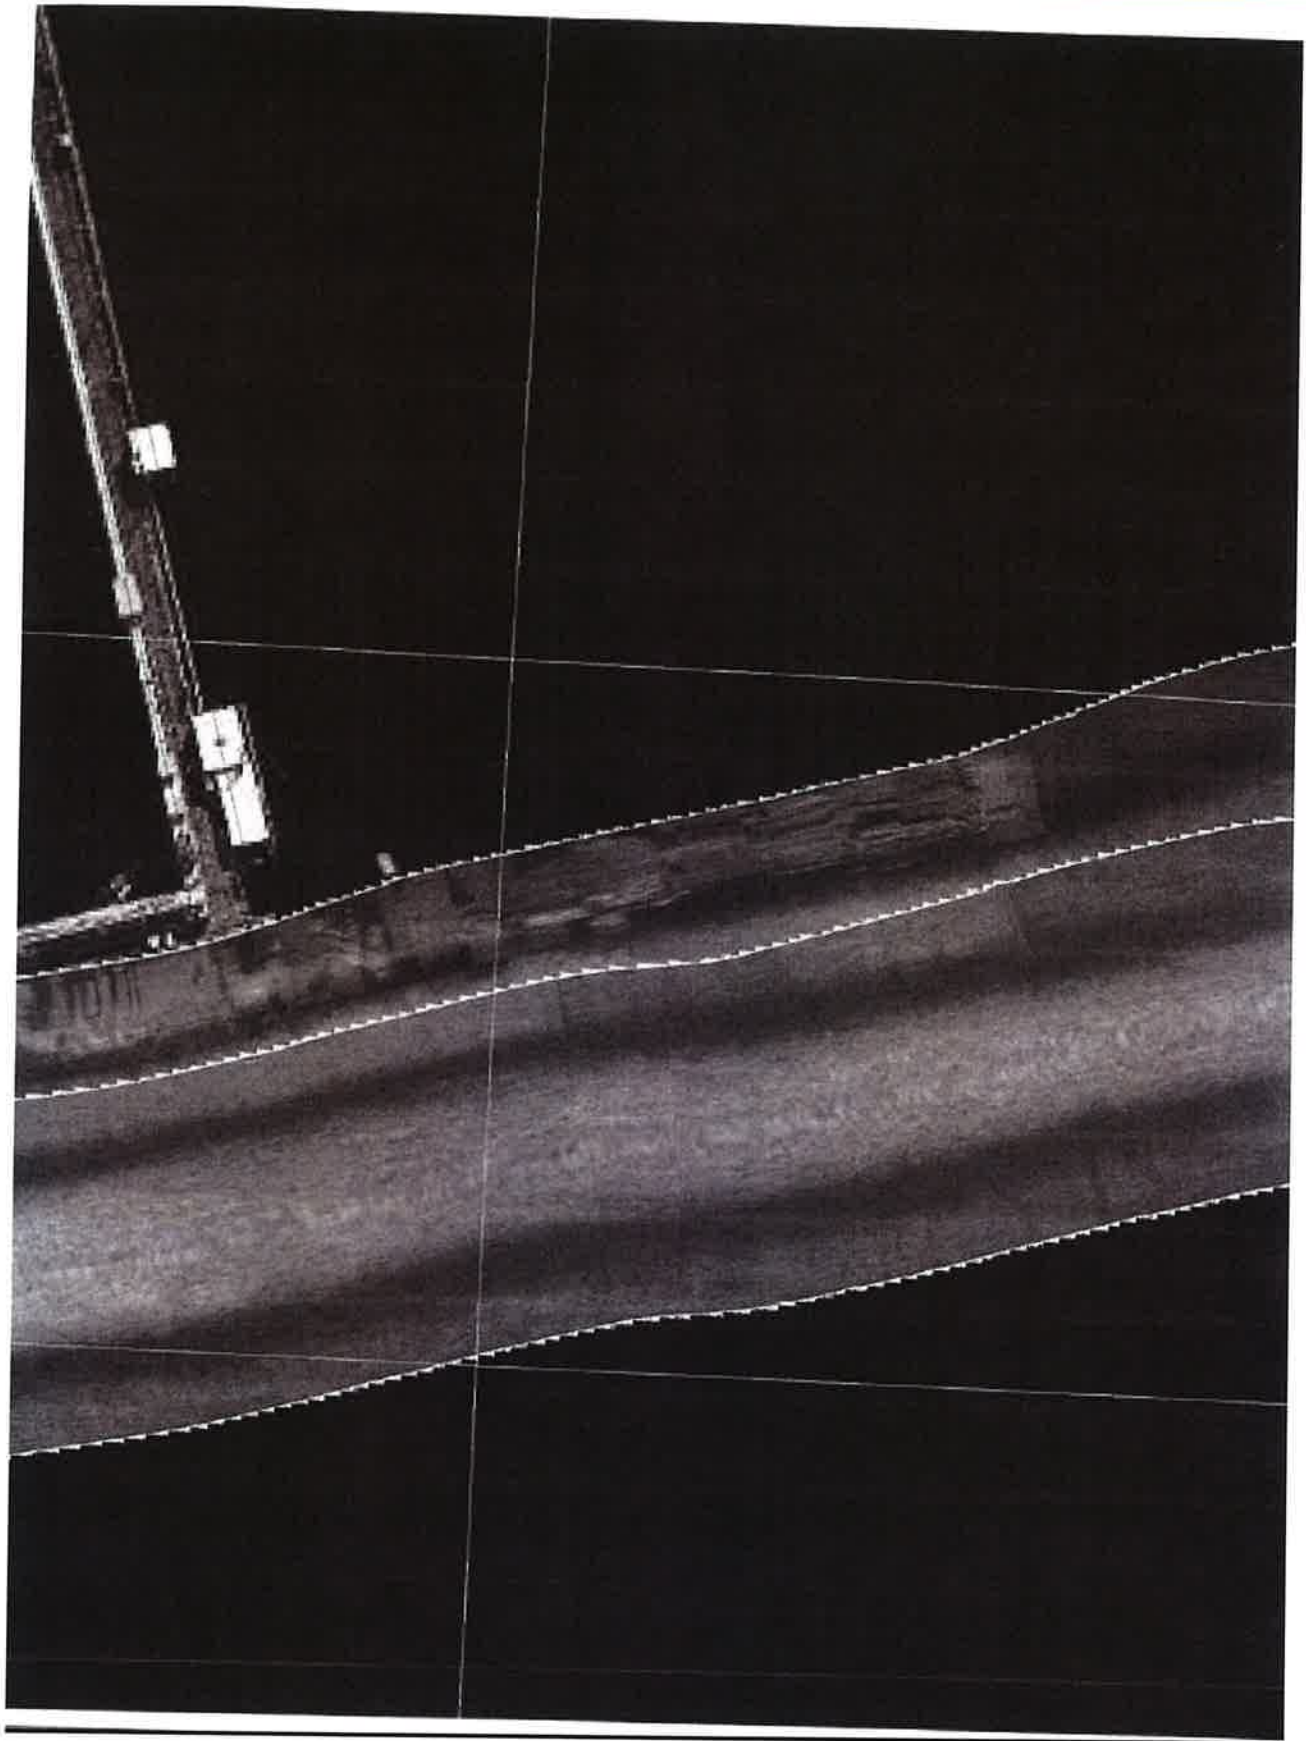
The Side scan image shows that the debris from the south mooring dolphin and south finger dolphin laid north and east of its previous location. Not debris was found in the navigable channel.
