National Transportation Safety Board

Marine Accident Brief

Contact of Liquid Petroleum Gas Carrier *Levant* with Mooring Dolphin

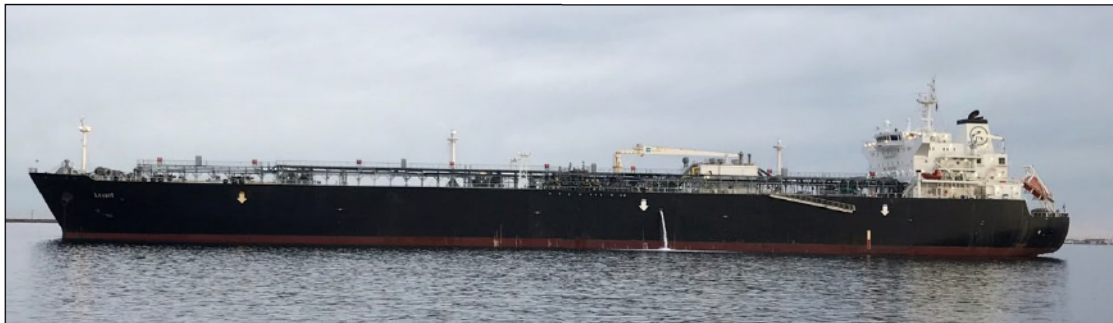
Postaccident photo of the *Levant* at anchor.

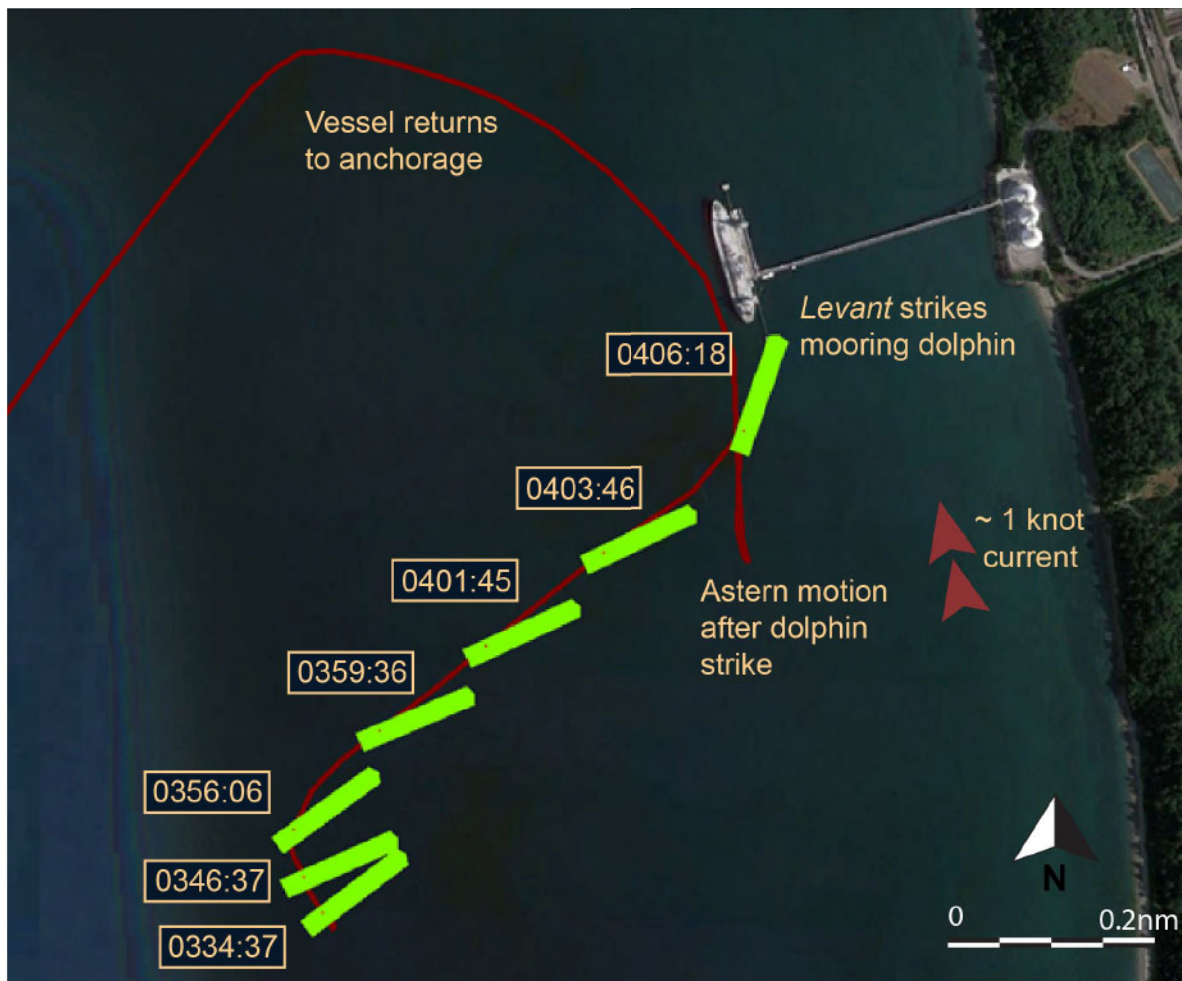
a position where they could see the wharf and south mooring dolphin. The fourth officer radioed the master that there was a 40-meter distance to the mooring dolphin, and the master relayed this distance to the pilot. After hearing this distance, the pilot ordered dead slow astern propulsion. The pilot asked for the distance to the wharf again, and he heard 10 meters as the reply over the radio. At 0406, the bosun announced over the radio the distance from the wharf was 5 meters before both he and the fourth officer moved further aft for personal safety. At that time, the heading of the *Levant* was 024 degrees with a speed of 4.3 knots, about 41 degrees off the dock alignment heading of 343 degrees.

The *Levant's* positions as it moved from the anchorage to the Petrogas Wharf, based on automatic identification system (AIS) data. Vessel scale approximate; vessel at pier was not present at the time of the accident. (Background source: Google Earth)

The *Levant* approached the Petrogas Wharf at too steep of an angle, at an excessive speed for the proximity to the wharf. After getting under way, the pilot ordered a heading of 065 degrees, toward the shoreline at an angle of about 80 degrees to the Petrogas Wharf (343 degrees) to account for the current. The pilot, who said he did not typically rely on the bridge team, only explained to the master his reason for the approach heading he chose. The vessel's speed increased to about 4.5 knots before the pilot ordered the rudder hard to port to bring the ship in line with the wharf. This order came too late, less than 3 minutes before the contact and when the *Levant* was less than two ship lengths from the wharf. By comparison, past approaches to the Petrogas Wharf were at a slower speed and a shallower angle (about 25 degrees). Additionally, Petrogas Wharf operators familiar with seeing vessels approach the wharf explained that the *Levant* had an unusual approach

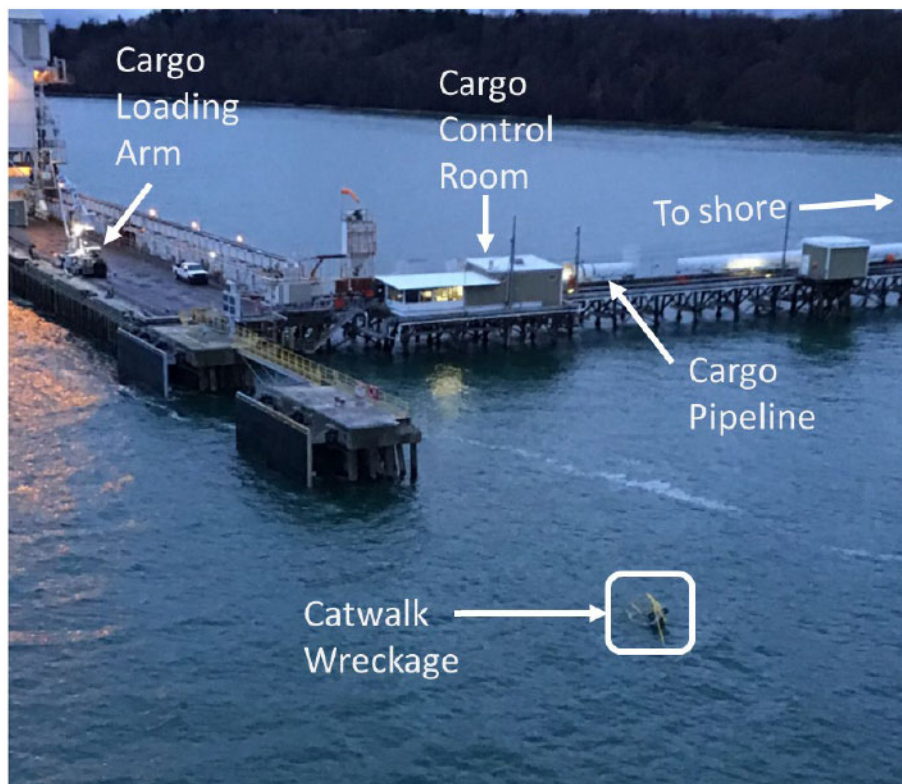
After the contact with the mooring dolphin, the *Levant* crew discovered that an empty forward ballast tank was taking on water. A subsequent damage assessment found four hull breaches below the waterline in the *Levant's* number one port ballast tank, and a crease approximately 40-60 inches long on the port bow. The estimated cost to repair the damage to the vessel was \$1.5 million. The south mooring dolphin and adjoining catwalk at the Petrogas Wharf were completely destroyed; the estimated replacement cost was \$6.75 million.

Postaccident photo of the Petrogas Wharf on the morning of December 15 with the catwalk and south mooring dolphin missing. (Source: US Coast Guard, annotated by NTSB)

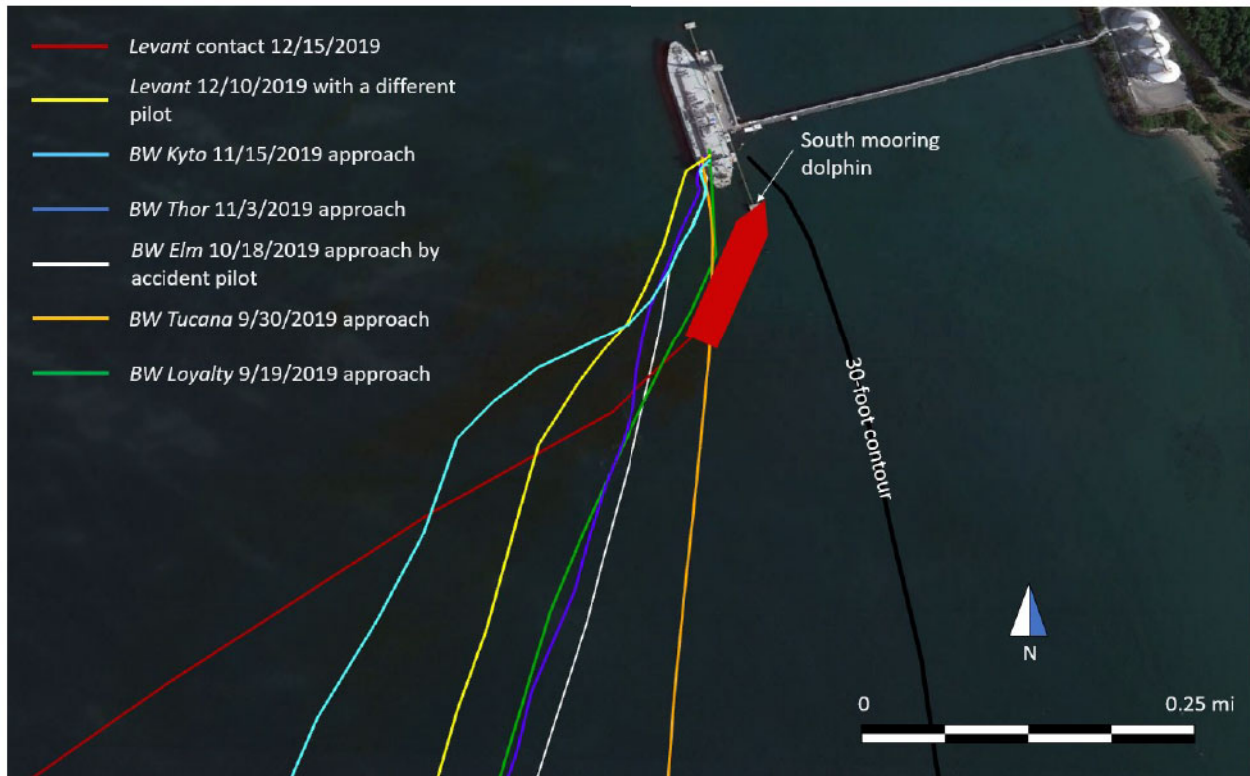
A sample of similar size liquefied petroleum gas carrier approaches to the Petrogas Wharf in the 90 days before the accident, including the accident pilot's last docking of a similar size tanker at the Petrogas Wharf on October 18, 2019, was examined. All six approaches, including the *Levant's* December 10 approach, were at a shallower angle than the accident docking. Additionally, all other approaches had less than 3 knots approach speed within 0.25 miles of the south mooring dolphin.

AIS tracks of all liquid petroleum gas carrier approaches to the Petrogas Wharf from September 19 to December 15, 2019. Included is the initial approach of the *Levant* to the wharf on December 10 (yellow line), and the accident pilot's last approach to the wharf on October 18 (white line). *Levant* scale approximate; vessel at pier was not present at the time of either approach. (Background source: Google Earth)
