A GFT COMPANY

December 15, 2008

⚠ WARNING PBV trunnion supported ball valves manufactured during the period 1990 through 1997 have the potential for a trunnion and gland cap screw failure if the valve is installed in a sour service as defined by NACE MR0175 or is installed in a buried service with applied cathodic protection.

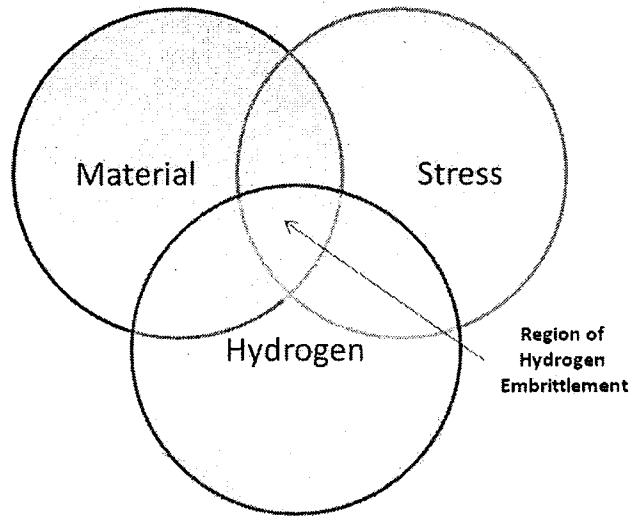
Hydrogen embrittlement is a form of environmentally assisted cracking whereby tensile stress associated with a part or component combines with a source of atomic hydrogen in a susceptible material resulting in a loss of ductility, brittle cracking and failure. Figure 1 shows the hydrogen embrittlement mechanism schematically as the intersection of three factors: stress, hydrogen and material. Typically, steels increase in susceptibility to hydrogen embrittlement with increasing strength, increasing levels of applied stress and increasing levels of atomic hydrogen. The resultant failure mechanism can be represented by enlarging the size of the appropriate circle in the diagram when a particular susceptibility parameter increases in severity. This results in an increased susceptibility to hydrogen embrittlement failure, which is reflected schematically as a larger intersection of the circular areas in Figure 2.

Figure 1 – Schematic of hydrogen embrittlement failure mechanism (only produced in the intersection of the three zones – material, hydrogen and stress).

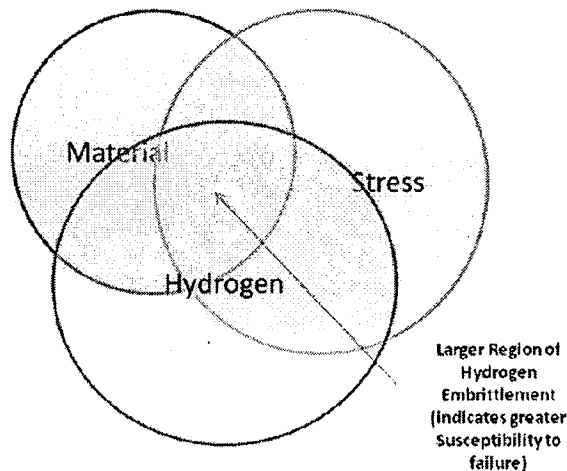
Figure 2 – Modified schematic of hydrogen embrittlement failure mechanism (Note – Shows increased susceptibility to hydrogen embrittlement due to increased amount of atomic hydrogen and increased level of stress).

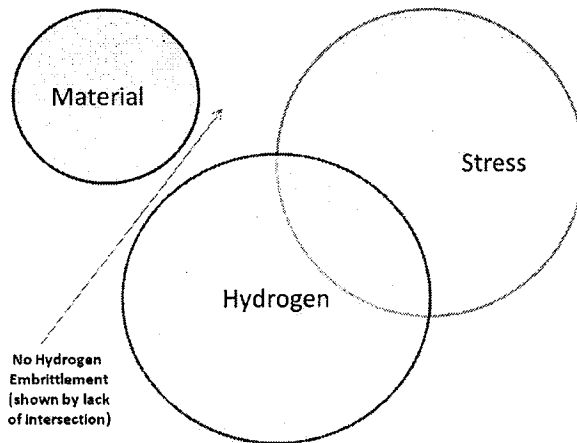
This atomic hydrogen does not cause failure in the other valve components because these components are made from steels of lower hardness and therefore they have a lower susceptibility to hydrogen embrittlement than the steel in the cap screws. Using the schematic presented previously to analyze the susceptibility of the other valve components to hydrogen embrittlement, the three regions in the diagram form no intersection (See Figure 3). This same diagram illustrates why the lower hardness replacement steel cap screws are not susceptible to hydrogen embrittlement.

Figure 3 - Modified schematic of hydrogen embrittlement failure mechanism (Note – Shows no susceptibility to hydrogen embrittlement due to decreased material hardness).

We recommend that the standard high strength steel cap screws used in trunnion supported, three-piece style PBV ball valves manufactured during the period 1990 through 1997 be replaced with lower hardness cap screws if the valve is installed in a sour service as defined by NACE MR0175 or is installed in a buried service with applied cathodic protection. PBV will provide these cap screws at no cost
