## **MARINE TRANSPORTATION SAFETY INVESTIGATION REPORT M19P0020**

### **STRIKING OF BERTH AND SHORE GANTRY CRANE**

#### **CONTAINER VESSEL *EVER SUMMIT***

Vanterm, Port of Vancouver  
Vancouver, British Columbia  
28 January 2019

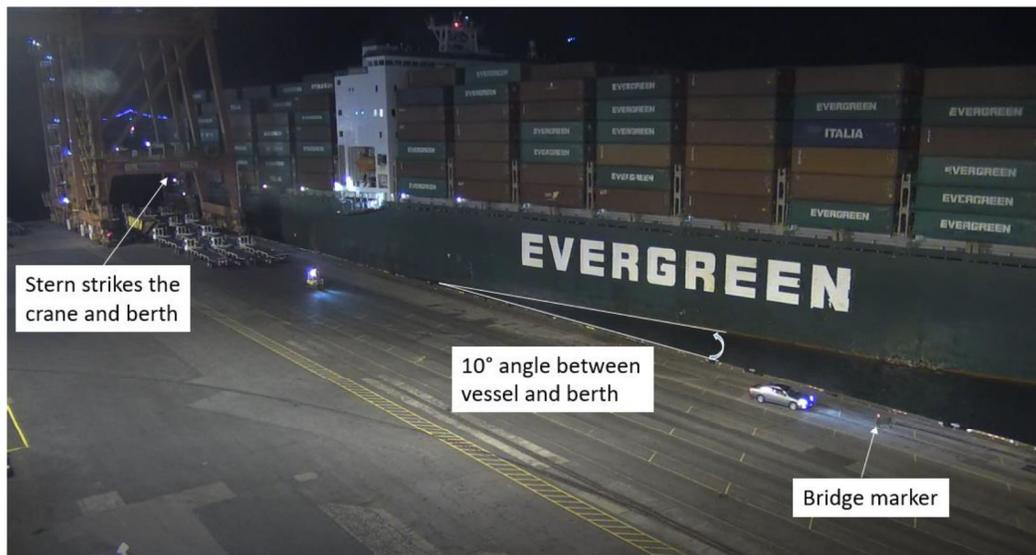
Figure 5. Capture from the closed-circuit television footage of the *Ever Summit* at the time of the striking (Source: GCT Canada, with TSB annotations)

Corrective action using the vessel's engine, rudder, and thruster had insufficient effect, and the vessel's stern struck the dock at an angle of 10° with the berth line and a speed of approximately 0.4 knots. The vessel's large overhang and the proximity of the crane to the berth line resulted in the vessel's hull striking the berth and the crane, which caused the gantry bogies to collapse and the boom to fall onto the vessel.

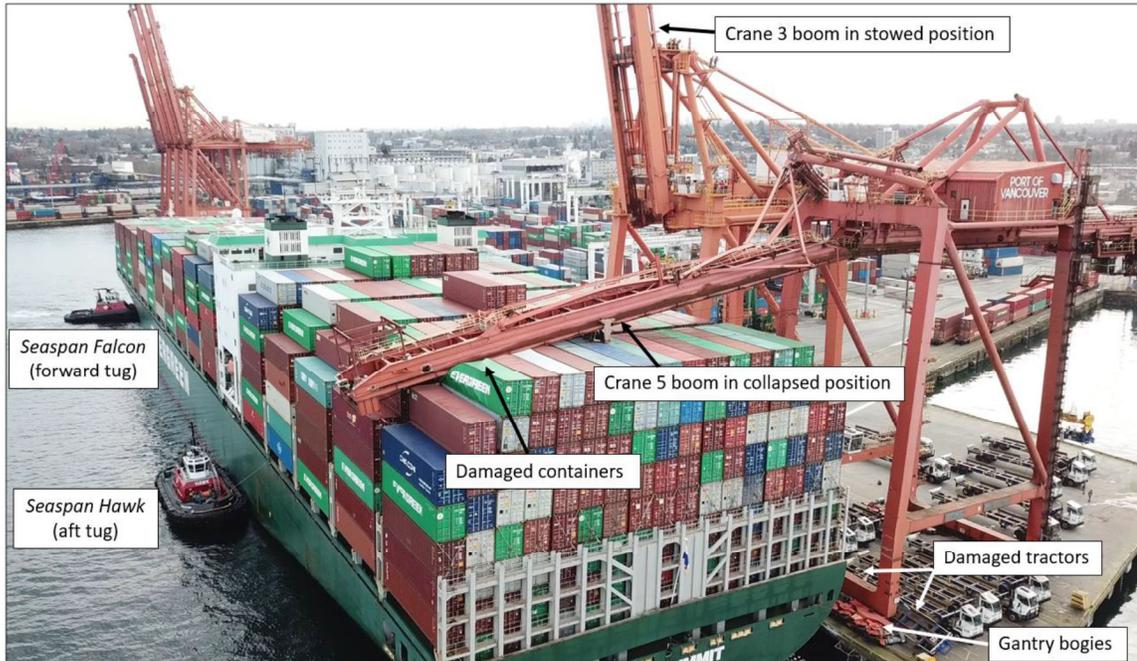
Figure 6. The *Ever Summit* maintaining position after the occurrence (Source: GCT Canada, with TSB annotations)

Approximately 6 containers stowed in the uppermost bays were damaged when the crane boom fell onto the vessel (Figure 6).

Crane 5 was declared a total loss, and Crane 3 sustained minor damage. In addition, numerous tractor-trailers stowed below Crane 5 were damaged (Figure 6).

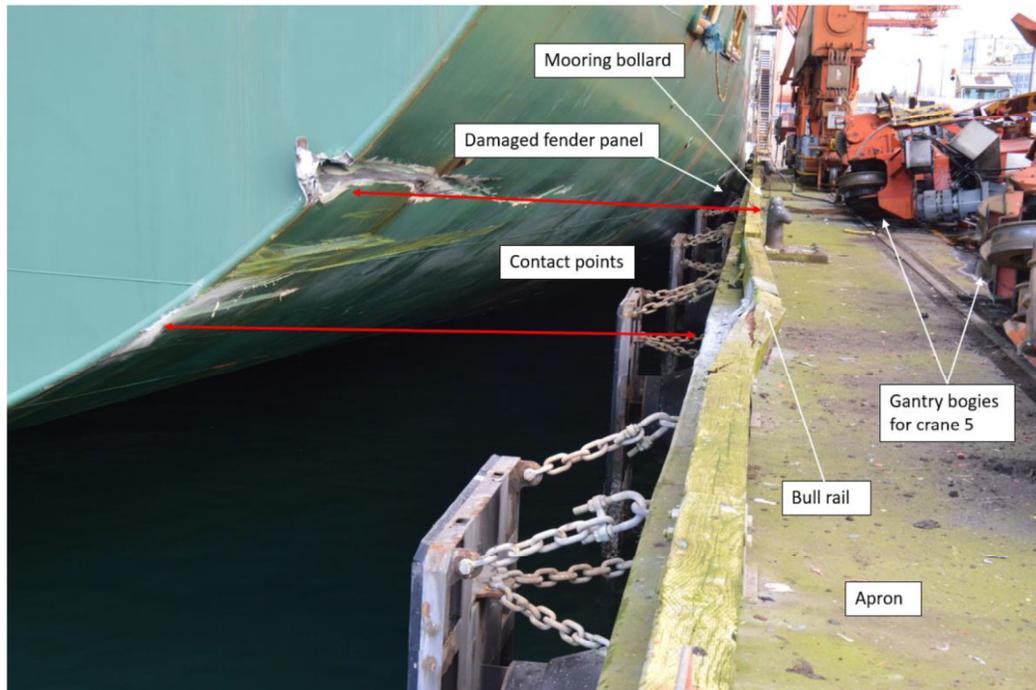
Figure 7. Damage to the vessel's starboard aft shell plating. The red arrows show the points where the vessel came into contact with the berth. (Source: TSB)

In addition, the vessel sustained the following damage (Figure 7):

The concrete edge of the berth sustained impact damage, and the wooden bull rail was cracked and pushed back by approximately 8 cm at the point of contact (Figure 7). The mooring bollard showed signs of abrasion (Figure 7), and 2 of the fender panels were bent and had topside damage.

Before the vessel departed for its next voyage, temporary repairs to the hull were completed on 06 February in Vancouver, BC, to the satisfaction of the attending classification society surveyor.

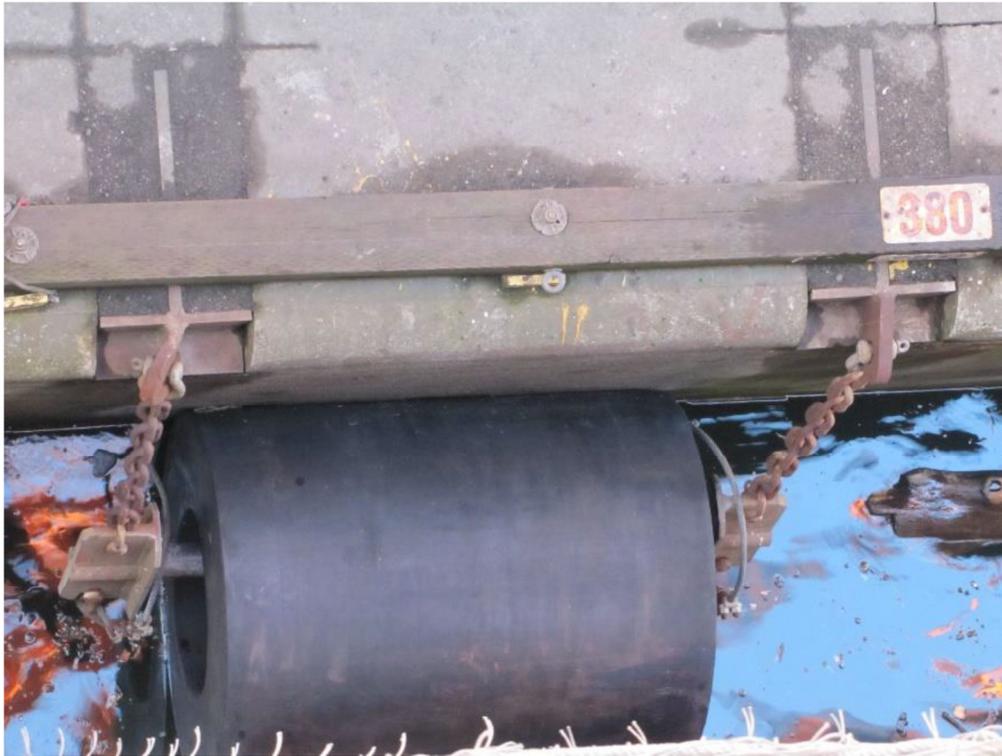
Figure 8. Cylindrical fender on Vanterm berth 5 (Source: TSB)

As part of an upgrade in 1990, berths 5 and 6 were fitted with hollow rubber cylindrical fenders (Figure 8). The fenders are 120 cm in external diameter and 150 cm long. They are draped along the side of the berths at 18.3 m intervals. Each fender hangs on a steel bar that is anchored to the berth with chains. The energy absorption capacity of the fenders is rated at 243 kilonewton metres (kN-m).

When a vessel’s hull presses on the cylindrical fenders, they will compress up to a maximum of 60 cm, which is equal to the inner diameter of the fender, leaving a clearance of approximately 60 cm between the vessel’s hull and the berth face. Once the fender is fully compressed, it behaves as a solid rubber element. Any further compression past this point causes pressure on the vessel’s hull.

The cylindrical fenders do not have a means of reducing sliding friction. Large friction forces can develop as the rubber fender is compressed between the vessel hull and the concrete berth face, resulting in damage to the anchoring chains or plates. The fenders are known to the pilots as being “sticky,” meaning that the vessel’s hull does not slide easily along the fenders, but rather “sticks” on them, which can make berthing more difficult.

The review concluded that the damage was a result of the existing fendering system not having sufficient capacity to absorb the kinetic energy of the large vessels berthing at the terminal. Specifically, when the fenders are compressed to their maximum, large vessels can make contact with the berth face, causing impact damage to both the berth and the vessels.

The review also identified that the existing cylinder fender system was inappropriate for the size of container vessels that dock at the berth. The energy absorption capacity of the fenders was significantly less than the required energy absorption for the maximum design vessel<sup>30</sup> (1662 kN-m). The fender stand-off distance<sup>31</sup> was inadequate, and the fender spacing was too far apart considering the size of the fenders and the heavy loads placed on them.

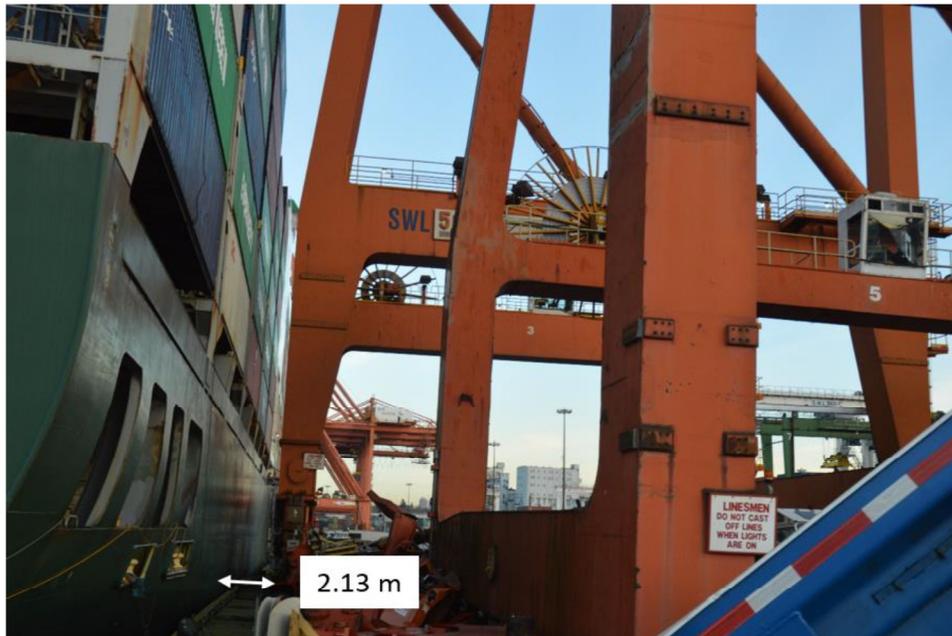
Figure 12. Distances between the berth line and crane rail at Vanterm (Source: TSB)

Deltaport 3 was designed for a maximum approach angle of 5° at a velocity of 12.5 cm/s. The bollards are rated for 125 tonnes safe working load, with 200 tonnes safe working load bollards at the ends of the berth. The distance from the waterside crane rail to the berth line is approximately 6.96 m at Deltaport 3, whereas the distance from the crane rail to the berth line at Vanterm is 2.13 m (Figure 12 and Figure 13).

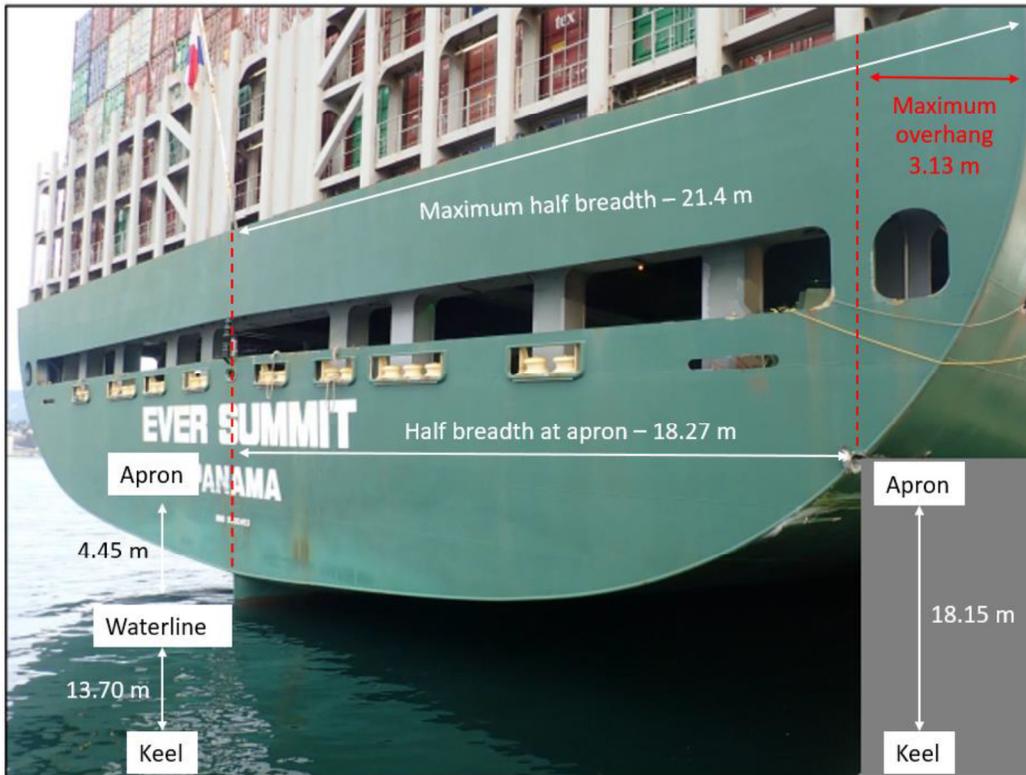
Figure 15. The *Ever Summit's* maximum overhang at the stern at the time of the occurrence (Source: TSB)

The TSB determined that, at the time of the occurrence, the *Ever Summit’s* maximum possible overhang at the stern was approximately 3.13 m (Figure 15 and Appendix D).

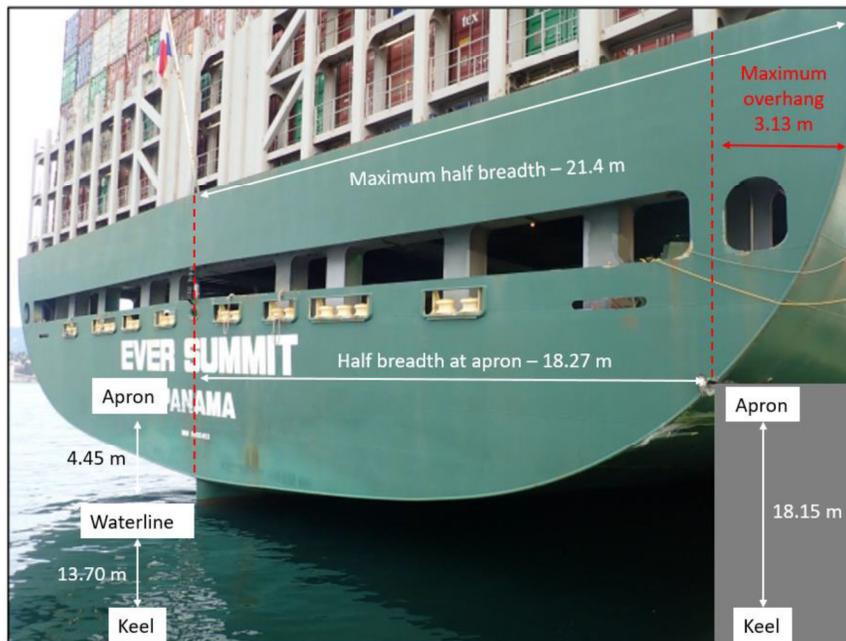
Figure D1. The *Ever Summit*'s maximum overhang at the stern at the time of the occurrence (Source: TSB)

To determine the maximum overhang at the transom, the difference between the half-breadth of the vessel at the apron level and the maximum half-breadth of the vessel was calculated. The maximum possible overhang at the transom was determined to be **3.13 m** (Figure D1).
