BEFORE THE WASHINGTON UTILITIES AND TRANSPORTATION COMMISSION

DON F. KOPCZYNSKI

REPRESENTING AVISTA CORPORATION

Protocol for Managing Select Aldyl A Pipe in Avista Utilities' Natural Gas System

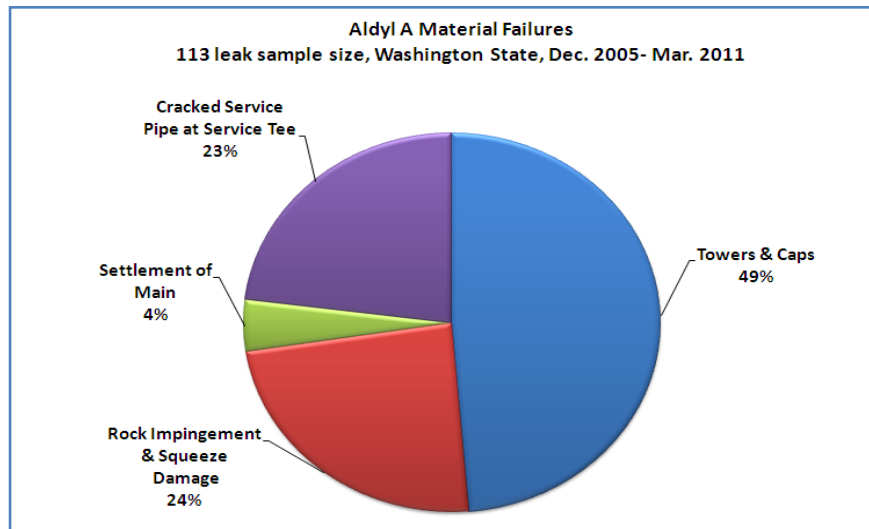
In tackling the first objective of the assessment of its Aldyl A piping, Avista aggregated the gas leaks resulting from Aldyl A material failures found in its gas system in Washington State from late 2005 through March 2011. The sample included 113 material failures that were evaluated and summarized by component to offer an understanding of the specific failure modes for Aldyl A pipe. The 'modes' or types of material failures categorized are shown below in Figure 1.

Figure 1. Modes or types of material failures documented in a sample of 113 leaks in Avista's Aldyl A piping in Washington State, December 2005 through March 2011.

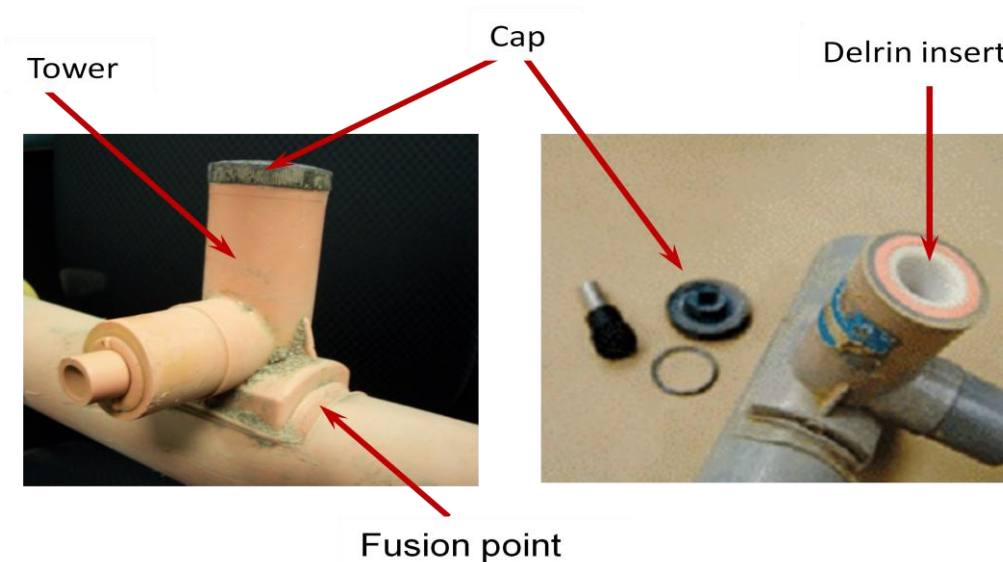
The largest percentage of material failures in the sample occurred in Towers and Caps, referring to failure of the service tapping tee itself, shown below in Figure 2. In these cases, the pressure applied to the tee as the cap was tightened onto the body during initial installation has resulted in slow crack growth and failure of the tower body, the cap, or the Delrin[®] insert many years later. Additionally, the saddle fusion point of the tower to the main pipe is another frequent point of failure in this assembly. The unavoidable stresses created during standard installation (using factory recommended procedures) have led to brittle cracking in these components many years later. This phenomenon clearly demonstrates the susceptibility of certain resins of Aldyl A piping to tend to fail by brittle cracking due to the slow crack growth initiated during installation.

Figure 2. External features and internal components of a typical Aldyl A service tee, as fused to Aldyl A main pipe.

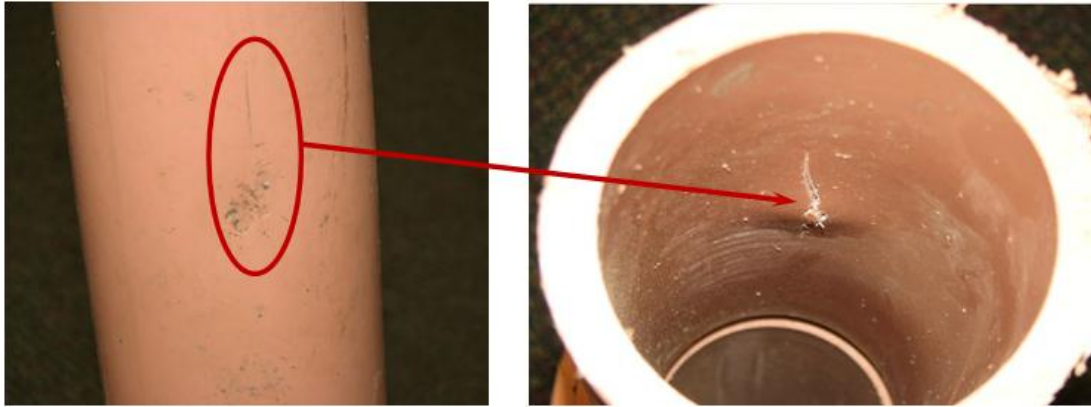
The second-most common material failure observed in Avista's Aldyl A pipe was due to localized, brittle cracking in Aldyl A mains that resulted from rock impingement – rock pressure directly on the pipe, or places where ‘squeeze-off’ was applied over the pipe's service life. These failures are very typical for certain resins of Aldyl A main pipe, having been consistently reported by other utilities since before the time of DuPont's 1986 letter. As described earlier, when these external stresses (rock impingement or squeeze-off) cause the pipe to fail, it always begins with crack initiation on the inside surface of the pipe wall, eventually resulting in slow crack growth that propagates toward the outer wall of the pipe, and finally, through-wall failure. These failures generally appear as short, tight cracks in the outer wall of the pipe that run either parallel, or slightly off-parallel with the length of the pipe. A typical failure in Aldyl A main pipe, showing a crack through the pipe wall as it appears on both the inner and outer surfaces, is shown below in Figure 3.

Figure 3. Typical brittle-like crack through the wall of Aldyl A pipe, resulting from rock contact directly on the pipe.

Although the duration of the stress caused by rock contact with the pipe is very different from that associated with squeeze-off, they both result the same pattern of crack initiation and slow crack growth leading to failure of the pipe. Other sources of external stress that can result in brittle failure of Aldyl A pipe, as mentioned earlier in the report, include bending of the pipe, soil settlement, dents or gouges to the pipe, and improper installation of fittings.

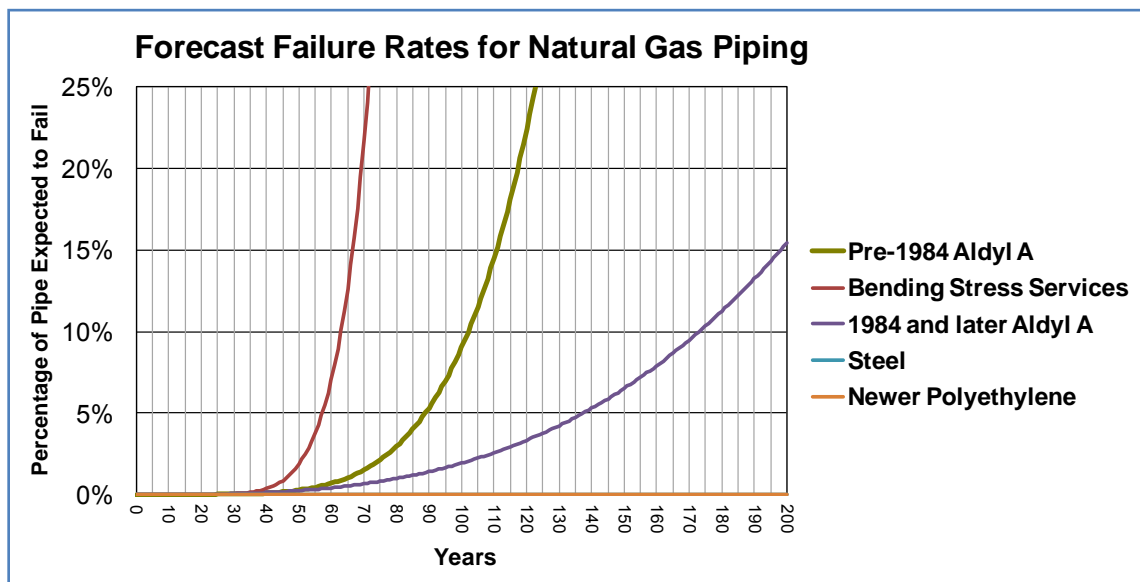
Figure 5. The expected failure rates for several classes of pipe in Avista’s system, as forecast by Availability Workbench Modeling. The “Steel” curve is obscured by the “Newer Polyethylene” curve, both of which are essentially flat lines.

The failure curves show dramatic differences in the expected life for the pipe classes evaluated. The difference in expected life between the Aldyl A products as a group, compared with that of steel and newer-generation plastic pipe, is particularly evident. Striking also, are the expected performance differences among the classes of Aldyl A pipe evaluated, providing some clear trends useful in designing remediation strategies.

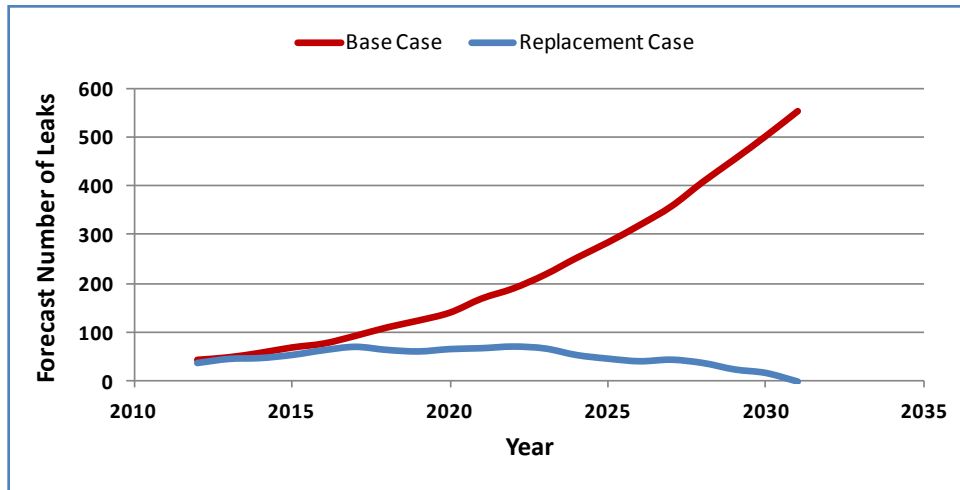
failures each year is expected to increase slightly until 2017, at which time the cumulative effect of priority piping replaced since 2012 begins to check the failure count and then drive it toward zero over the remaining course of the program (Figure 8).

Figure 8. Expected numbers of material failures in Avista's priority Aldyl A piping in two cases: Replacement Case - piping replaced over a twenty year horizon in the manner proposed by Avista in this report, and Base Case - assumed that priority piping was not remediated under any program.
