DOCKET UW-240151

SANITARY SURVEY REPORT

January 12, 2022 Dale Metzger Estates Inc. Post Office Box 92 Sequim, Washington 98382	Estates Inc. Water System ID #081669	
	County:	Clallam
	System Type:	Community
	Operating Permit Color:	Green
	Surveyor:	Jocelyne Gray
	Water System Attendees:	Dale Metzger Culley Lehman
	County Health Attendees:	Sue Waldrip Ben Majors
	Inspection Date:	December 8, 2021

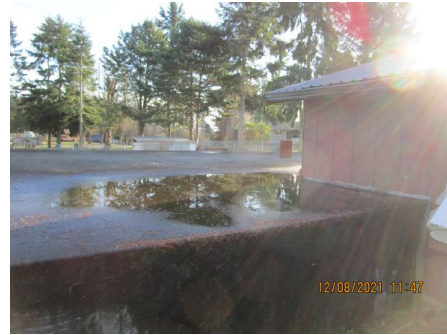
Large Storage Tank - Ponding

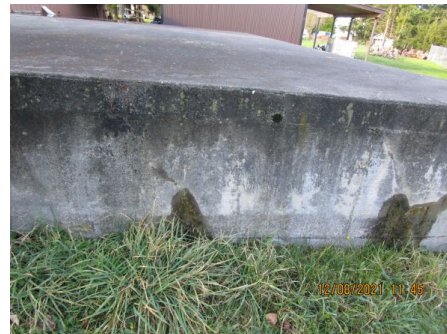
Tank 2, the larger tank, has several locations on the north side and one on the east side that are leaking. ODW is aware Cascadia Water plans to replace both buried reservoirs with an above ground storage tank. Submit a corrective action plan for engineering design and construction of the proposed tank. If a new tank is not proposed, hire a qualified structural inspector to evaluate the reservoir. Submit a copy of the inspection results and a corrective action plan describing how you will address the inspector's findings.

East Side Large Storage Tank

2. Submit a corrective action plan for engineering design and construction of the proposed tank. Tank 2, the larger tank, has several locations on the north side and one on the east side that are leaking. ODW is aware Cascadia Water plans to replace both buried reservoirs with an above ground storage tank.

If a new tank is not proposed, hire a qualified structural inspector to evaluate the reservoir. Submit a copy of the inspection results and a corrective action plan describing how you will address the inspector's findings.

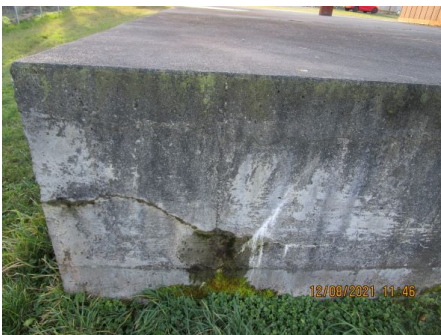
North Side Large Storage Tank

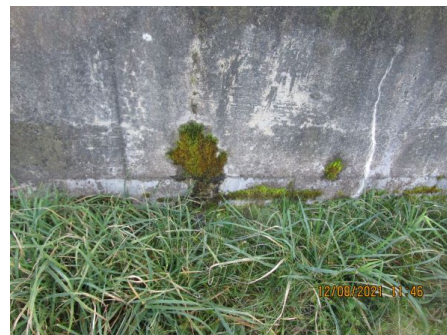
North Side Large Storage Tank

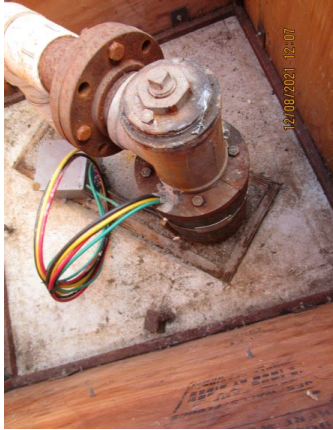
Electrical wires entering Well 1 need to be sealed. Wires were sealed during inspection.

Well 1 With Sealed Wires

1. Electrical wires entering Well 1 needs to be sealed. Wires were sealed during inspection.

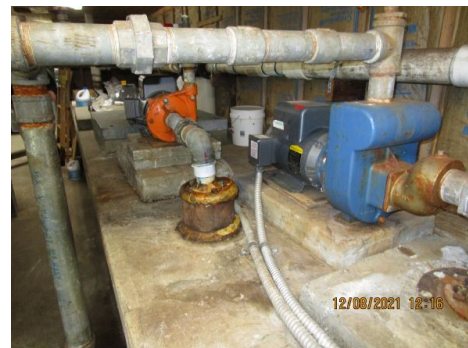
The existing generator only runs the booster pumps for Tank 1.

Booster Pumps for Small Storage Tank

The generator is currently sized to run just the booster pumps for Tank 1, which requires water conservation during power outages. A larger generator is on order that can run both wells and booster pumps without conservation. This increases system reliability. Due to supply chain issues worldwide, delivery and installation are delayed.
