Subject: Annual Flow Meter and Outfall Inspections, NW Natural Source Control Groundwater Treatment Facility, 7900 NW St. Helens Road, Portland, NPDES Permit Number 103061 (permit renewal pending with DEQ)

DIVE INSPECTION REPORT

NW Natural - Gasco Willamette River Outfall Diffuser
Inspection

REPORT DATE: October 3, 2019

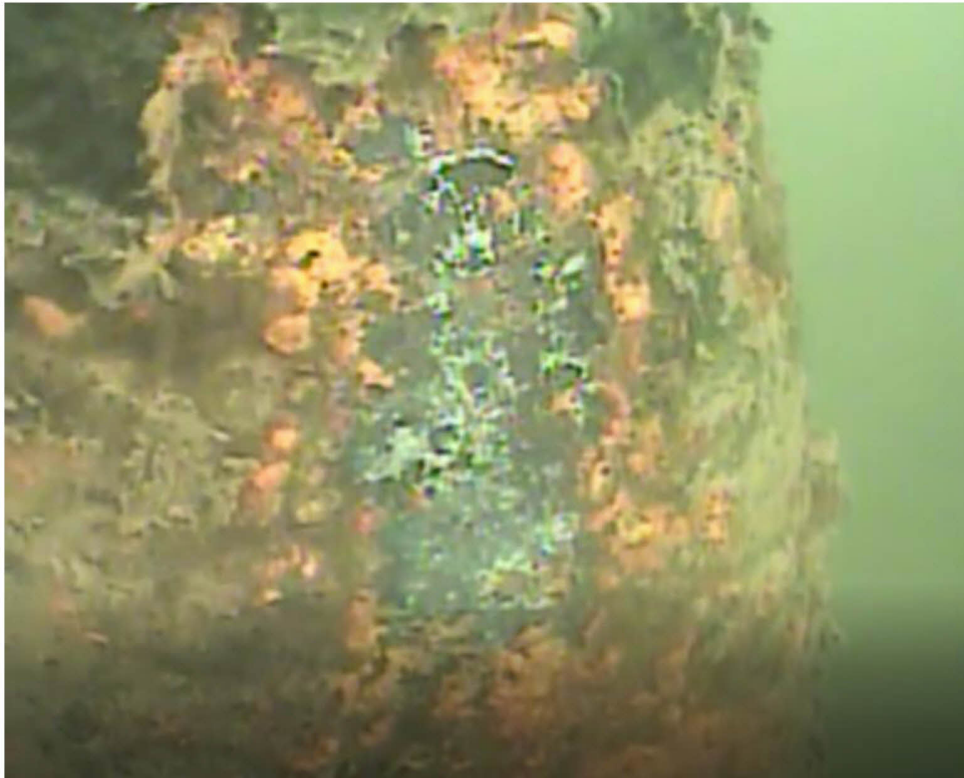
- Pipe had both minor corrosion and marine growth build up present. Pitting was also present on pipe after it was cleaned off.
- Overall integrity of the pipe was determined to be good with no discrepancies noted.
- Pipe was securely hanging in water column with very little movement when checked by the diver.

Figure 2 – 8” Outfall pipe marine growth and rust scale build-up, middle area is cleaned are that exposes pitting

- Consider replacing the corroded flange hardware.
- Weld an anode to the 8" outfall pipe to provide corrosion protection.
- Perform annual inspections to monitor condition of outfall components.

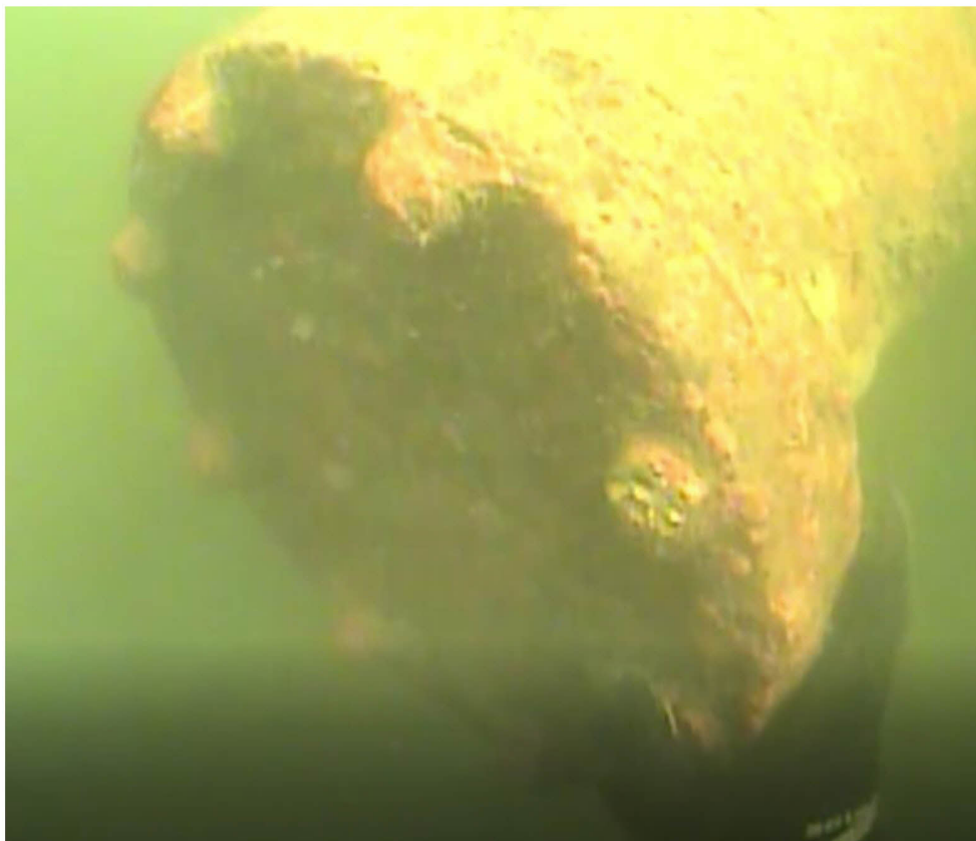
- Both the vertical flange that was installed prior to the 8" main pipe turns horizontal in water and the blind flange had all hardware present and tight. Hardware and flange highly corroded and marine growth build-up present (see Figures 3,4, and 5)
- During GPM flow testing no flow was detected leaking from the flanges.

Figure 3- Blind Flange and hardware

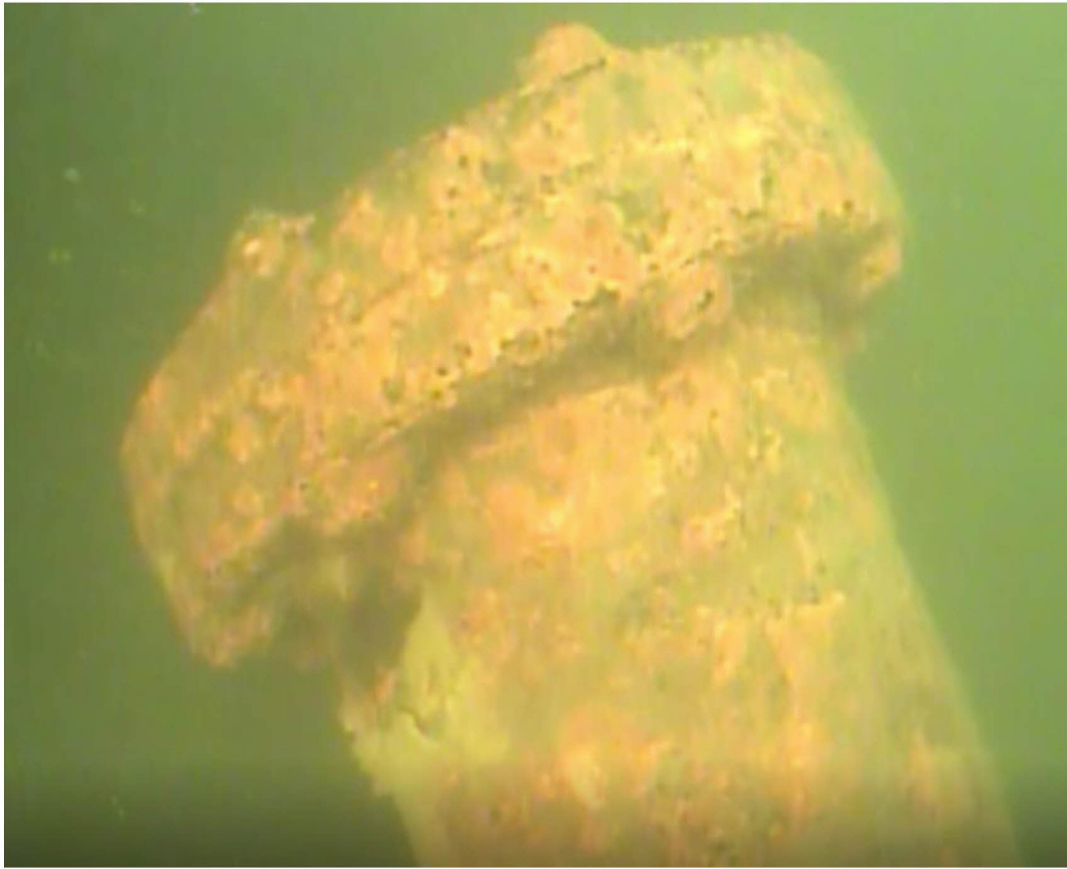
Figure 4- Blind flange and hardware from backside

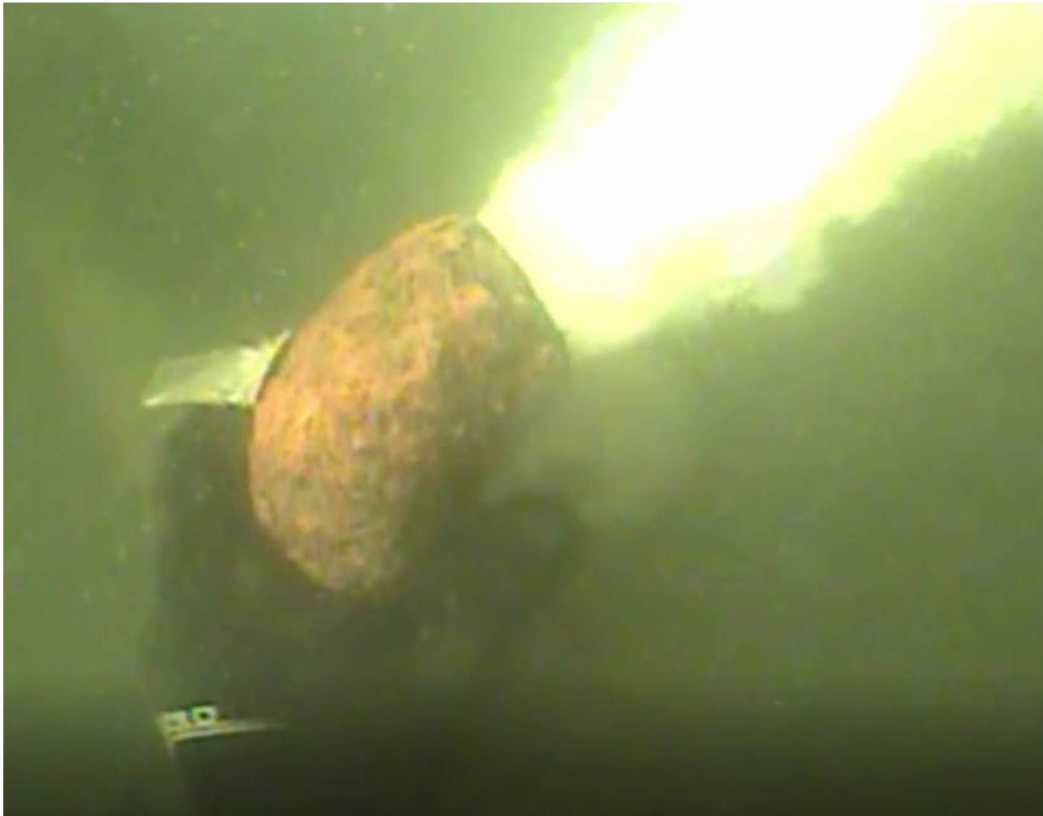
- Diffuser #1 – Welded connection to crown of main 8" pipe was in good condition with no cracks. Pipe had both rust corrosion and marine growth build up present. Pitting was present on pipe. Diffuser was not obstructed, and no cover or screen was present.

- Diver noted that diffuser #1 had the strongest flow and it began tapering down as he moved down to each diffuser with #4 being the weakest.
- During the flow test diver inspected all components of the submerged section of the outfall and no leaks were present.

Figure 6- Diffuser #1 during flow test

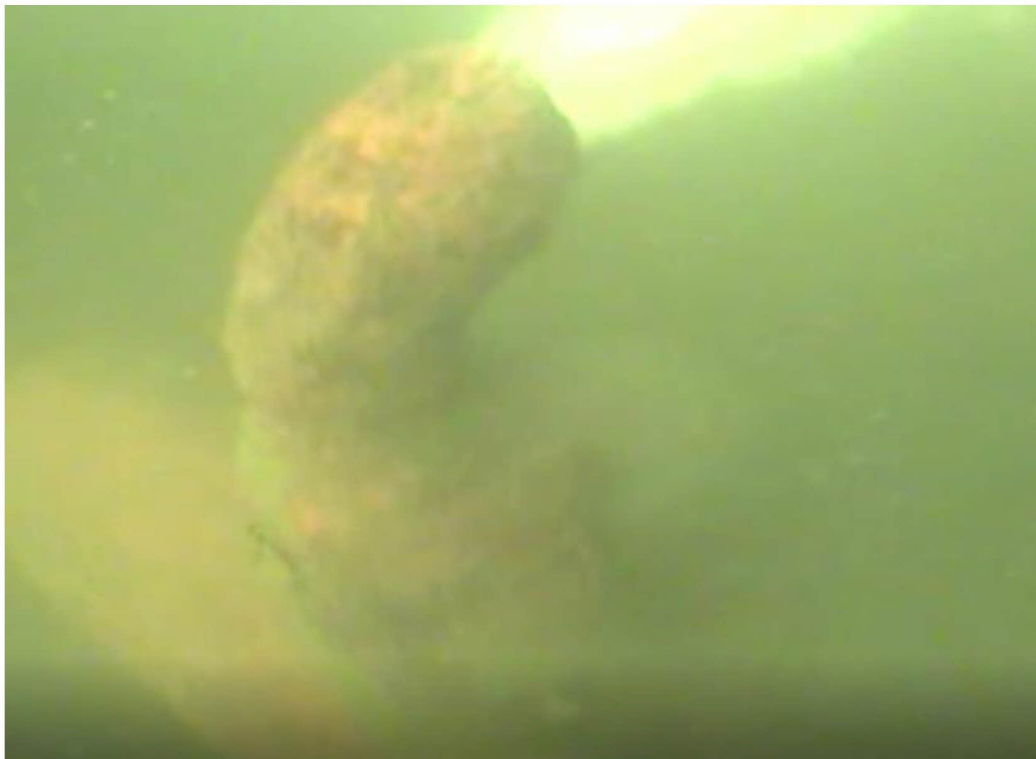
- Diffuser #2 - Welded connection to crown of main 8" pipe was in good condition with no cracks. Pipe had both rust corrosion and marine growth build up present. Pitting was present on pipe. Diffuser was not obstructed, and no cover or screen was present.

Figure 7- Diffuser #2 during flow test

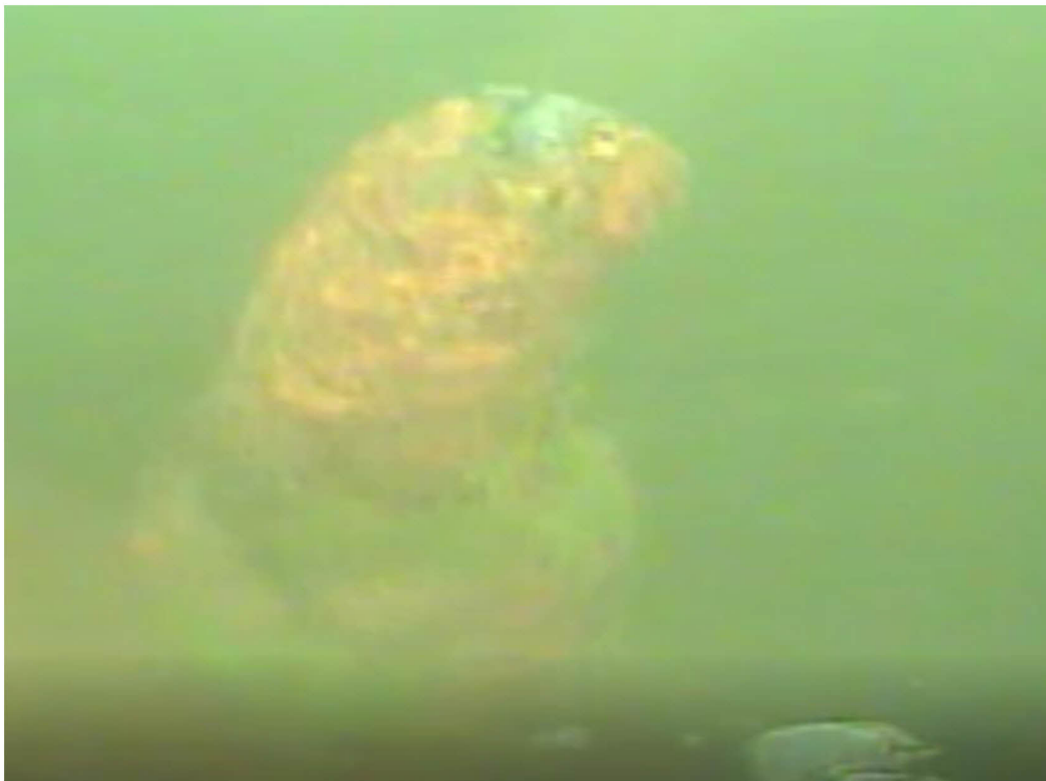
- Diffuser #4 - Welded connection to crown of main 8" pipe was in good condition with no cracks. Pipe had both rust corrosion and marine growth build up present. Pitting was present on pipe. Diffuser was not obstructed, and no cover or screen was present.

Figure 9- Diffuser #4 during flow test

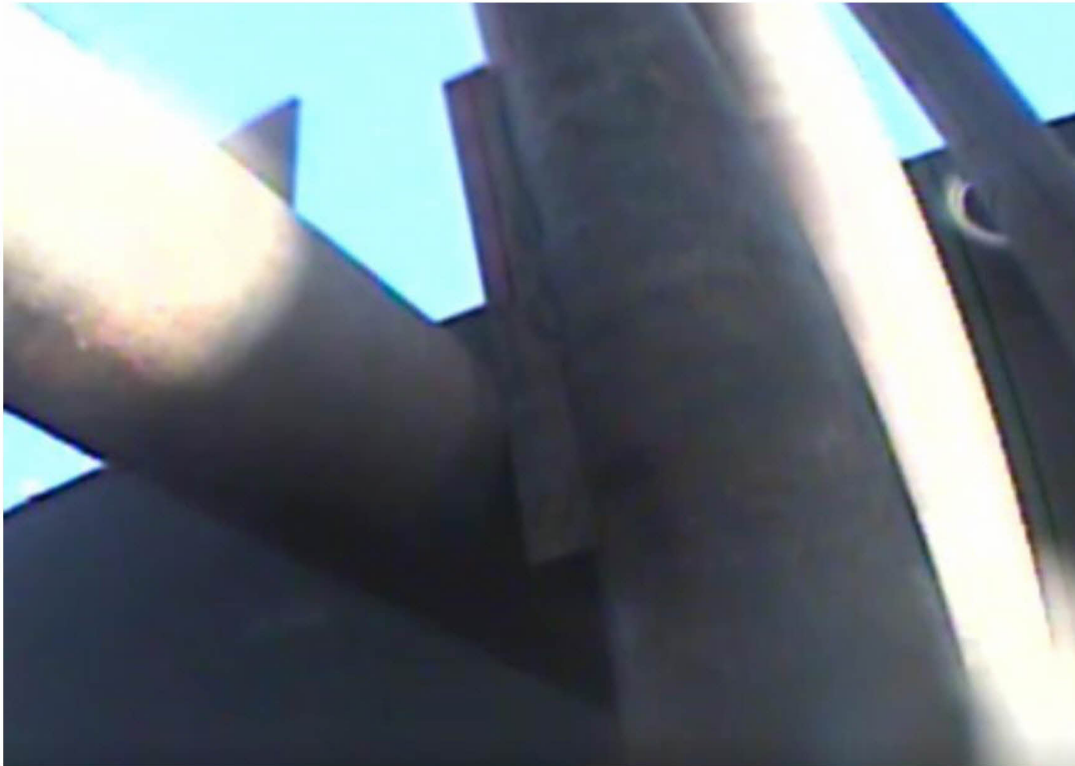
- Above surface horizontal support welded to 8" outfall pipe was in good working order with no broken welds present. (Figure 10)
- Below water vertical channel that is welded to 8" outfall pipe was in good working order with no broken welds present. Below water section was heavily corroded with marine growth and minor pitting is present. (Figures 11 and 12)

Figure 10- Above water of 8" pipe welded to horizontal support

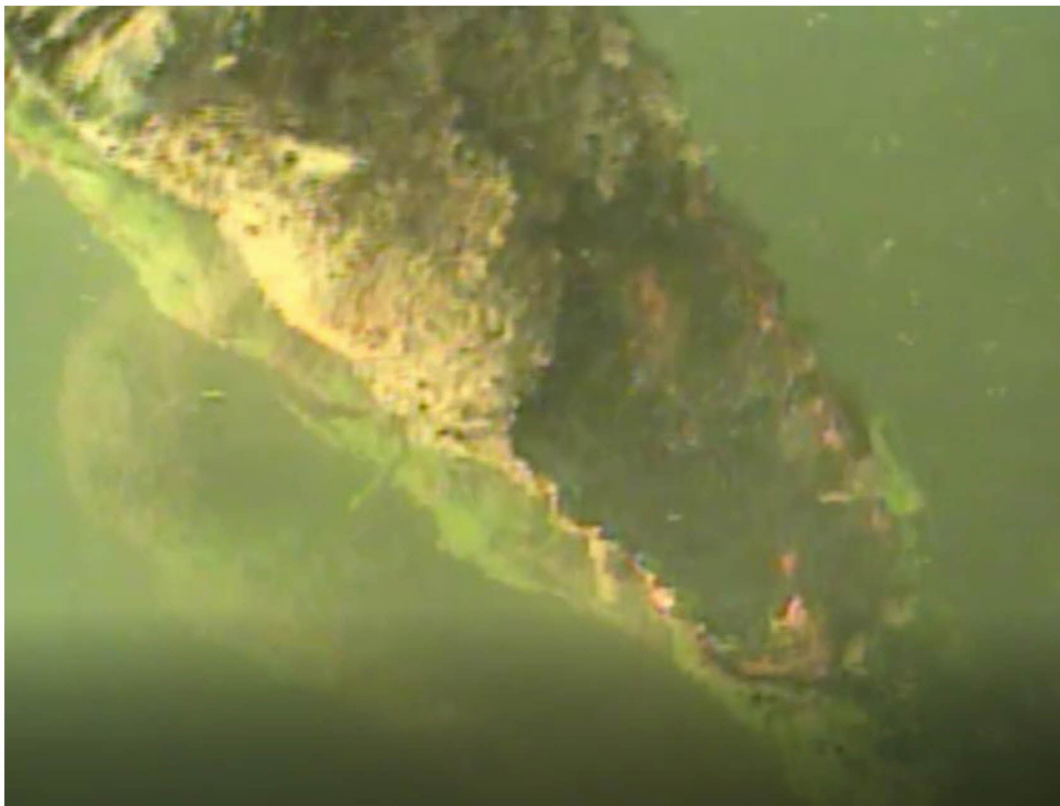
Figure 11- Below water vertical support with marine growth, rust build up and clean area exposing pitting

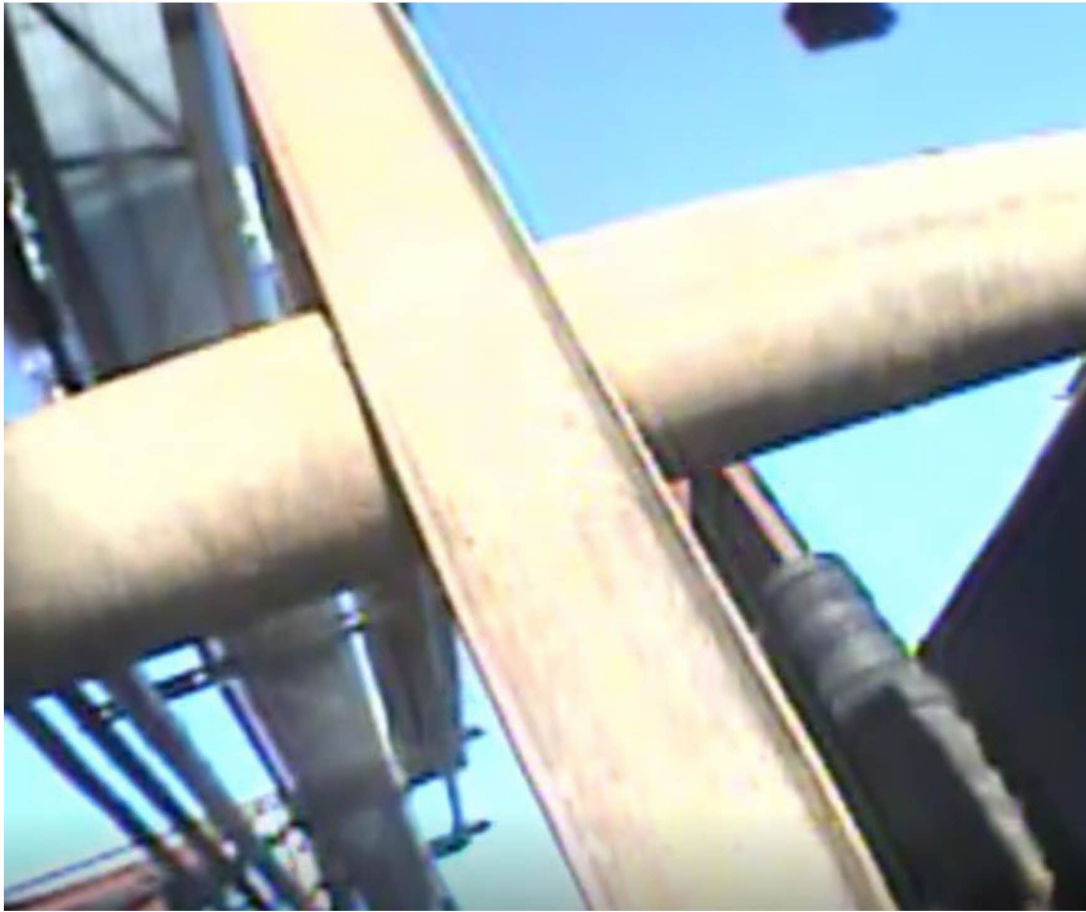
Figure 12- Above water view of vertical channel support welded into horizontal support
