Investigation Report

CenturyTel of Inter Island d/b/a CenturyLink

UT-132234

Staff Investigation
Consumer Protection
Regulatory Services

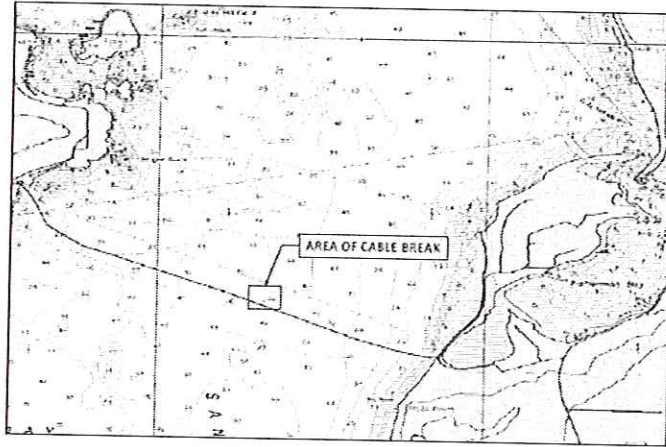
Figure 1 - Area of Cable Break

The following is my expert report, including assessments and recommendations, related to the Century Link cable break between Lopez Island and San Juan Island. The cable break was observed to have occurred sometime between the hours of 3:00 am and 4:00 am on November 5, 2015 midway in the San Juan Channel in about 230 feet of water. The Century Link submarine cable was installed in 1999 and was laid within a designated Cable Corridor. The cause of the break is still unknown.

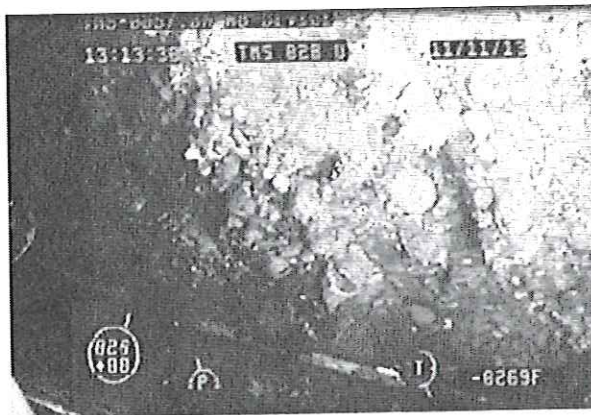
Figure 2 - Cable Wrapped on Rock Feature

Repair operations commenced on November 11, 2013 with a Remote Operated Vehicle (ROV) video inspection of the Century Link cable in the vicinity of the break. The ROV inspection revealed that the cable had been dragged north from its original position and pulled tight up against a rock feature.

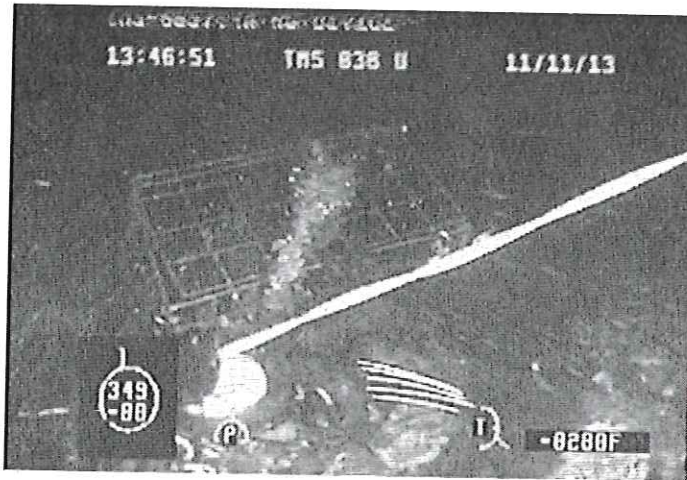
Figure 3 - Crab Pot with Polypropylene Line

A crab pot with polypropylene line was found entangled in the cable 90 feet west of the rock feature.

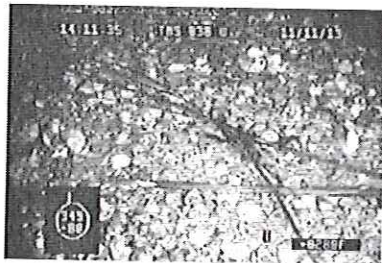
Figure 5 - Parted Cable End Eastern Side

The parted cable end on the eastern side of the break was found approximately 65 feet west of the entangled fishing gear and the end on the western side was found to be approximately 93 feet west of that.

As stated earlier, the cause of the break is still unknown, however, ROV inspection of the two parted cable ends strongly suggests that the cable fault was due to a tension break (as opposed to a localized failure due to abrasion).

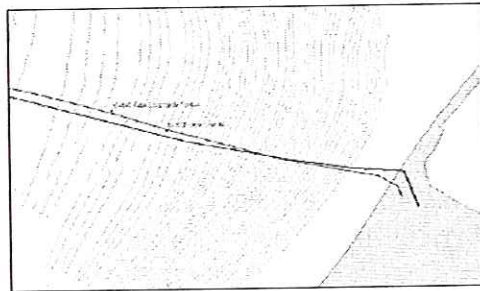
Figure 15 - Cable Loop Locations

The ROV also conducted video inspection of the Century Link cable starting west of the cable repair splice and then to the east, towards the Fishermen Bay landing. Areas of slight suspensions were found to the west of the cable repair splice.

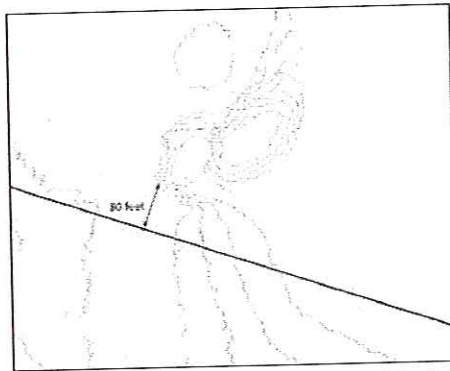
Figure 16 - Cable Route Separation from Rock Feature

Overlaying the 1999 cable route on the 2013 OPALCO survey data, the Century Link cable was installed within 80 feet of the rocky features within the cable corridor.

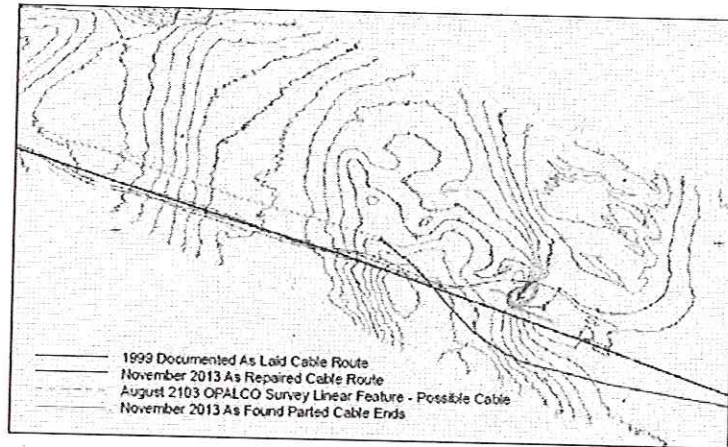
Figure 18 - Linear Feature Possible Actual As Laid Route

An observation worth noting is that the 2013 OPALCO route survey identified a linear feature that lines up with the Century Link repair splice position. The broken cable was found approximately 245 feet north of the documented 1999 as laid position. The linear feature (green dashed line in the drawing below) appears to run parallel to the 1999 cable route without any deviations or signs of localized displacement. It is possible that the cable laid in 1999 was actually laid 245 feet north of the documented route position list. This would have routed the 1999 Century Link cable through the rocky areas from the very start.

In hind sight, the cables in the San Juan Channel could have been buried below the seabed using either a towed plow or an ROV with jet burial capabilities. Cable burial should be considered for future cables crossing the channel.

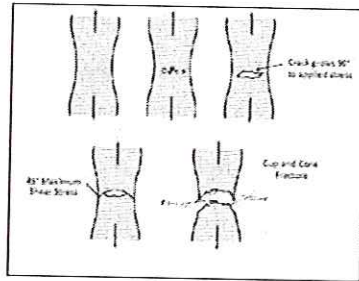
Figure 21 - Tension Break Characteristics

Visual inspection of the western parted cable end clearly indicated that the cable failed due to a tension break. Armor cable tension breaks are characterized by necking, or a thinning of the armor wires and copper sheath before failure.

It is of my expert opinion that the cable was dragged along the seabed by an anchor, fishing gear or some other towed device that caused the cable to wrap itself tightly around a large rock feature. The cable broke due to excessive tension over time after multiple entanglements or during a single entanglement event.

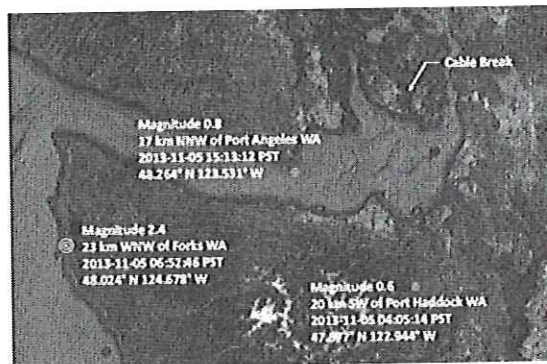
Figure 24 - USGS Historical Data November 5, 2013

According to the U.S. Geological Survey (USGS) historical database, there were three earthquakes in the region on the day of the cable break on November 5, 2013.

Given the magnitude of the earthquakes, the 2013 OPALCO route survey and video observations of the rock features in the vicinity of the break, it seems very unlikely that any of these earthquakes were responsible for the cable break. The OPALCO survey and the ROV video inspection show no indication of instability of the rocky area. There are no signs of slumping or rock slides in the area of the break.

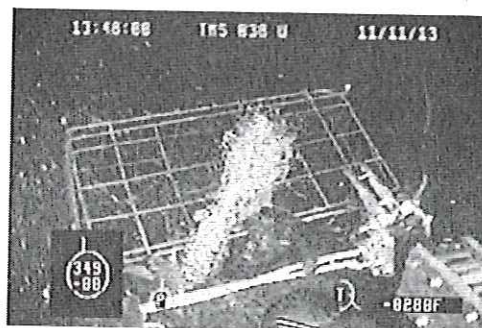
Figure 25 - Crab Pot Entangled with Cable

The ROV inspection shows one crab pot entangled in the cable and another, mostly buried, in a nearby area.

It is possible that a pot was involved in the cable fault, but it may also be a piece of derelict gear entangled in the cable before or after the break. Factors that make it a less likely cause include the fact that crab pots are legally required to be fished with one pot per buoy line. That means that strings of pots on "ground lines" that may be retrieved with grapnels are not used.

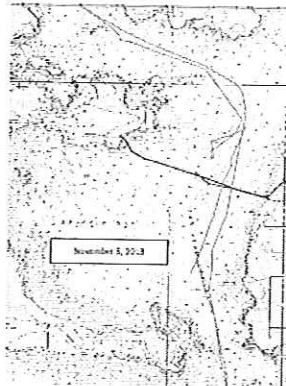
Figure 29 - RV Centennial Nov 5 2013

AIS data initially pointed to activity of a research vessel. The RV Centennial is capable of such a complete cable break, with 58' length, 425 HP engine, winches, trawl and dredge equipment for scientific sampling. However AIS records indicated that the RV Centennial was at the dock in Friday Harbor when the fault was reported. It did not arrive in the break area until approximately 10:14 PM PST on transit to an area well south of the break. It returned to the break area and conducted more complex maneuvers at slow speed at approximately 1:30 PM PST, almost ten hours after the reported alarm.

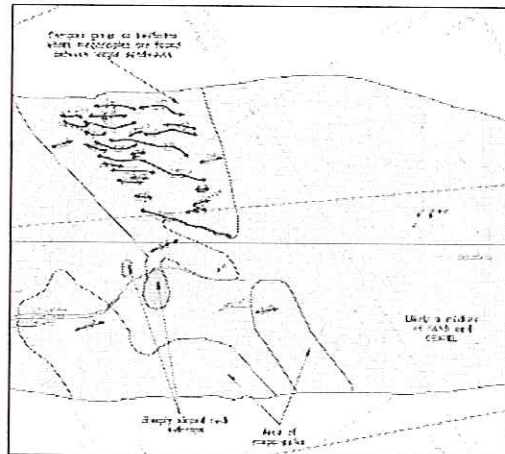
Figure 34 - 2013 OPALCO Survey Geophysical Interpretation

Post lay burial may be performed on sections of the Century Link cable in the middle of the channel. Geophysical data interpretations from the 2013 OPALCO survey indicate that most of the seabed along the cable is comprised of a mixture of sand and gravel.

An ROV with high pressure jetting swords could be used to retro bury the Century Link cable to a target depth of 1 meter below the seabed.

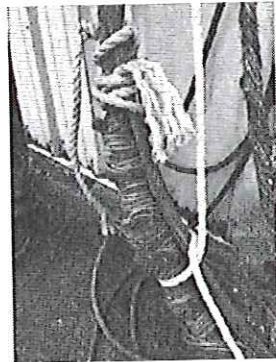
Figure 36 - Balled Up Jute

The 2013 OPALCO survey data indicates that several of cables in the vicinity of the cable break have been dragged to the north into the rocky areas. The 1995 OPALCO Power Cable repair encountered fishing nets entangled with the cable. The 2013 Century Link cable repair encountered a crab pot entangled with the cable and visual inspection of the cable showed damaged sections of jute indicating that the cable had been dragged along the seabed or that an object had been dragged along the cable.

This suggests that vessels have been active in the area and that the cables have been subjected to external aggression from bottom fishing, anchors or towed devices.

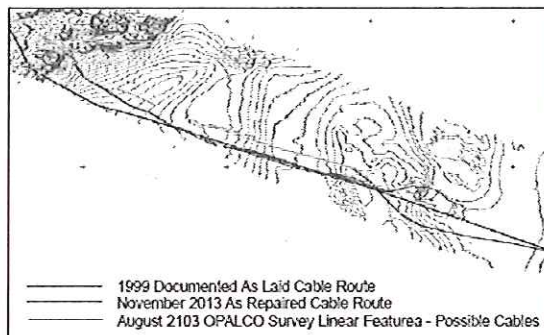
Figure 38 - Other Cables in the San Juan Channel

From conversations with UTC and Century Link, there are several live cables and several out of service cables laid in the same vicinity as the Century Link cable. From the ROV video inspection and the 2013 OPALCO survey, it is clear that these cables cross each other.

Great care will need to be taken on future cable repairs so as not to damage another live cable. As additional cable are planned for the future, Century Link and other cable owners should interface with each other to establish new non-conflicting cable routes. Removal of out of service cables is now required t many landing sites around the world. Consideration for cable removal at landing sites may also be required at some into to make room for new cables.
